ACADEMY OF HOPE - WARD 5 & 8

EDUCATIONAL SPECIFICATION:

Report of Property Condition Assessment

Academy of Hope - Ward 5

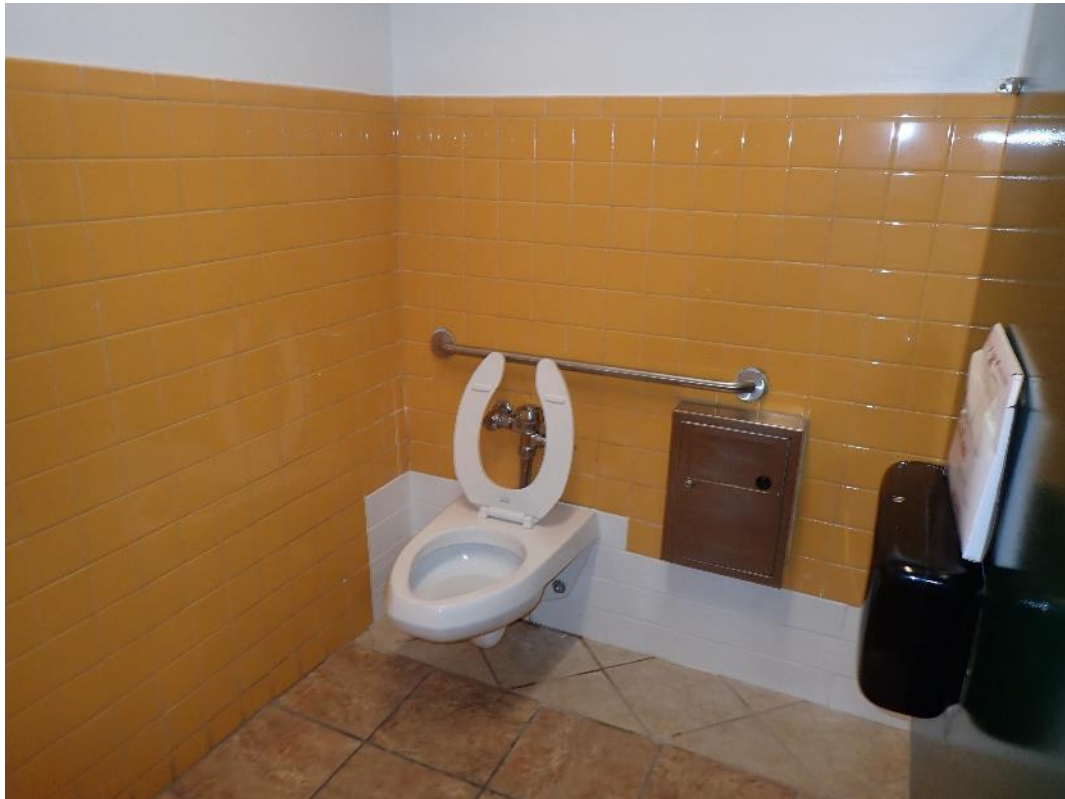
Photograph 3: Accessible stall (note: missing handrail to left-hand side).

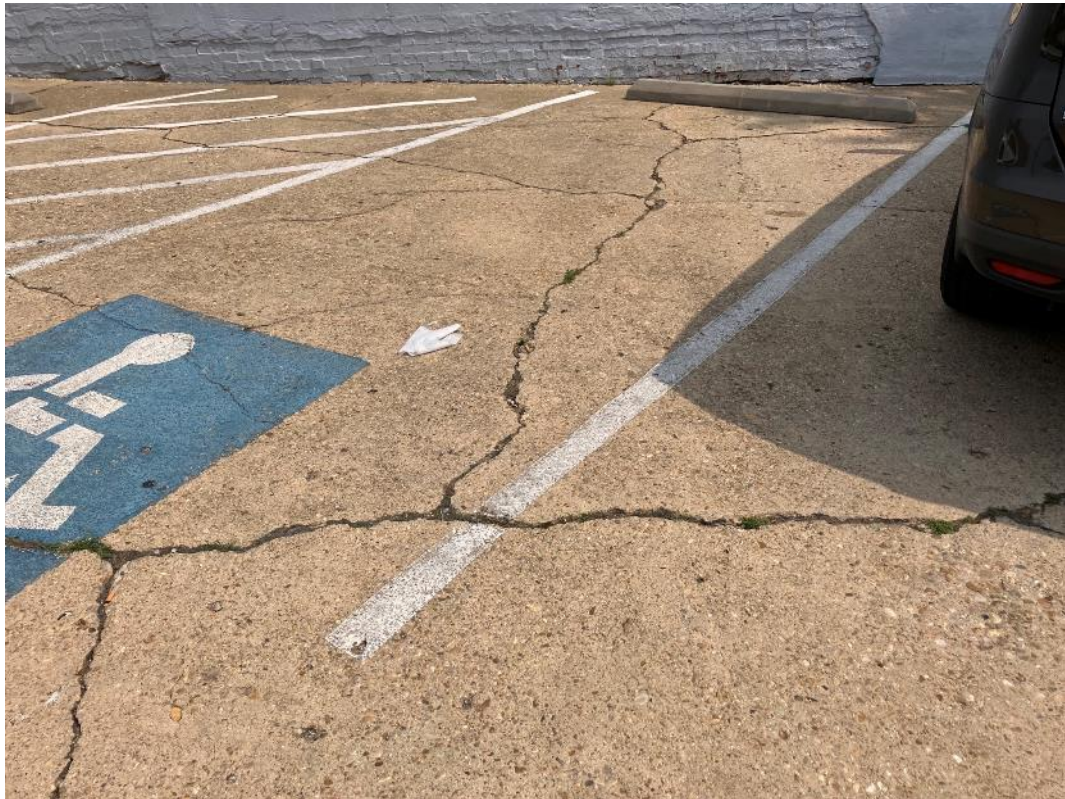
Photograph 7: Cracking to concrete paving at parking area.

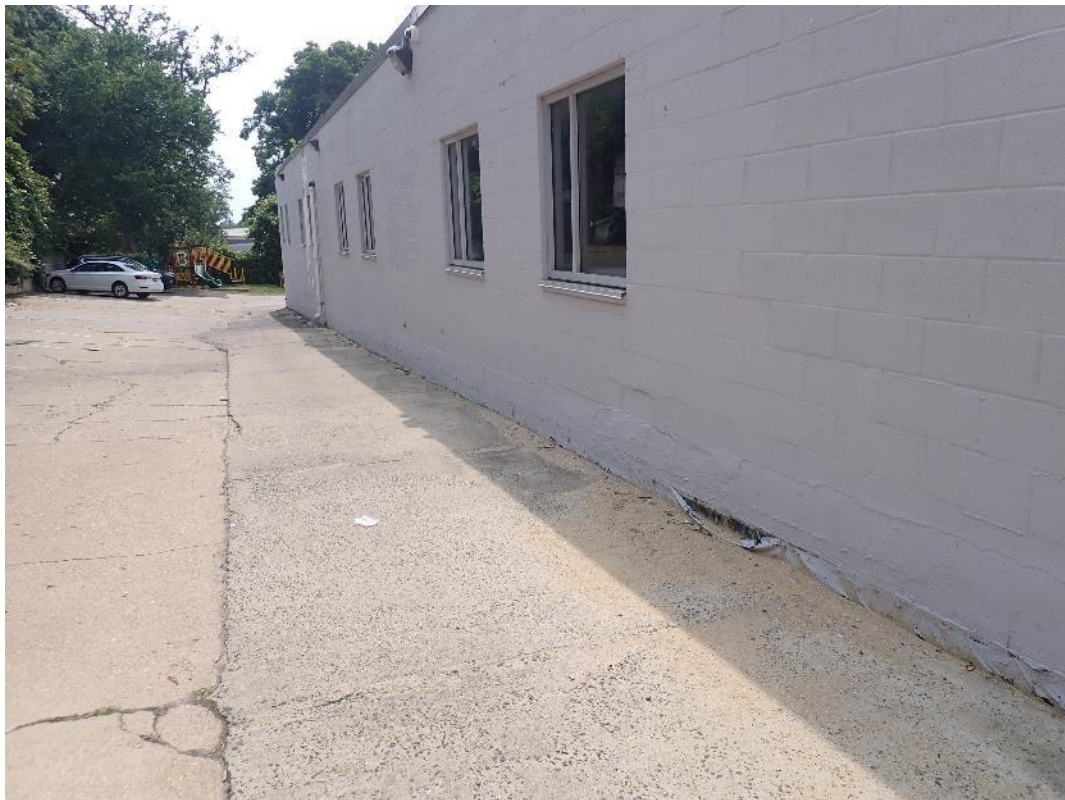
Photograph 8: Cracked concrete paving.

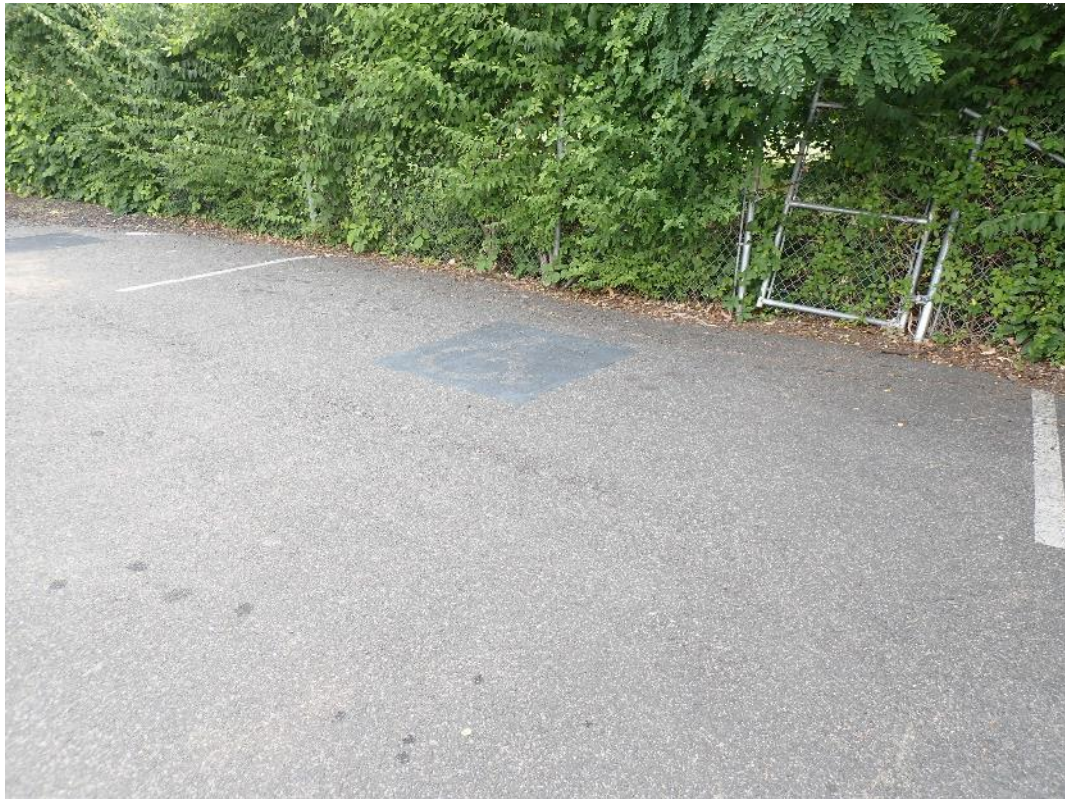
Photograph 9: Typical site asphalt - note non-compliant ADA parking stall

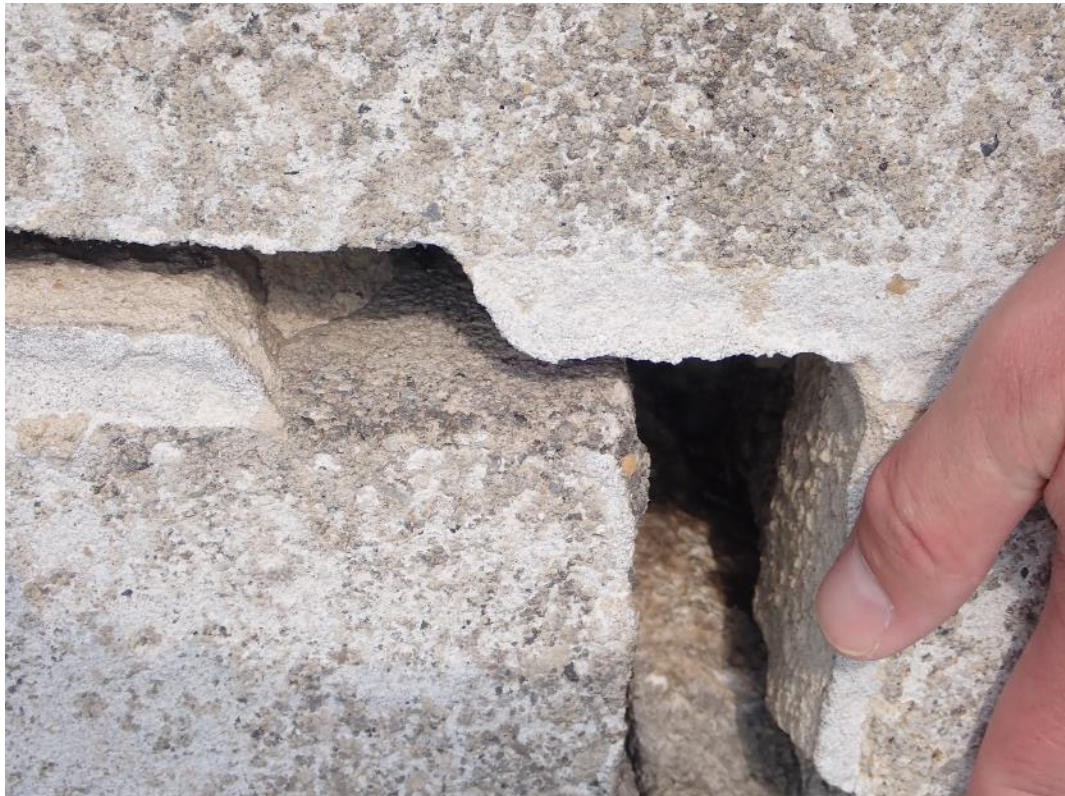
Photograph 14: Extensive structural cracking at exterior wall.

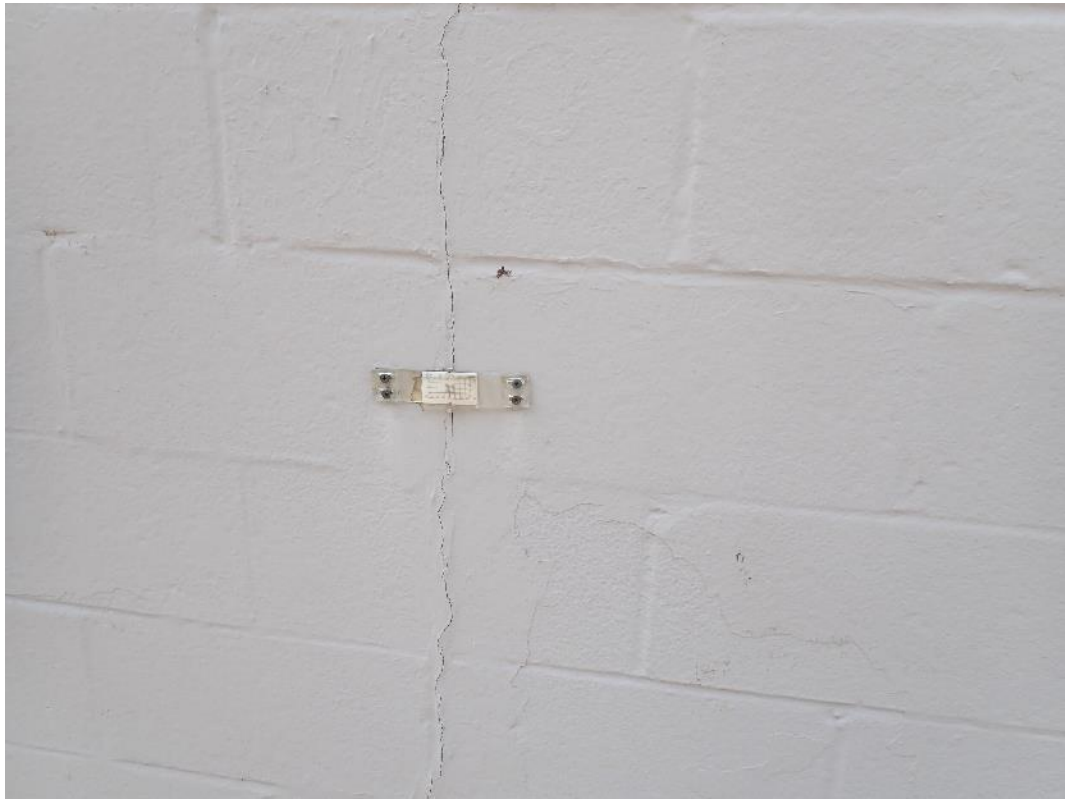
Photograph 15: Crack gauges on exterior wall from previous crack monitoring.

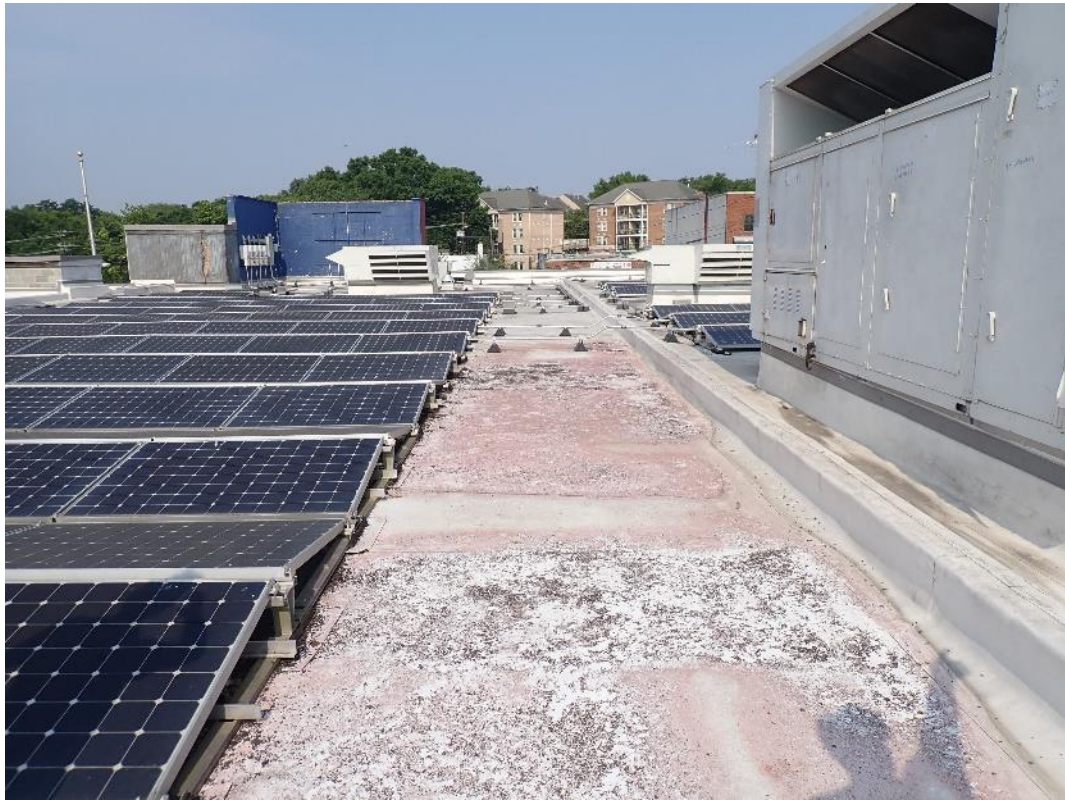
Photograph 17: Staining and debris on TPO roof from excessive water/drainage issues.

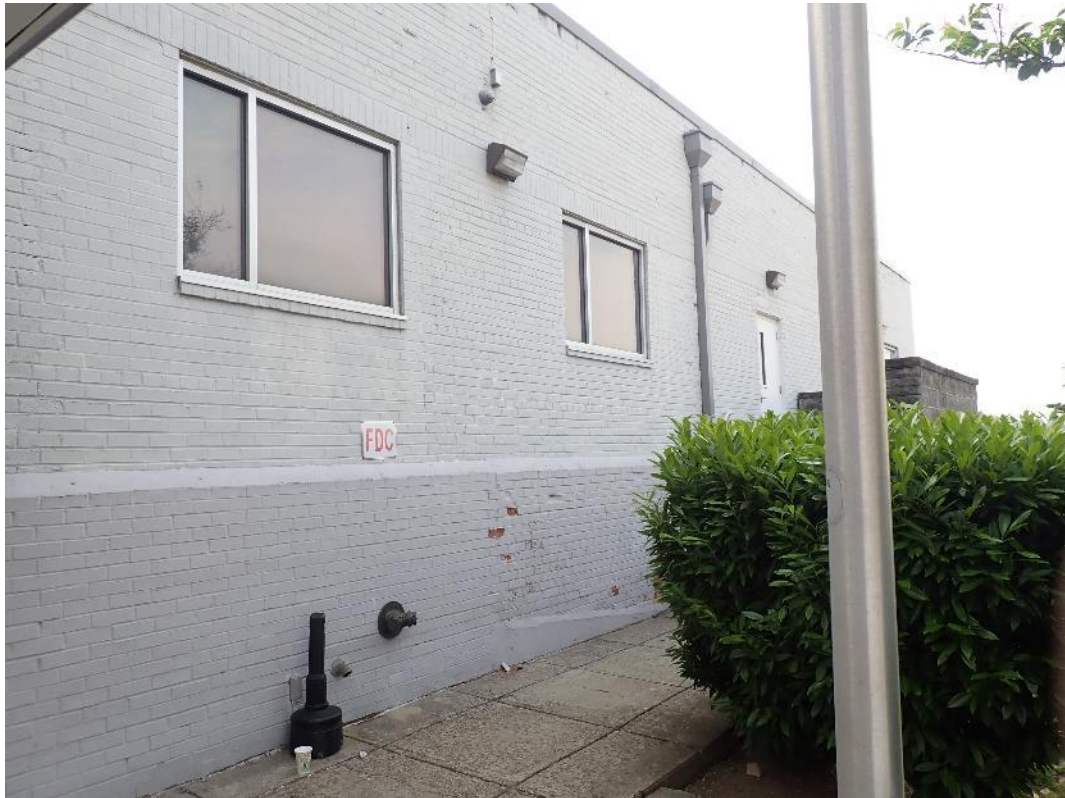
Photograph 20: Typical exterior wall and window systems. Note localized spalled bricks

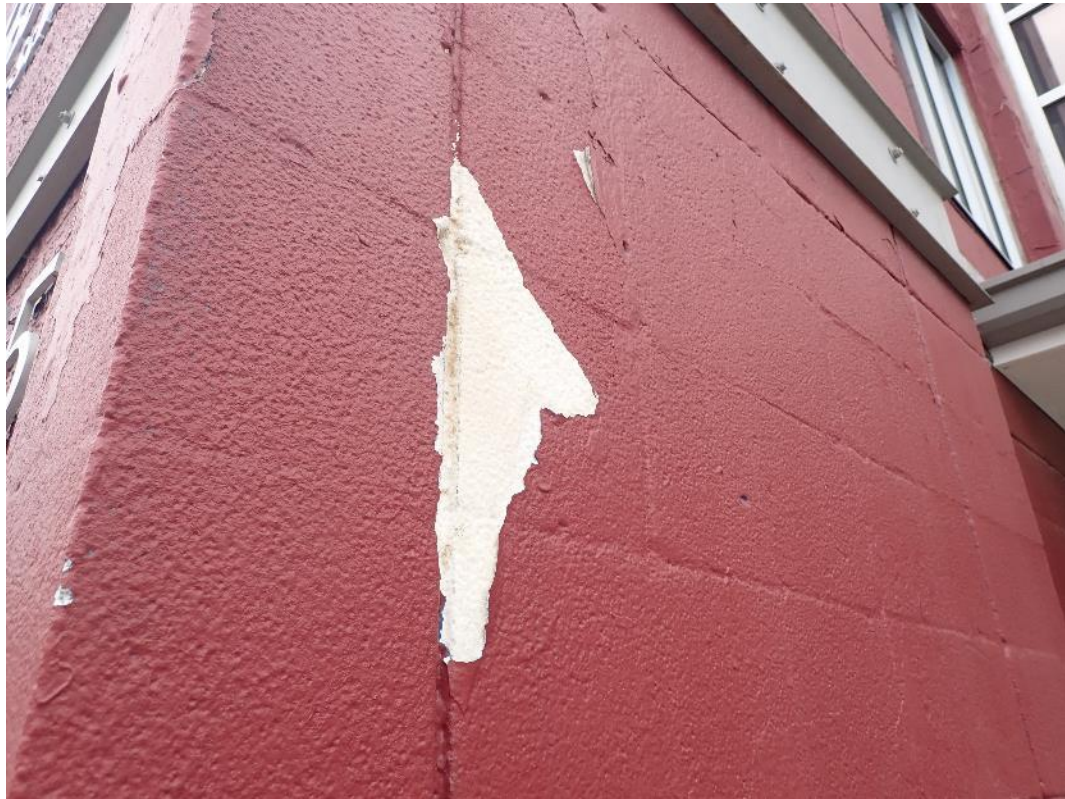
Photograph 23: Deteriorated paint finishes at main entrance area.

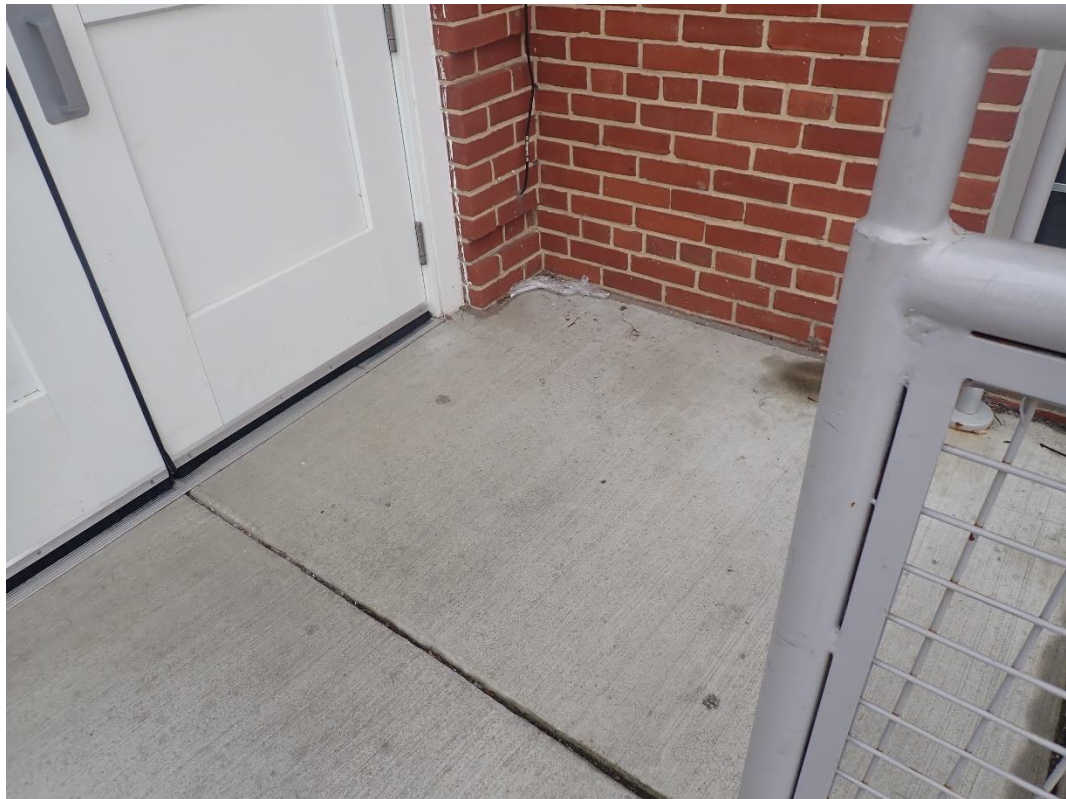
Photograph 2: Inadequate space provided at the top of the accessible ramp

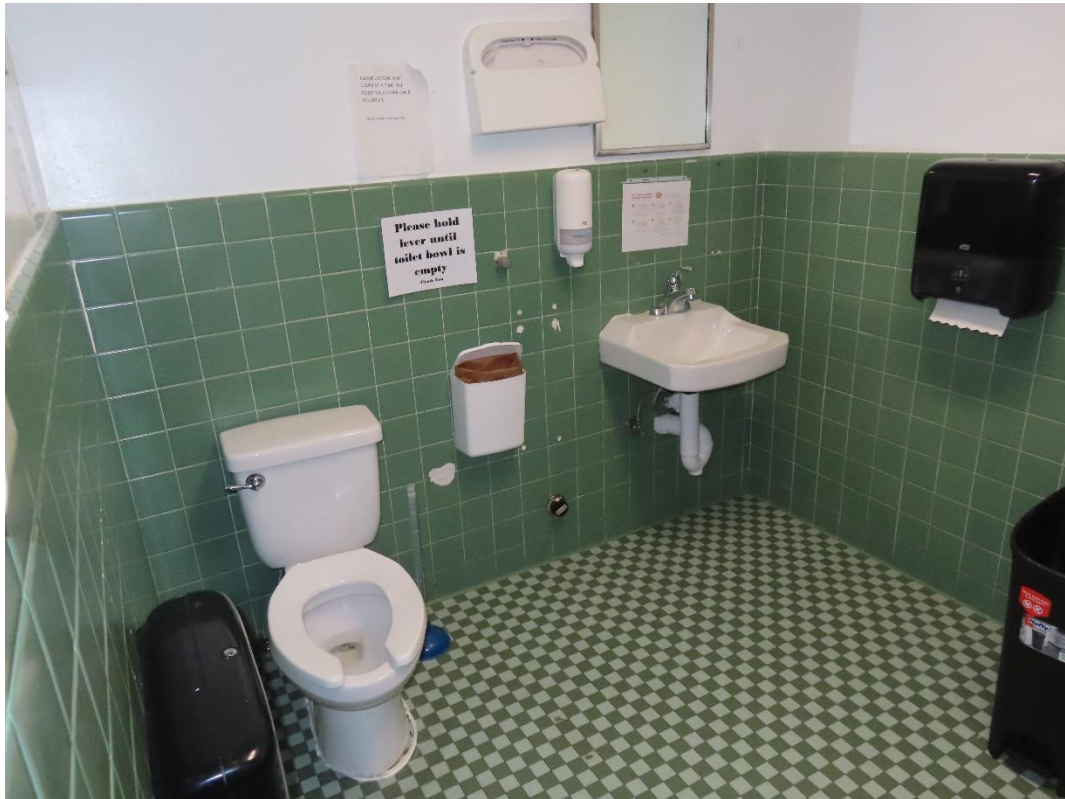
Photograph 3: Add grab rails to make ground floor accessible rest room fully accessible.

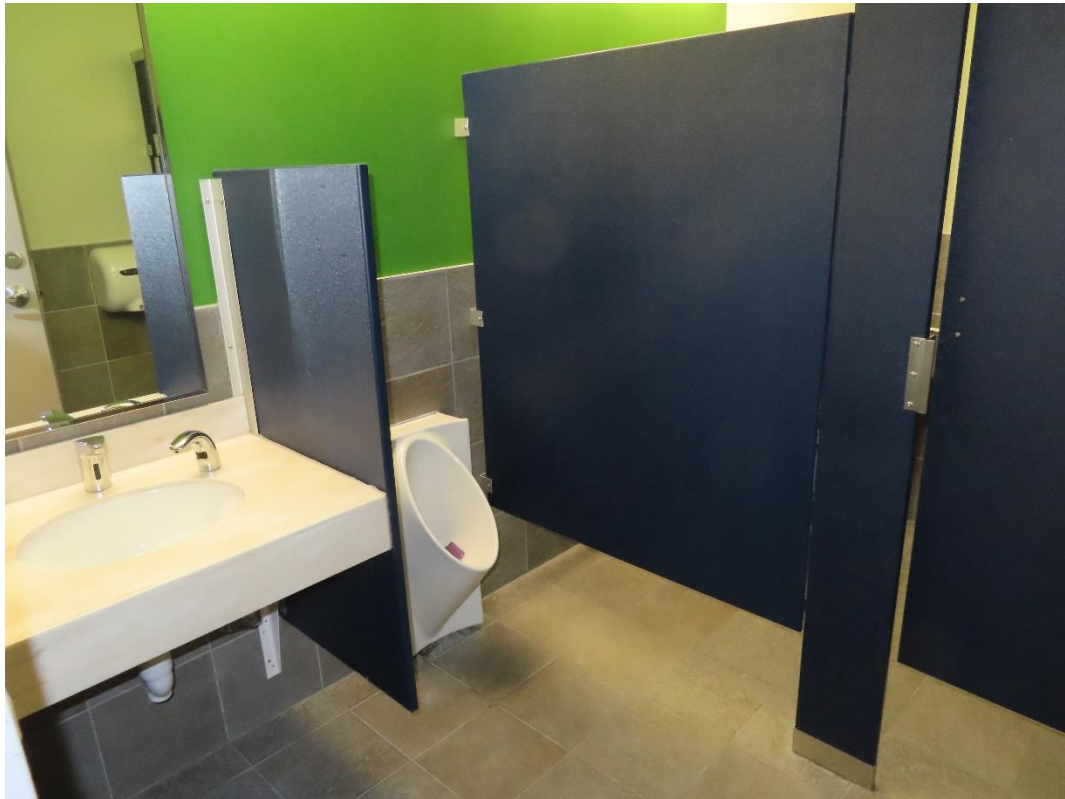
Photograph 5: Inadequate turning space in male restroom adjacent to main hall.

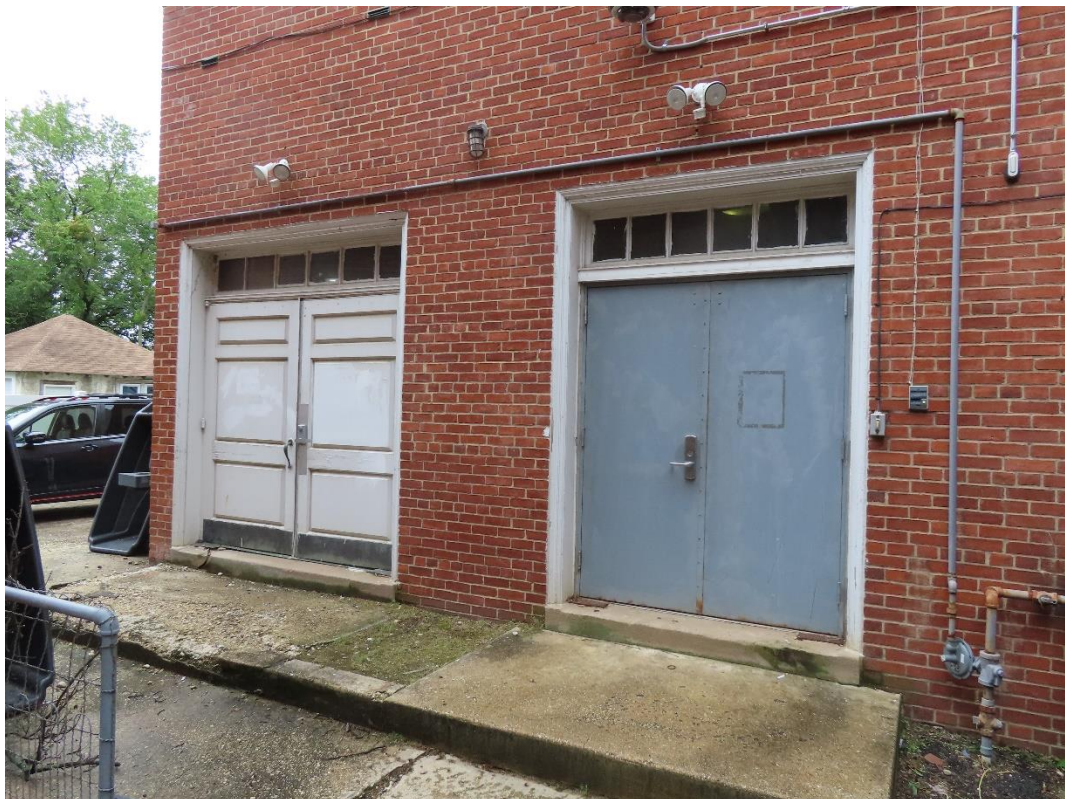
Photograph 6: Deteriorated concrete at step

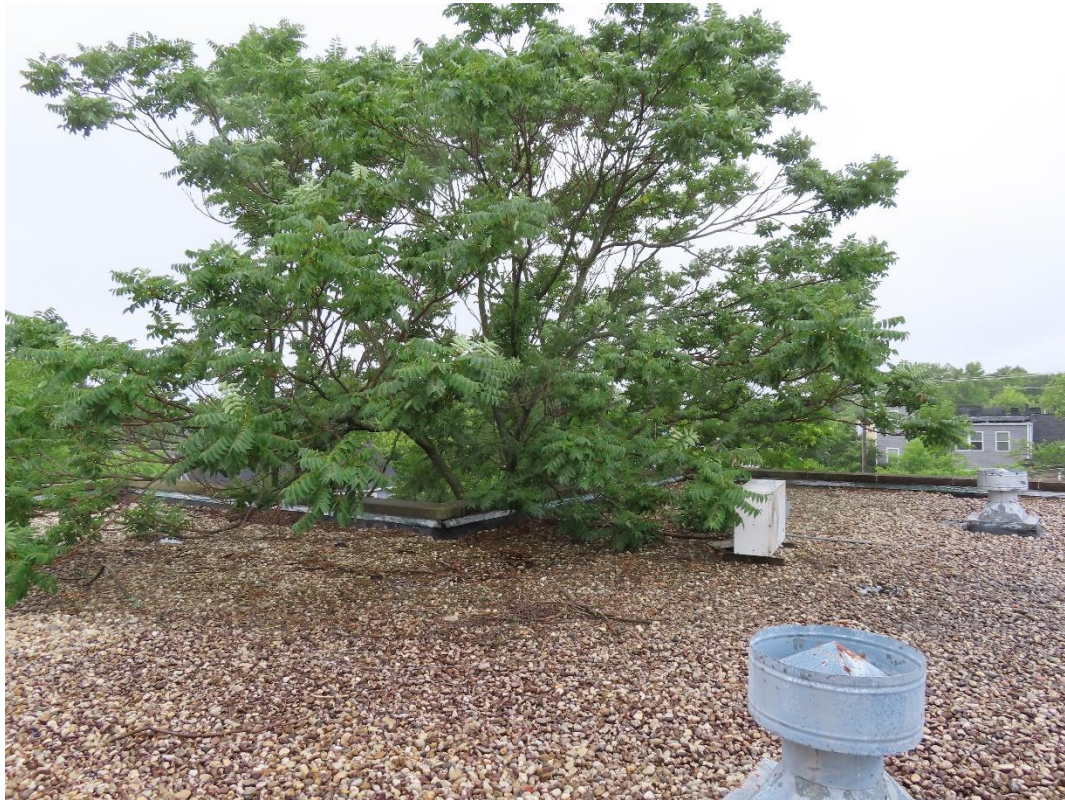
Photograph 7: Encroaching trees on roof.

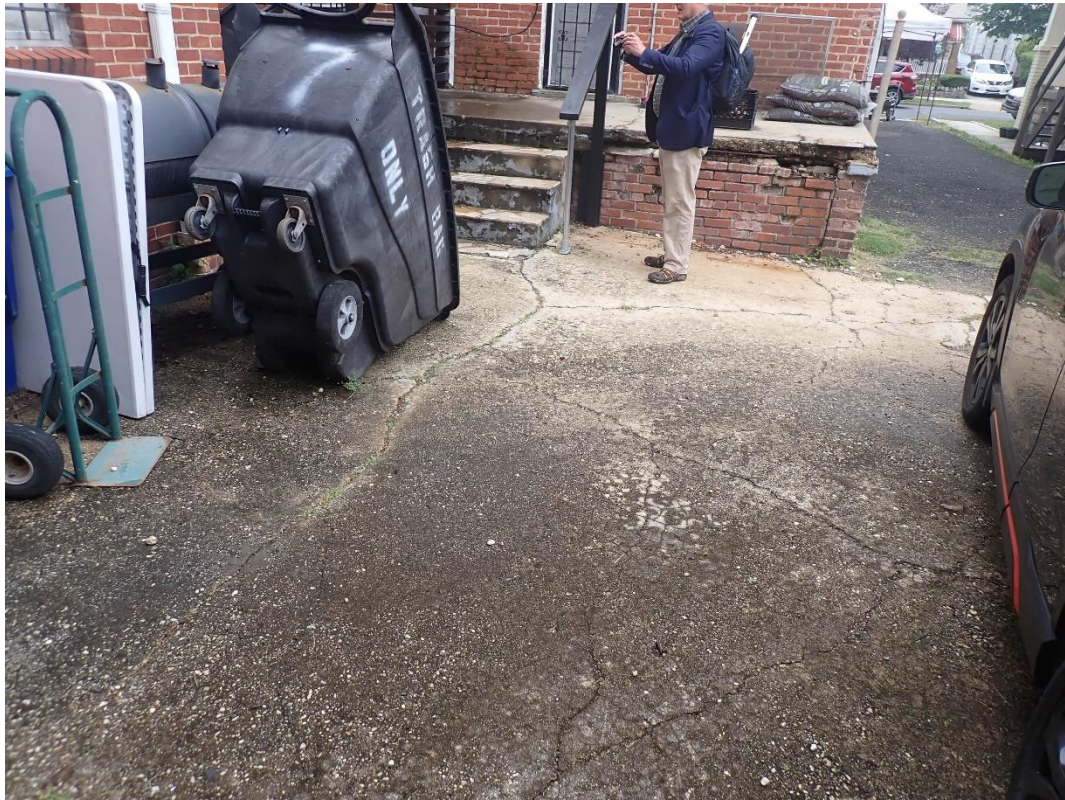
Photograph 9: Cracked concrete paving.

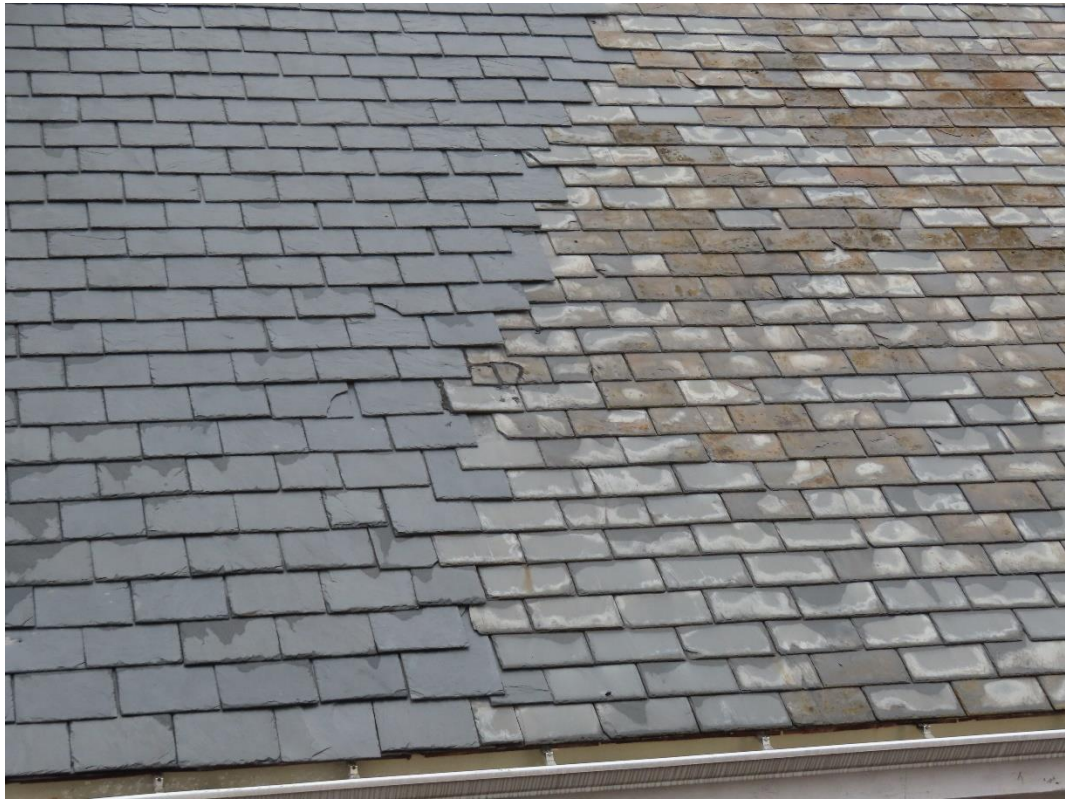
Photograph 13: Misalignment of slate materials and slipped and damaged slates.

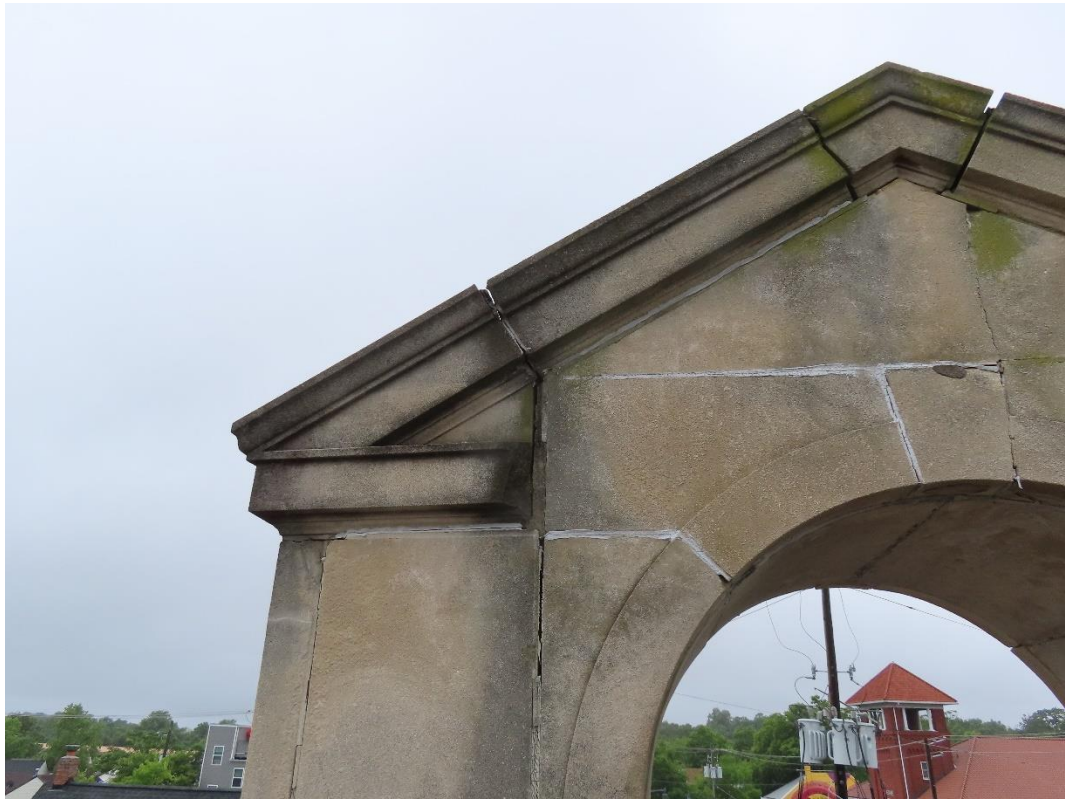
Photograph 15: Open mortar joints and previous joint repair to bell tower.

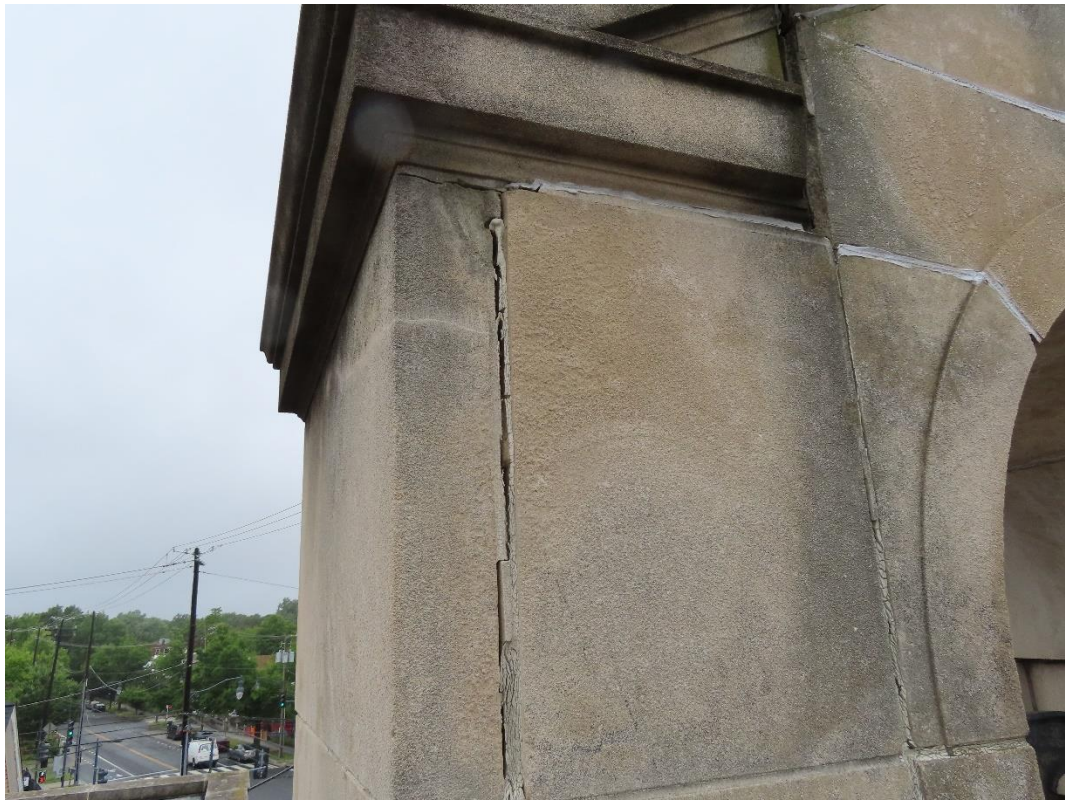
Photograph 16: Movement of stone panels to bell tower.

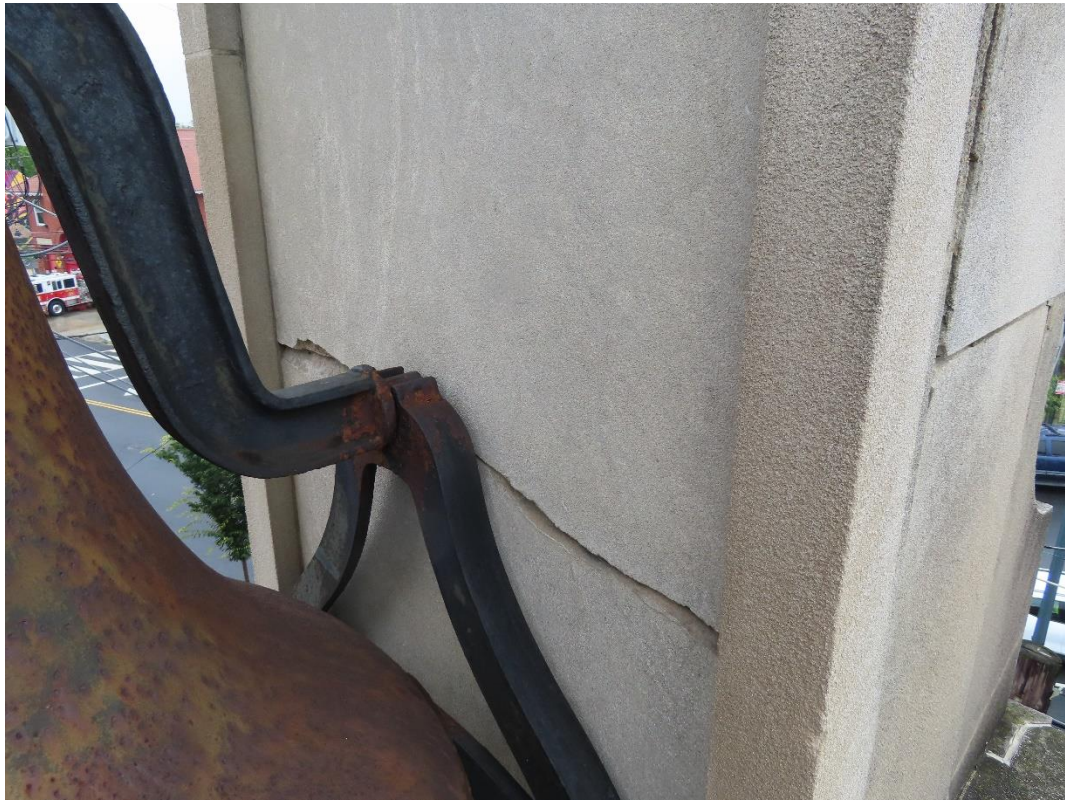
Photograph 17: Cracked stone panel and panel movement.

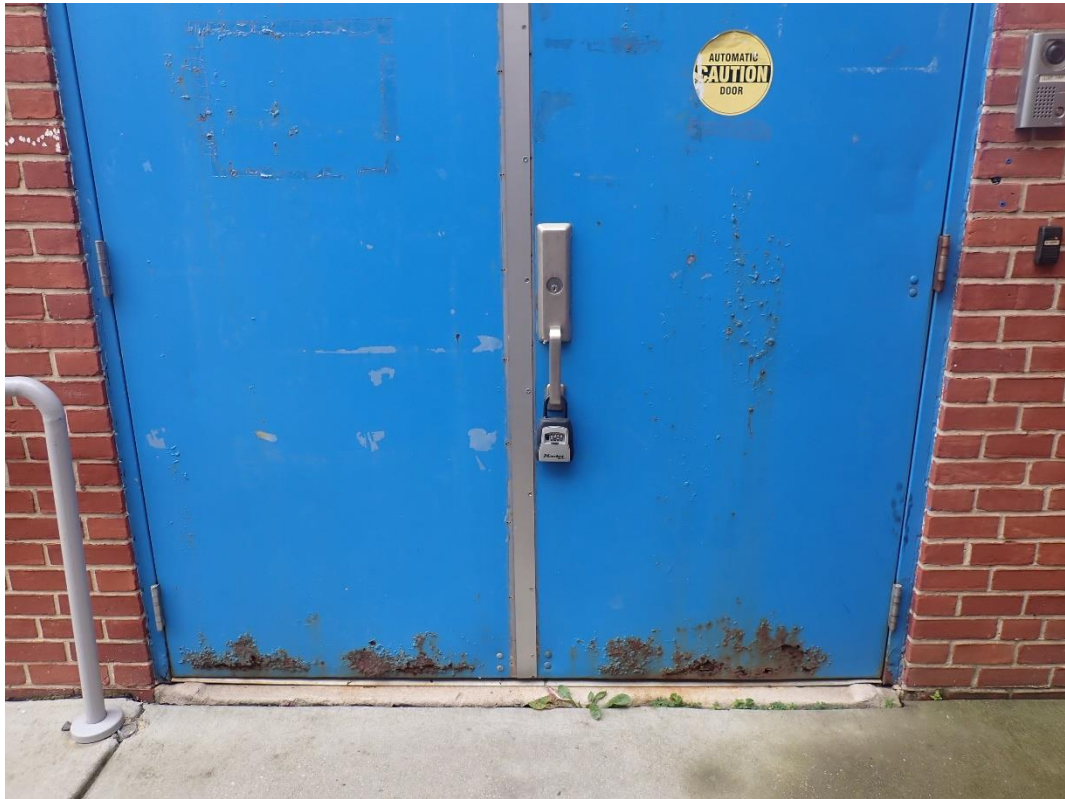
Photograph 21: Corroding egress doors to Stairwell B.

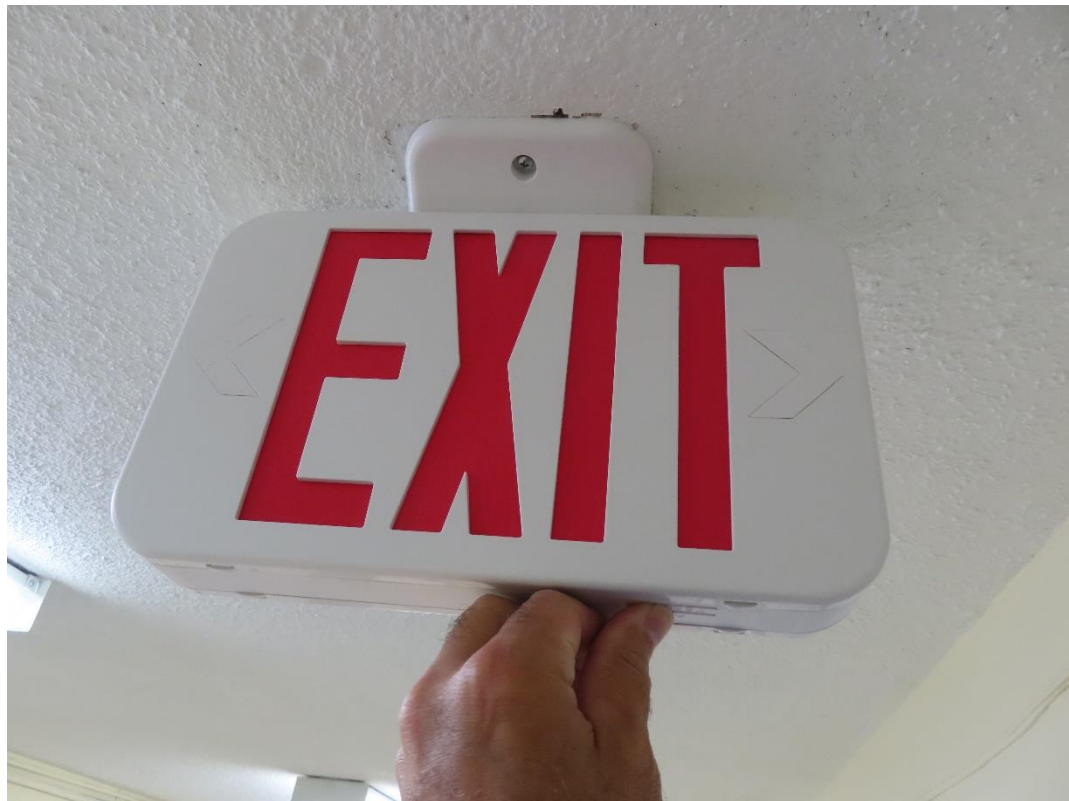
Photograph 47: Non-operational battery backup to internal egress light.

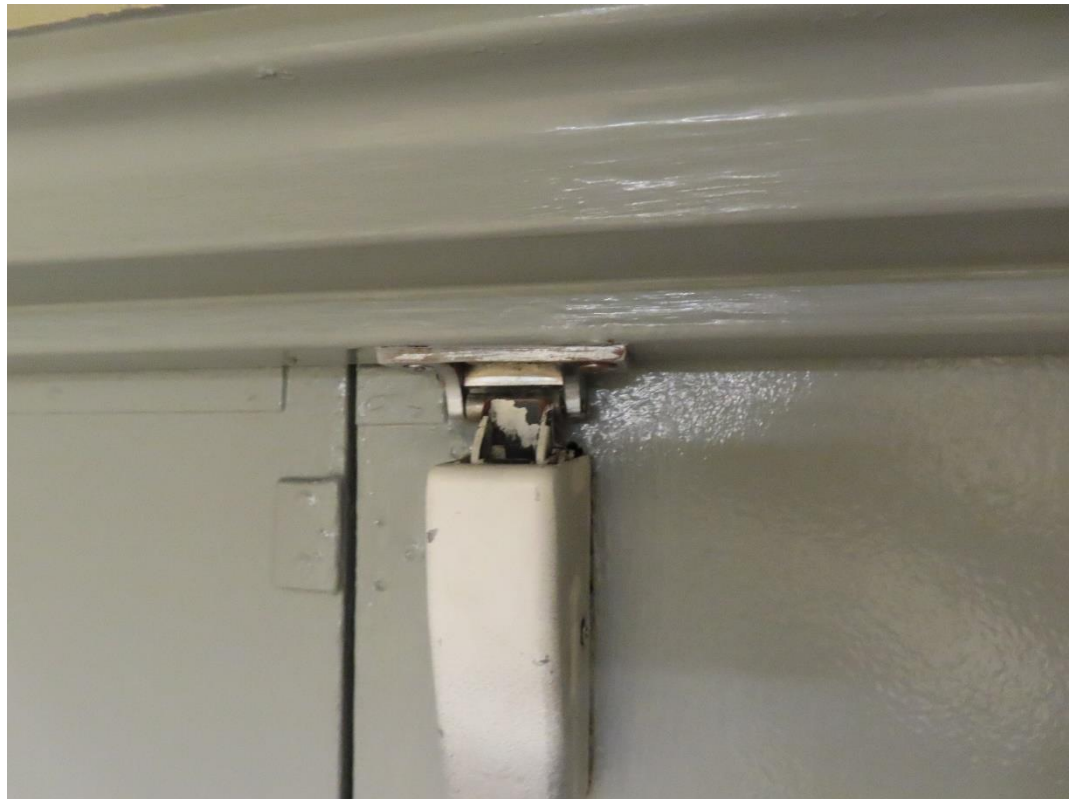
Photograph 48: Inoperable emergency egress hardware.

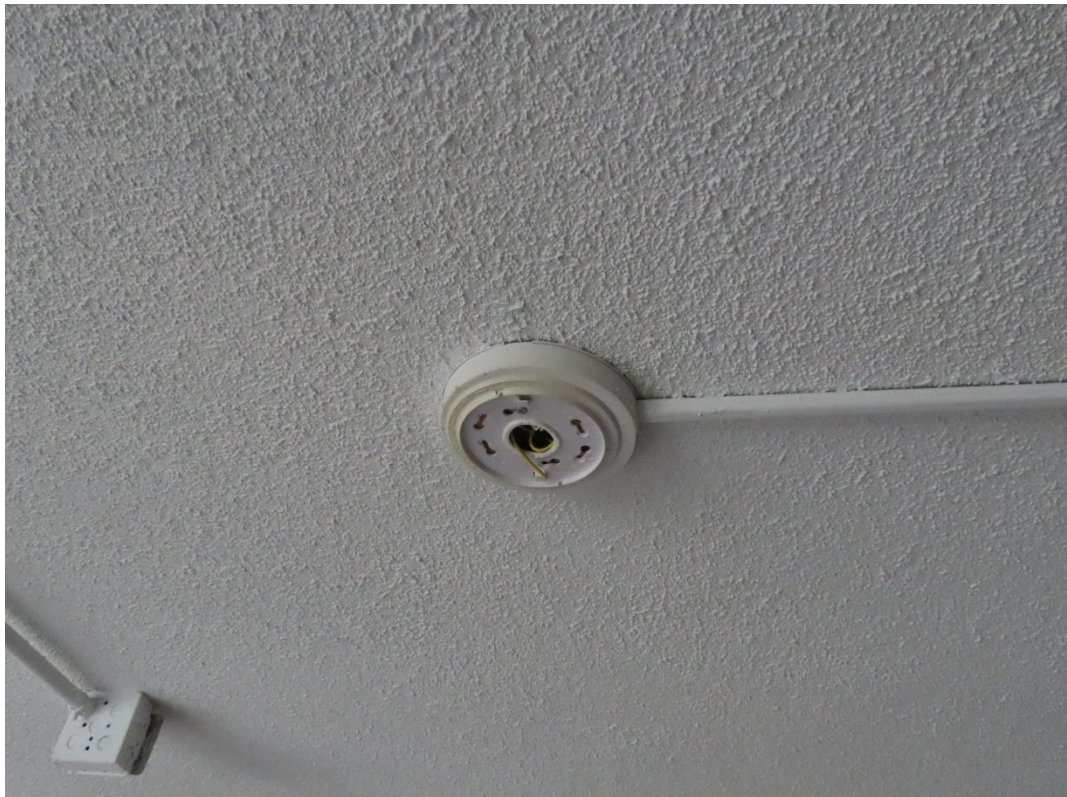
Photograph 50: Missing detector head in classroom.
