27 June 2018
File No. 16081-001

Subject: Quarterly Instrumentation Report No. 8
Academy of Hope
2315 18th Place NE
Washington, DC 20018

CRACK GAGE LOCATION PLAN

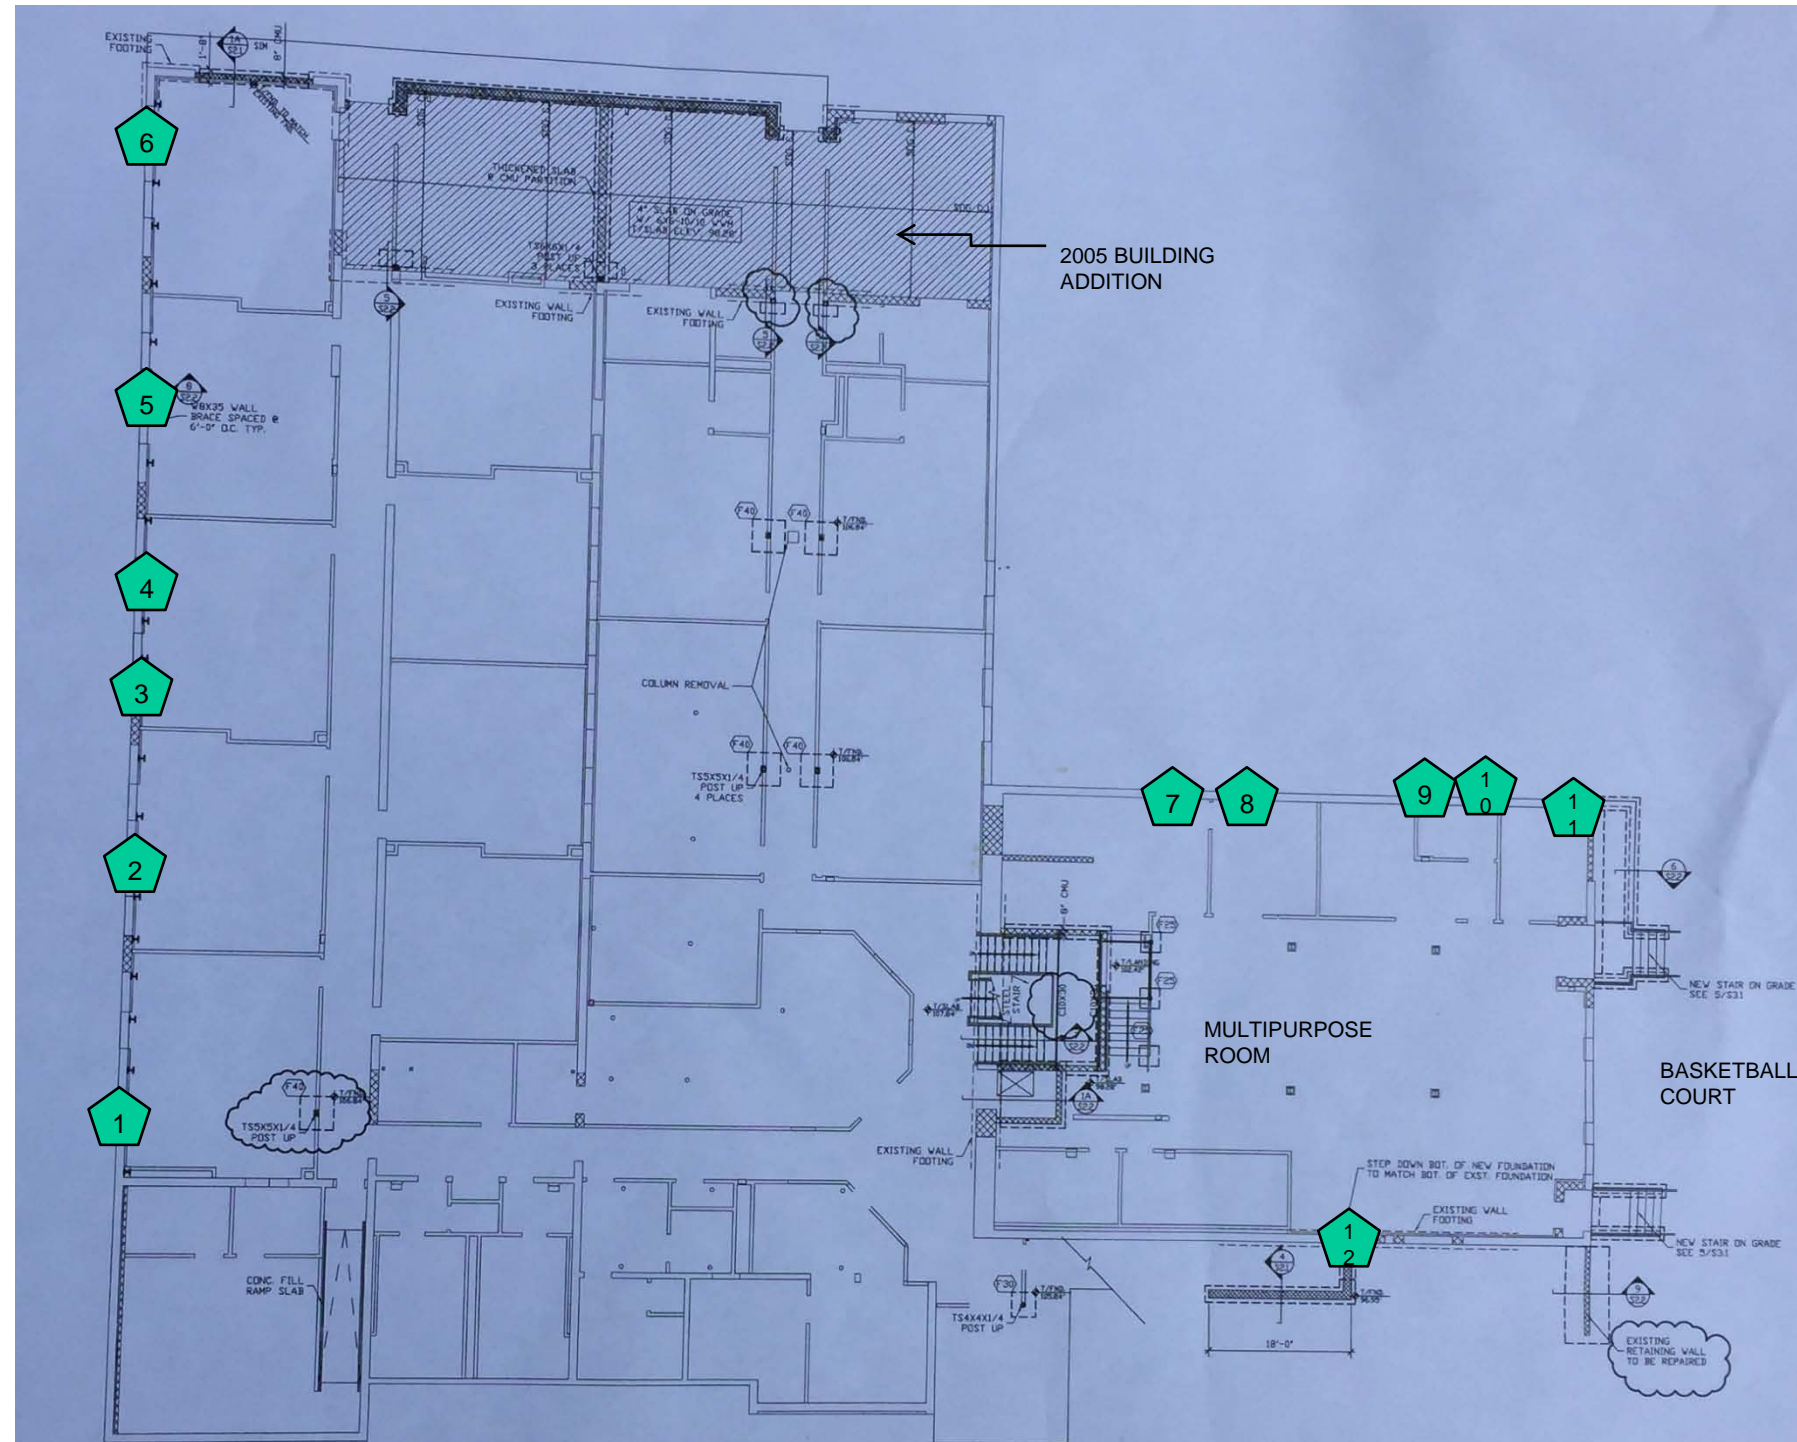
FIGURE 1

DESIGNATION AND APPROXIMATE LOCATION OF CRACK GAGES

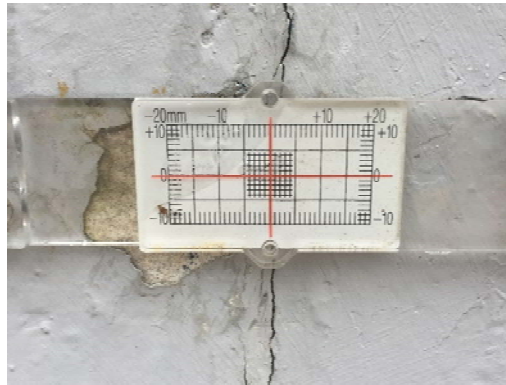
In examining all of the readings to date, crack gauges #'s 1, 2, 3, 4, 5, 9, and 12 have all showed patterns of movement and reversion of movement with overall range of motion of less than approximately 1.0 mm, except for gauge #12 which is discussed below. Crack gauges #6, #7, and #8 have shown very slight movements of 0.3 mm or less for the last seven quarters, and gauges #10 and #11 experienced movement of 1.0 mm along the vertical axis during the first quarter of monitoring, but these readings have changed very little over time. The small magnitudes of movement can likely be attributed to environmental factors such as moisture or temperature changes, or could be related to seasonal changes in the moisture content of underlying plastic soils resulting in some shrink-swell action. The trends in the readings over time support this conclusion.

Photo 1: Crack gauge 1 position on a vertical crack on the north exterior wall.

Photo 2: Close up view of crack gauge 1.

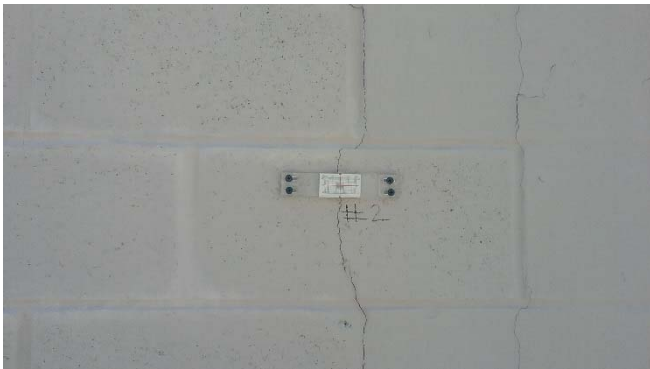
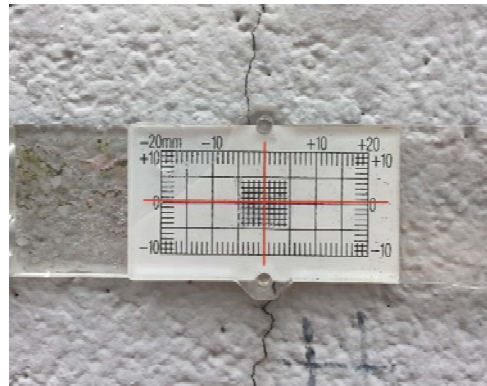
Photo 3: Crack gauge 2 position on a vertical crack on the north exterior wall.

Photo 4: Close up view of crack gauge 2.

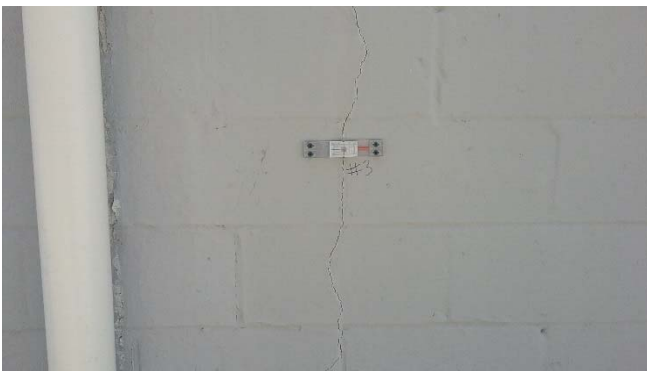
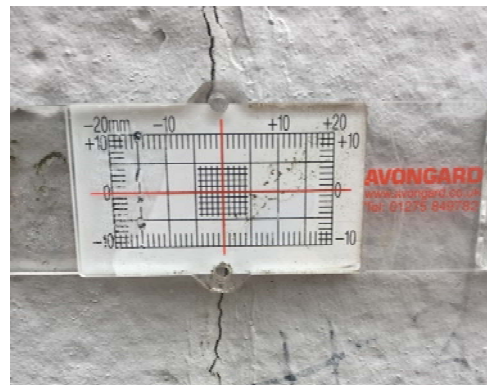
Photo 5: Crack gauge 3 position on a vertical crack on the north exterior wall.

Photo 6: Close up view of crack gauge 3.

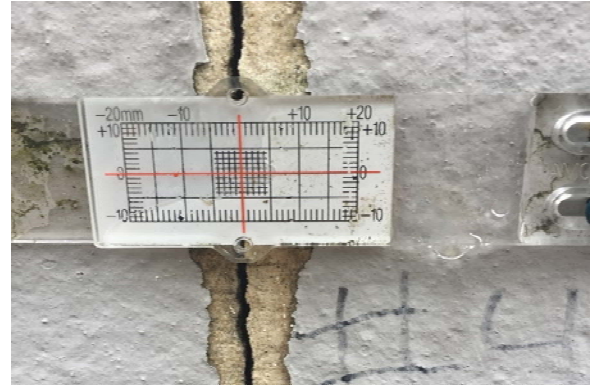
Photo 7: Crack gauge 4 position on a vertical crack on the north exterior wall.

Photo 8: Close up view of crack gauge 4.

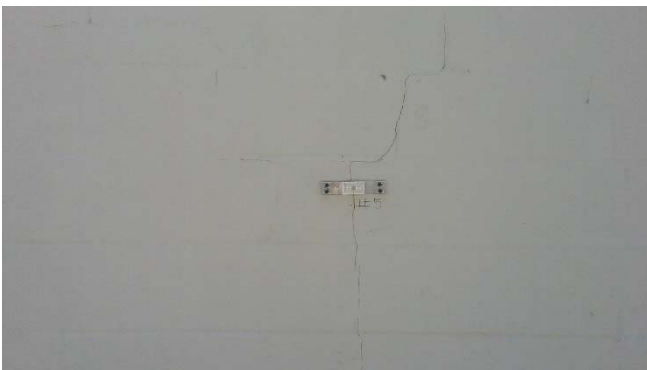
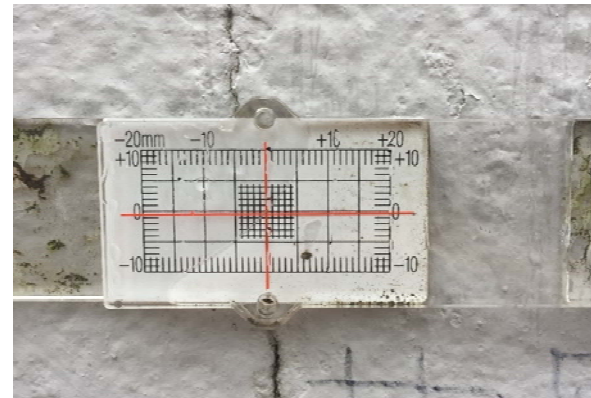
Photo 9: Crack gauge 5 position on a vertical crack on the north exterior wall.

Photo 10: Close up view of crack gauge 5.

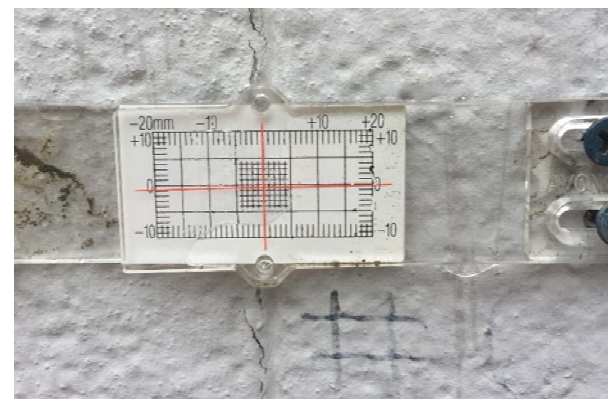
Photo 11: Crack gauge 6 position on a diagonal crack on the north exterior wall.

Photo 12: Close up view of crack gauge 6.

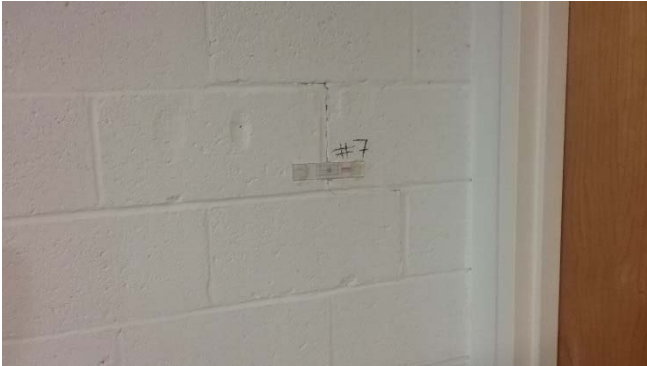
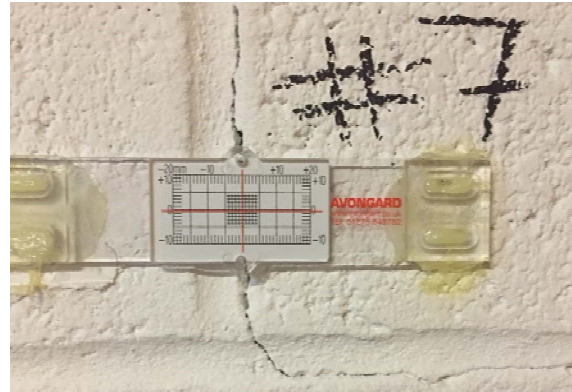
Twelve crack gauges were installed on 29 June 2016 on significant cracks identified in previous investigative work completed by others. Crack gauge #7, installed on a wall in an interior downstairs storage room, was re-installed on 29 September 2016 when it was found to be disengaged from the wall. Table I attached to this report provides a summary of crack gauge readings, including initial readings and quarterly readings, with the most recent readings taken on 11 June 2018 for the eighth quarter. Analysis of the crack gauge readings to date indicate that little or no movement of the cracks has occurred since the gauges were installed.

Photo 13: Crack gauge 7 position in an interior storage room.

Photo 14: Close up view of crack gauge 7.

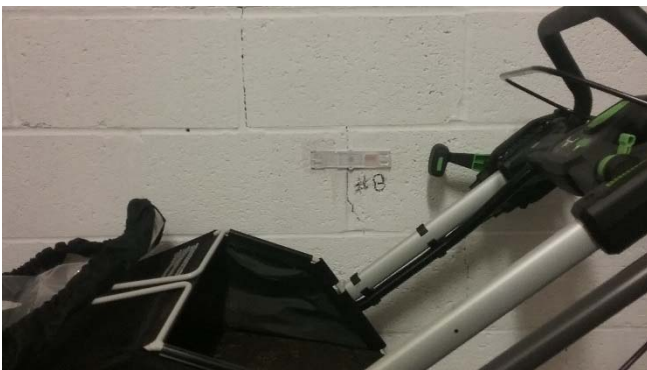
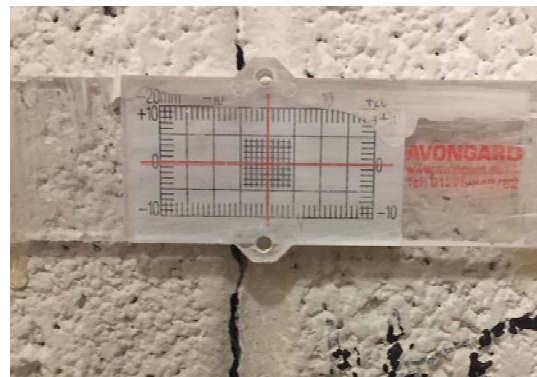
Photo 15: Crack gauge 8 position on a diagonal crack in an interior storage room.

Photo 16: Close up view of crack gauge 8.

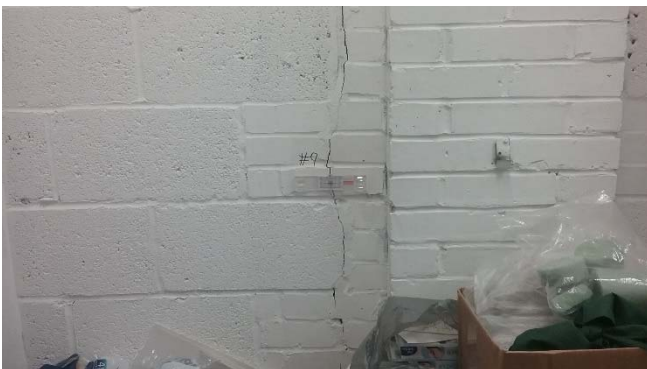
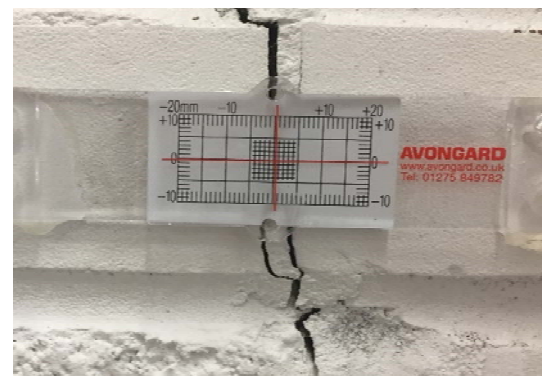
Photo 17: Crack gauge 9 position on a vertical crack in an interior storage room.

Photo 18: Close up view of crack gauge 9.

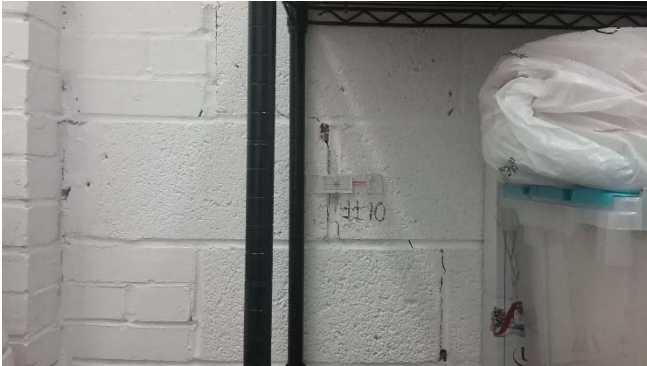
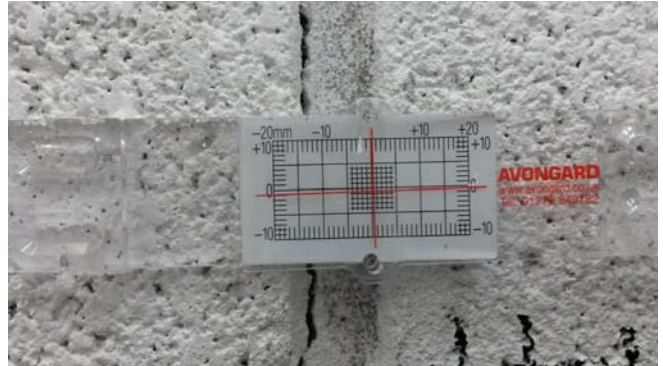
Photo 19: Crack gauge 10 position on a diagonal crack in an interior storage room.

Photo 20: Close up view of crack gauge 10.

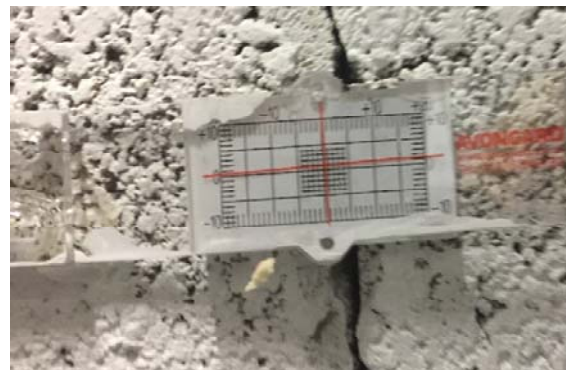
Photo 21: Crack gauge 11 position on a low diagonal crack inside the electrical room.

Photo 22: Close up view of crack gauge 11.

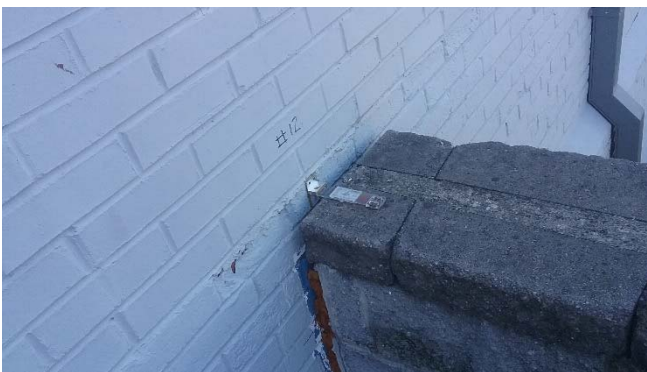
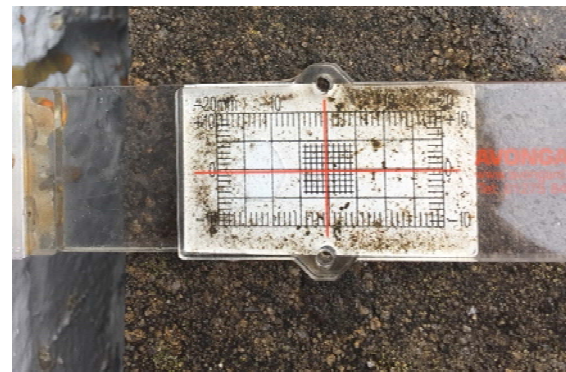
Crack gauge #12 installed on the western exterior stairwell showed lateral movement to the west (away from the building) of over 2.0 mm and a movement to the north of 1.9 mm over the first two quarters of monitoring. The third quarterly reading (15 March 2017) showed the stairs moved back east towards the wall slightly, narrowing the crack to 1.5 mm, and the northward reading increased slightly to 2.0 mm. The fourth quarterly reading (2 June 2017) showed a continued closure of the crack to only 0.75 mm (west movement) and 0.8 mm (north movement), and the fifth quarterly reading (27 September 2017) showed the horizontal movement reduced to 0.1 mm and the northerly movement the same at 0.8 mm. The sixth quarterly reading (18 December 2017) showed the horizontal movement increased again to 0.2 mm and the northerly movement increased to 1.1 mm. The seventh reading (28 March 2018) showed the horizontal reading to be zero and the northerly movement to be 1.0 mm. The most recent reading showed

the horizontal reading to be 0.2 mm and the northerly movement at 0.4 mm. This pattern of movement is likely related to seasonal changes in the moisture content of underlying plastic soils resulting in some shrink-swell action, or to other environmental factors as noted above, rather than reflective of progressive movement of the stairs relative to the wall.

Photo 23: Crack gauge 12 positioned between the wall and the exterior west staircase.

Photo 24: Close up view of crack gauge 12.
