15 June 2017  
File No. 16081-001

Academy of Hope Adult Public Charter School  
2315 18<sup>th</sup> Place NE  
Washington, DC 20017

Subject: Quarterly Instrumentation Report No. 4  
Academy of Hope  
2315 18<sup>th</sup> Place NE  
Washington, DC 20018

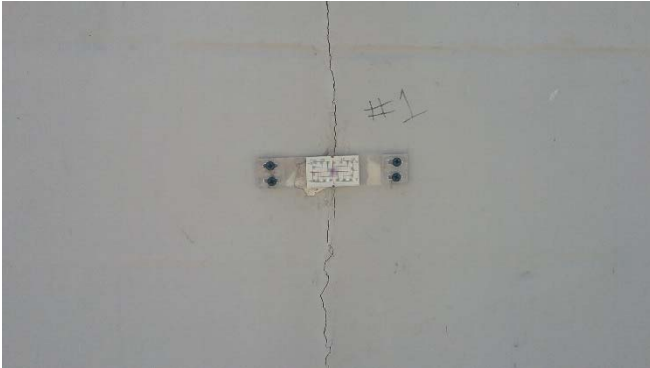
Crack gauge #1 on the north exterior wall did not show any movement in the first two quarterly readings, but showed possible right lateral movement of approximately 1.0 mm on 15 March 2017. This movement was reversed in the fourth quarter reading, back to the gauge's original position. Crack gauges #'s 2, 3, 4, 5, 9 and 12 all showed similar patterns of movement and reversion. Most of these showed overall range of motion of less than approximately 1.0 mm, except for gauge #12 which is discussed below. These gauges will be tracked for further movement, but the small magnitude of movement may be attributed to environmental factors such as moisture or temperature changes, or could be related to seasonal changes in the moisture content of underlying plastic soils resulting in some shrink-swell action. Gauges #'s 6, 7, 8, 10 and 11 showed little or no motion over the fourth quarter.

Photo 1: Crack gauge 1 position on a vertical crack on the north exterior wall.

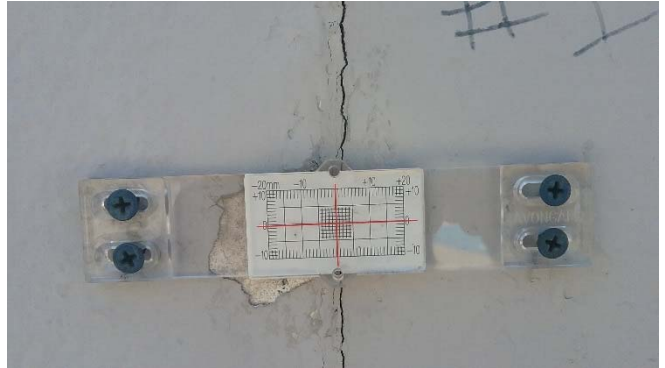
Photo 2: Close up view of crack gauge 1.

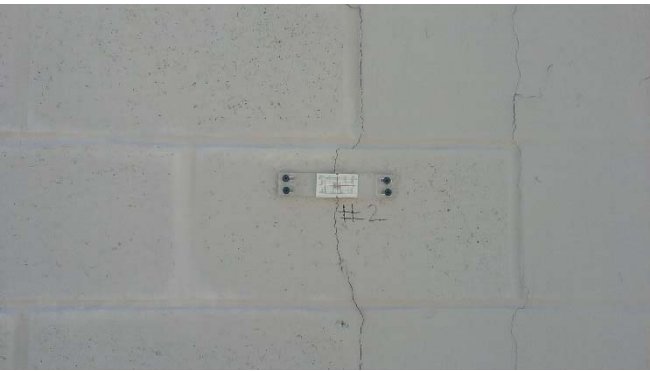
Photo 3: Crack gauge 2 position on a vertical crack on the north exterior wall.

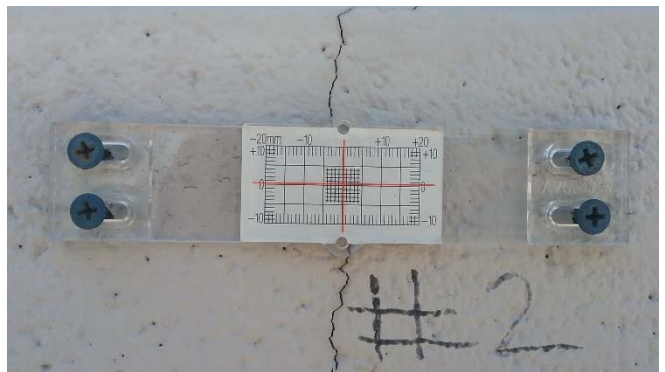
Photo 4: Close up view of crack gauge 2.

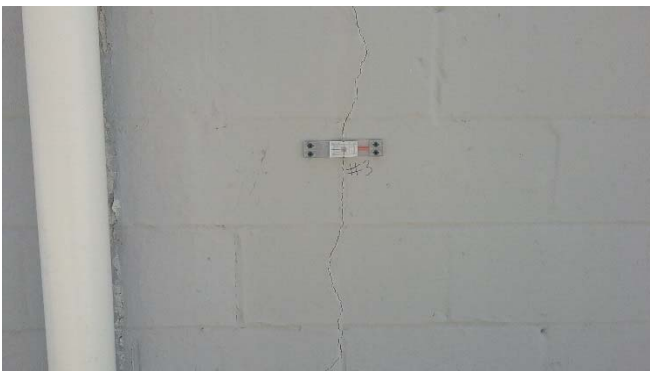
Photo 5: Crack gauge 3 position on a vertical crack on the north exterior wall.

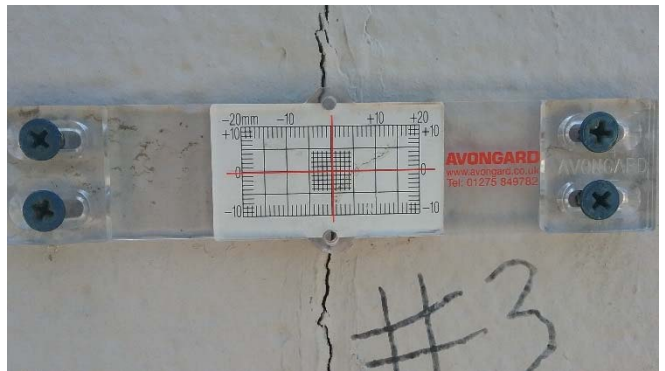
Photo 6: Close up view of crack gauge 3.

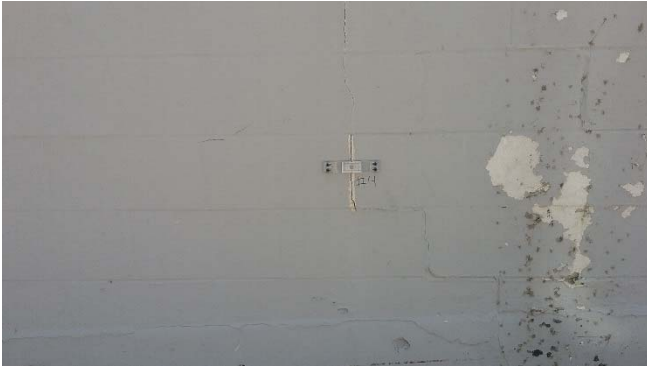
Photo 7: Crack gauge 4 position on a vertical crack on the north exterior wall.

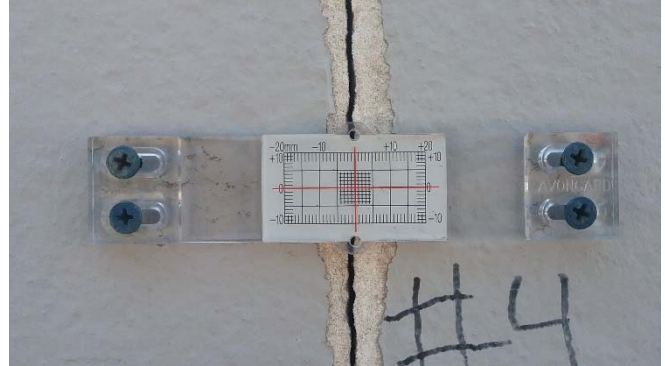
Photo 8: Close up view of crack gauge 4.

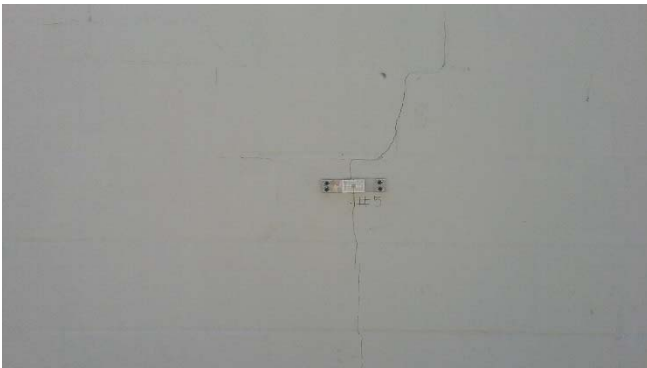
Photo 9: Crack gauge 5 position on a vertical crack on the north exterior wall.

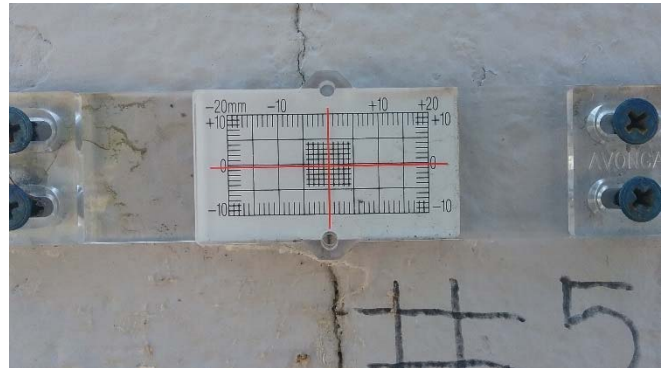
Photo 10: Close up view of crack gauge 5.

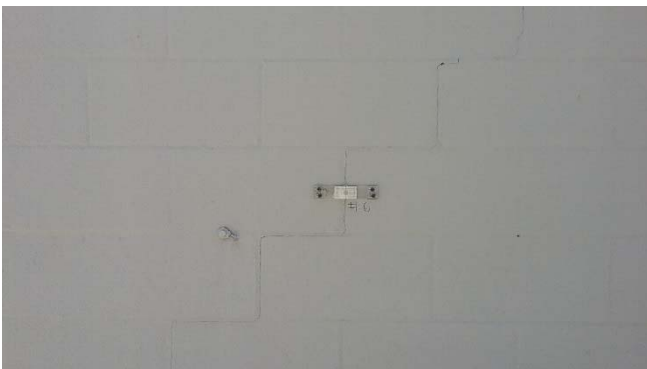
Photo 11: Crack gauge 6 position on a diagonal crack on the north exterior wall.

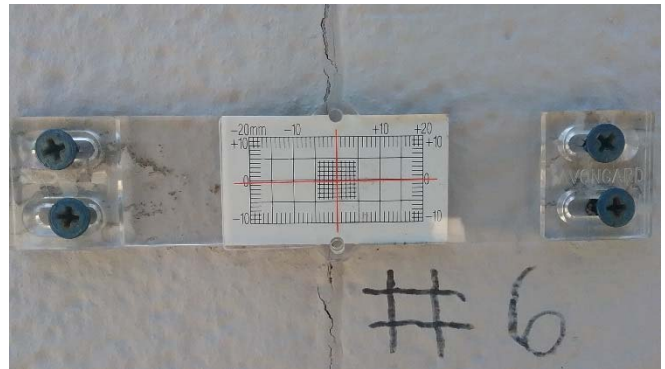
Photo 12: Close up view of crack gauge 6.

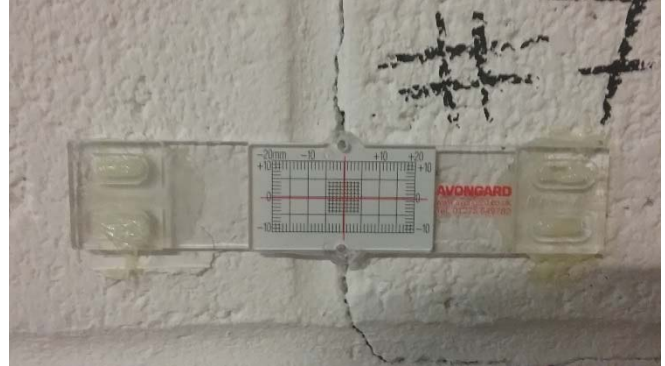
Photo 14: Close up view of crack gauge 7.

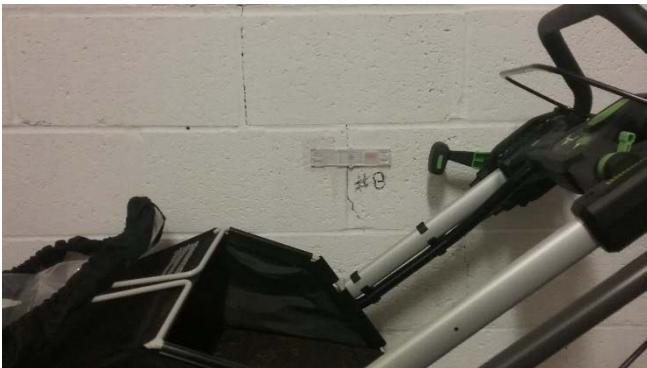
Photo 15: Crack gauge 8 position on a diagonal crack in an interior storage room.

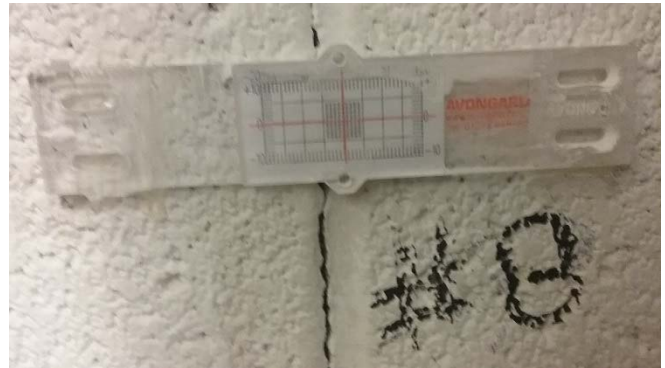
Photo 16: Close up view of crack gauge 8.

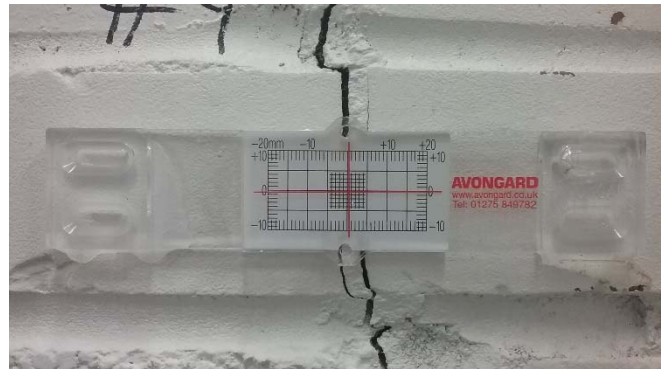
Photo 18: Close up view of crack gauge 9.

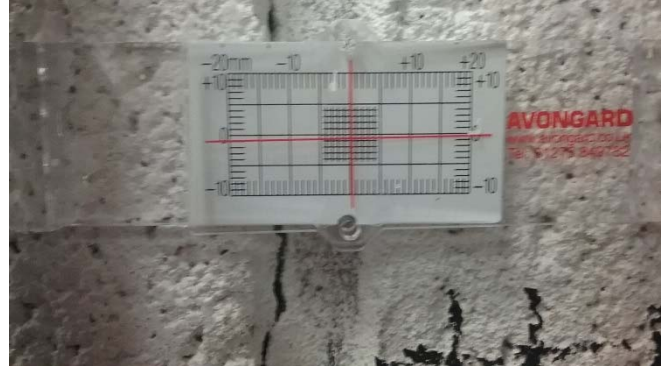
Photo 20: Close up view of crack gauge 10.

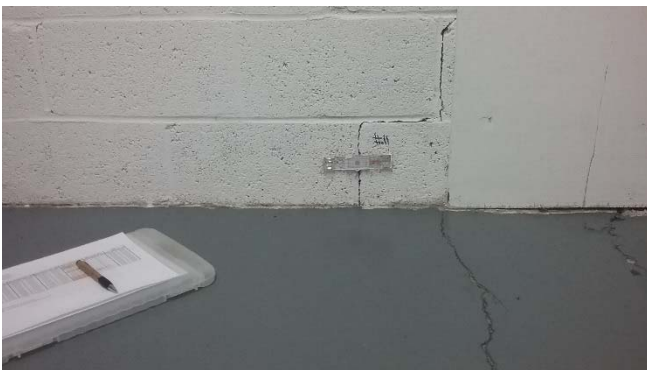
Photo 21: Crack gauge 11 position on a low diagonal crack inside the electrical room.

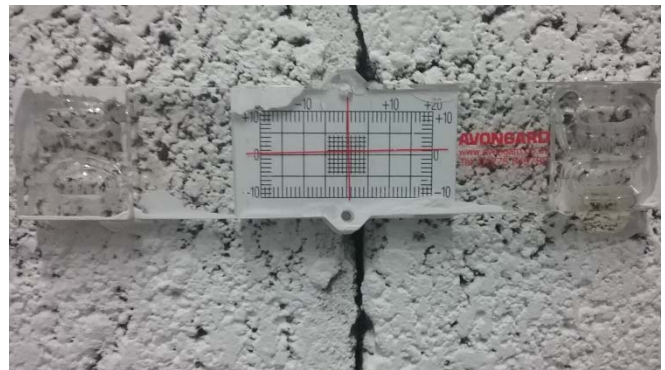
Photo 22: Close up view of crack gauge 11.

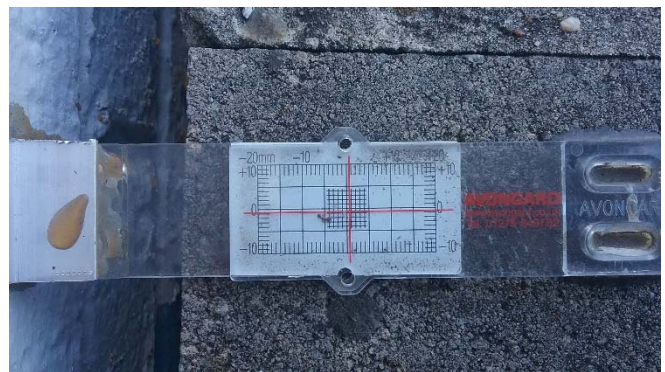
Photo 24: Close up view of crack gauge 12.
