20 March 2017  
File No. 16081-001

Academy of Hope Adult Public Charter School  
2315 18<sup>th</sup> Place NE  
Washington, DC 20017

Subject: Quarterly Instrumentation Report No. 3  
Academy of Hope  
2315 18<sup>th</sup> Place NE  
Washington, DC 20018

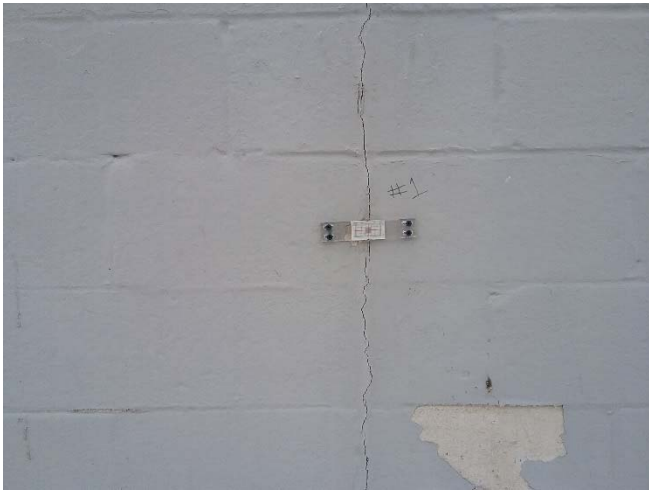
Crack gauge #1 on the north exterior wall did not show any movement in the first two quarterly readings, but showed possible right lateral movement of approximately 1.0 mm on 15 March 2017. This possible movement will continue to be tracked in subsequent quarterly readings. Crack gauges #2 and #5 on the north exterior wall and gauges #10 and #11 in the downstairs maintenance rooms showed possible movement of less than 1.0 mm between the 20 December 2016 and 15 March 2017 readings. These gauges will be tracked for further movement, but the small magnitude of movement may be attributed to environmental factors such as moisture or temperature changes.

Photo 1: Crack gauge 1 position on a vertical crack on the north exterior wall.

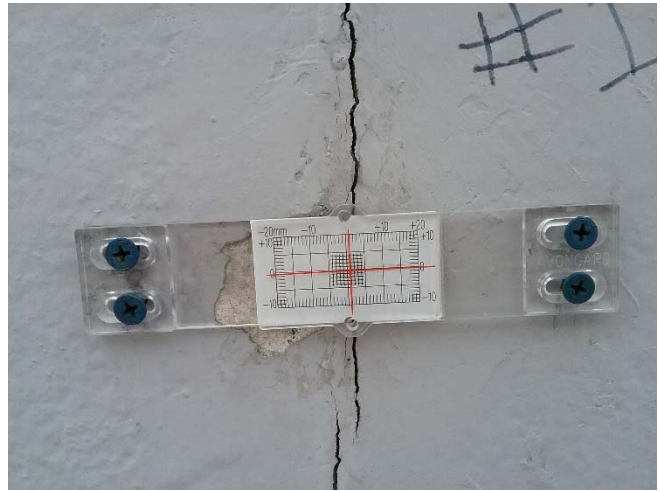
Photo 2: Close up view of crack gauge 1.

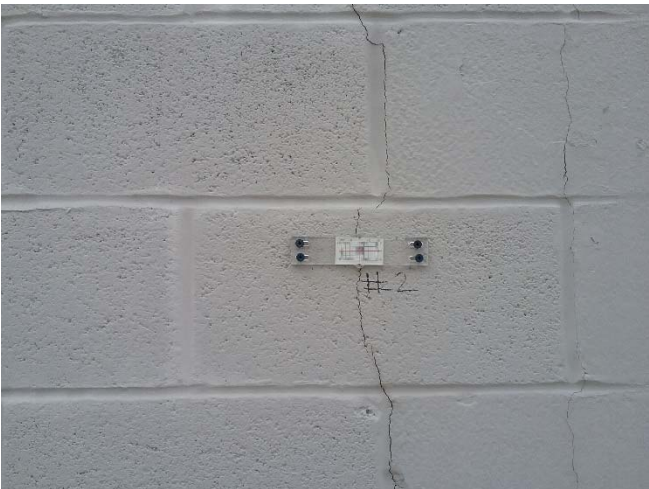
Photo 3: Crack gauge 2 position on a vertical crack on the north exterior wall.

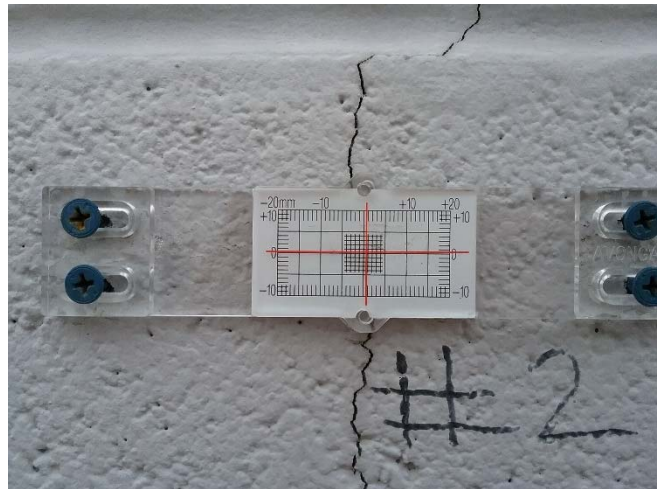
Photo 4: Close up view of crack gauge 2.

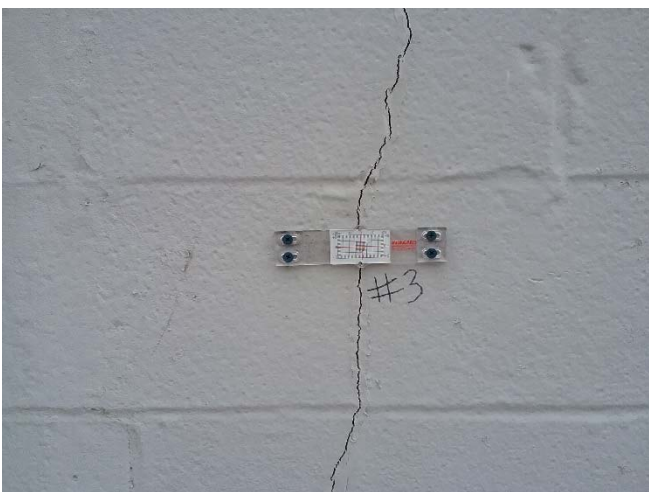
Photo 5: Crack gauge 3 position on a vertical crack on the north exterior wall.

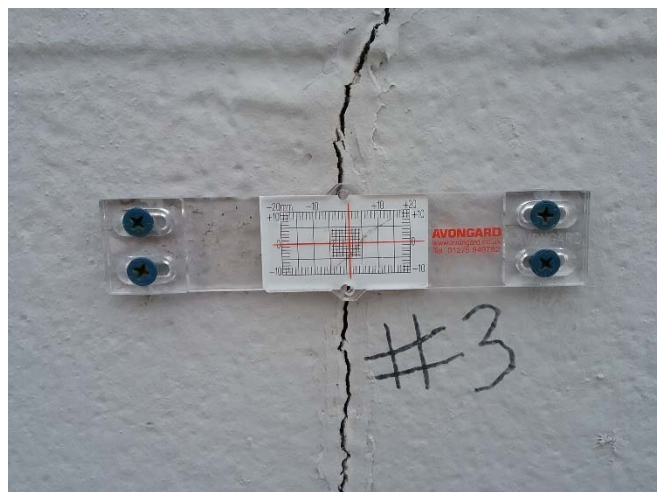
Photo 6: Close up view of crack gauge 3.

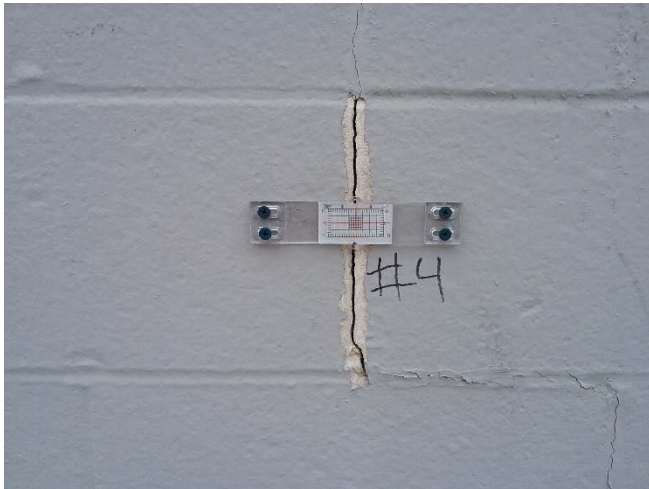
Photo 7: Crack gauge 4 position on a vertical crack on the north exterior wall.

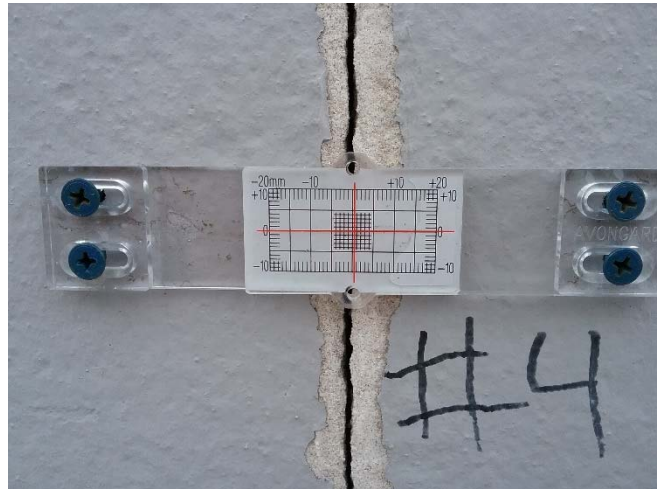
Photo 8: Close up view of crack gauge 4.

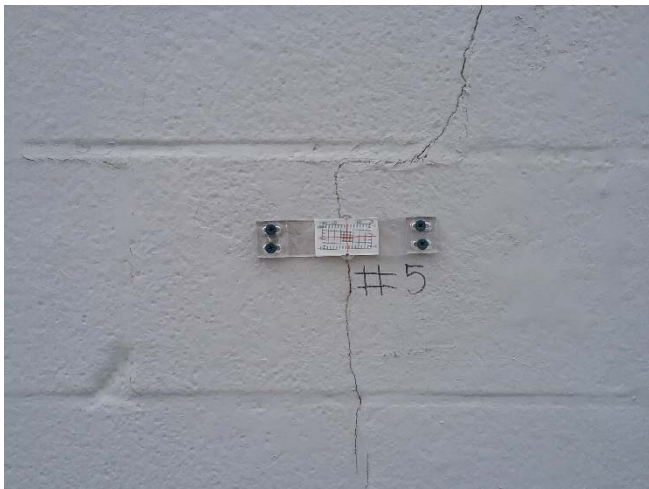
Photo 9: Crack gauge 5 position on a vertical crack on the north exterior wall.

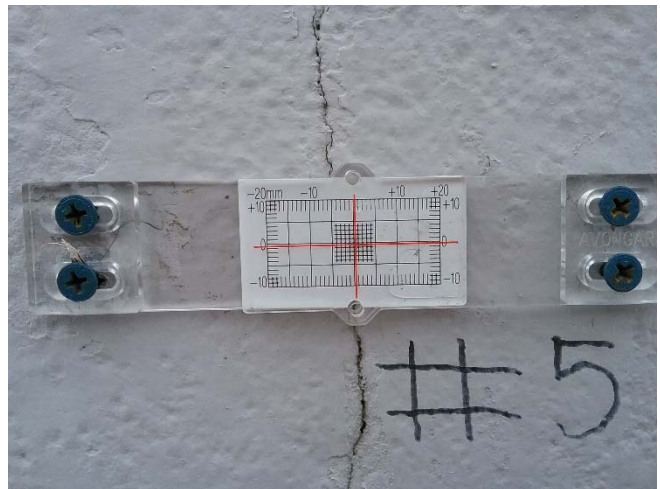
Photo 10: Close up view of crack gauge 5.

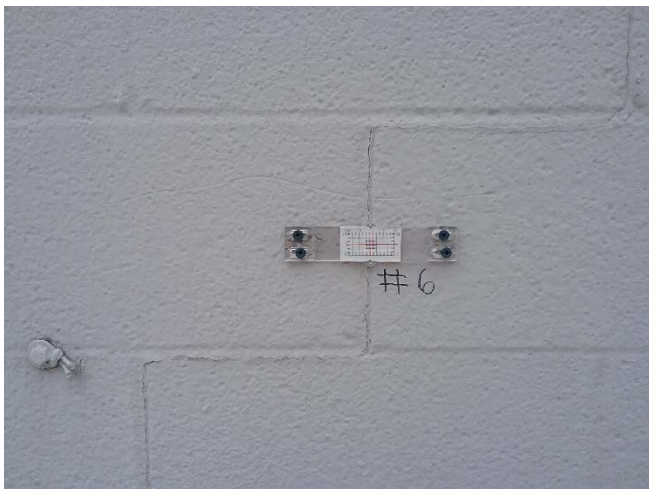
Photo 11: Crack gauge 6 position on a diagonal crack on the north exterior wall.

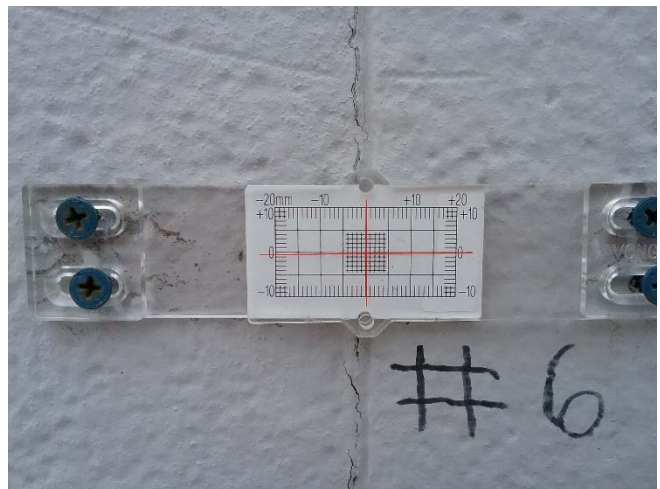
Photo 12: Close up view of crack gauge 6.

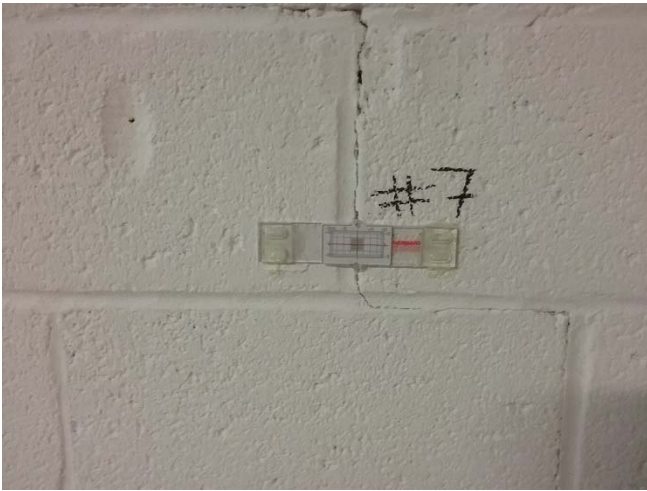
Photo 13: Crack gauge 7 position in an interior storage room.

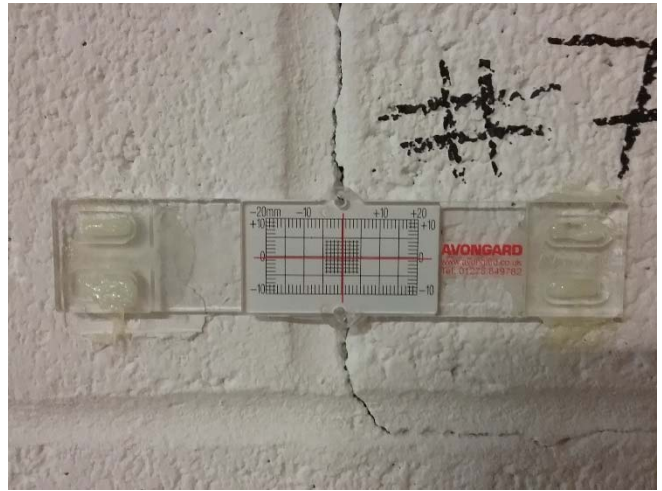
Photo 14: Close up view of crack gauge 7.

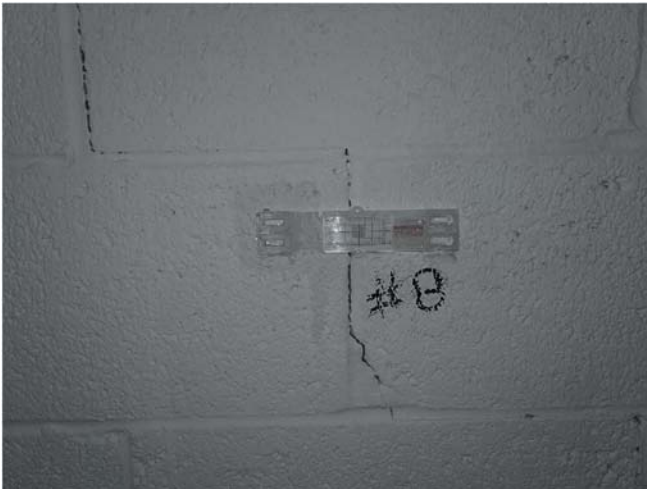
Photo 15: Crack gauge 8 position on a diagonal crack in an interior storage room.

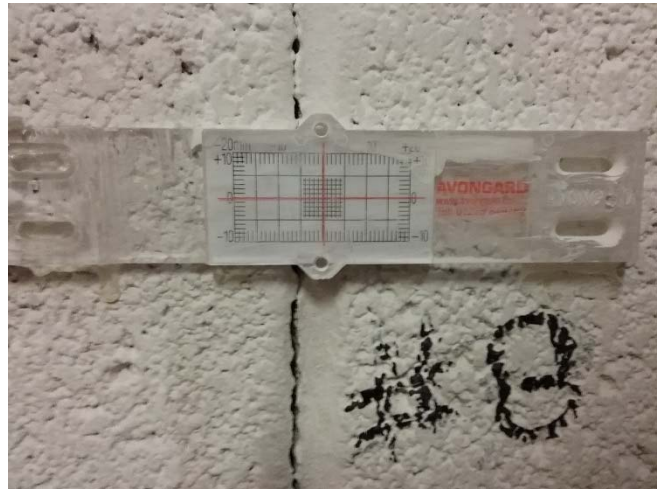
Photo 16: Close up view of crack gauge 8.

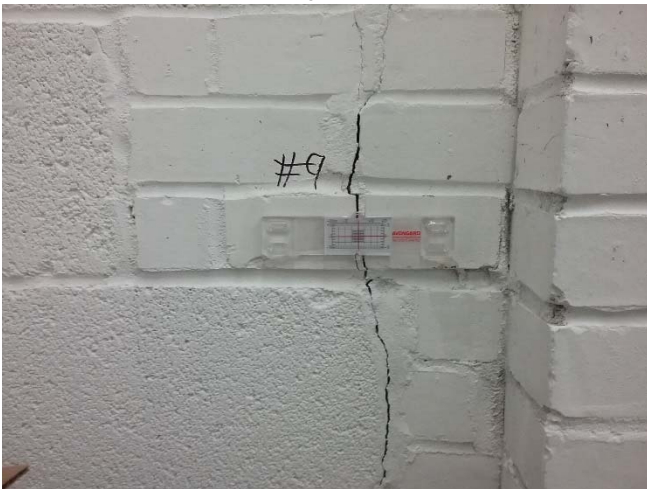
Photo 17: Crack gauge 9 position on a vertical crack in an interior storage room.

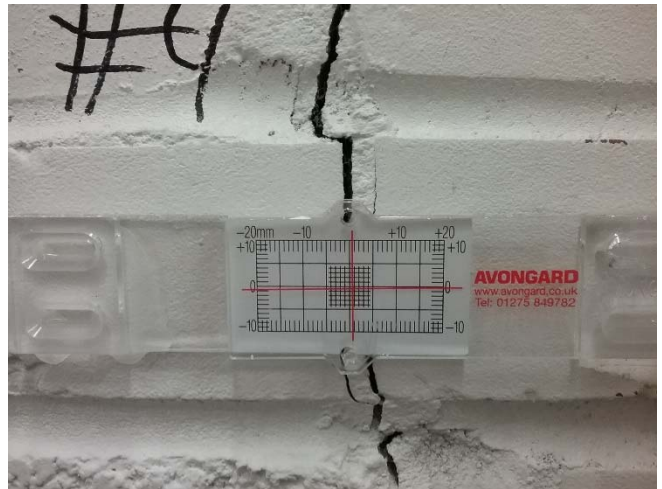
Photo 18: Close up view of crack gauge 9.

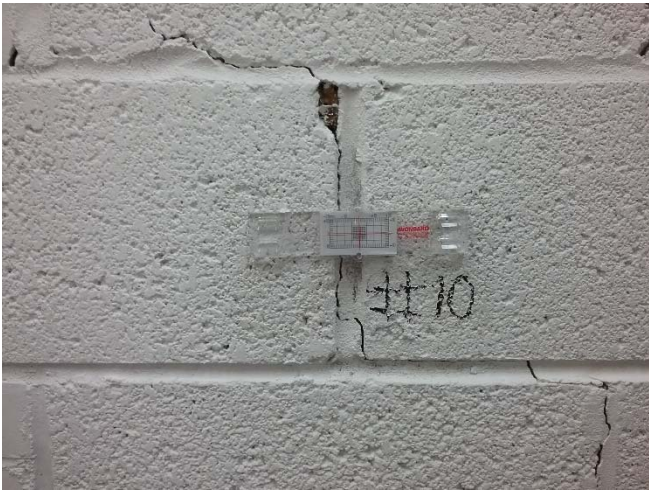
Photo 19: Crack gauge 10 position on a diagonal crack in an interior storage room.

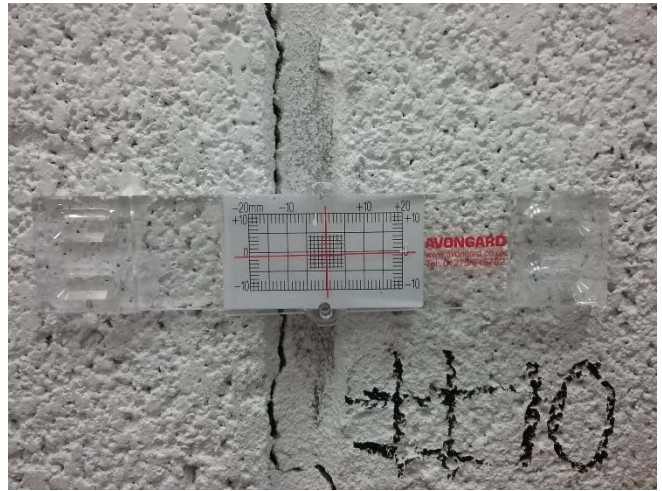
Photo 20: Close up view of crack gauge 10.

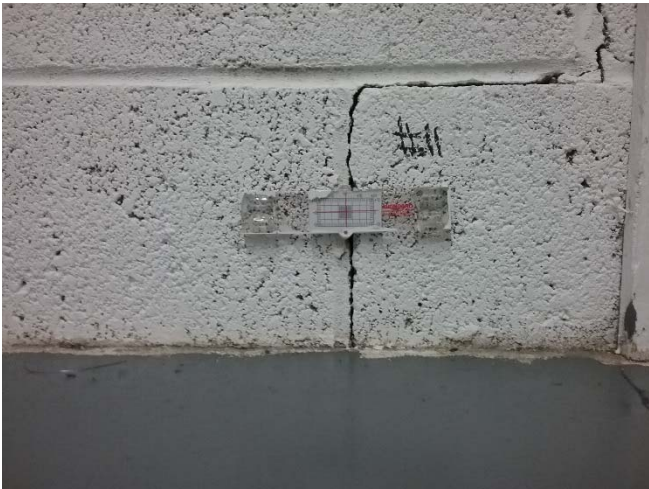
Photo 21: Crack gauge 11 position on a low diagonal crack inside the electrical room.

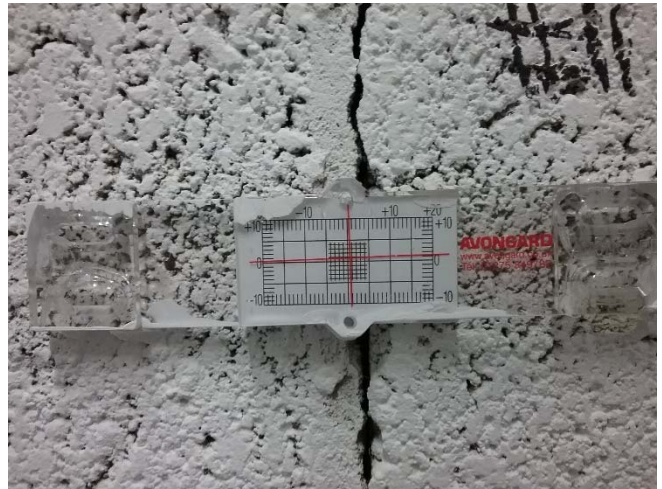
Photo 22: Close up view of crack gauge 11.

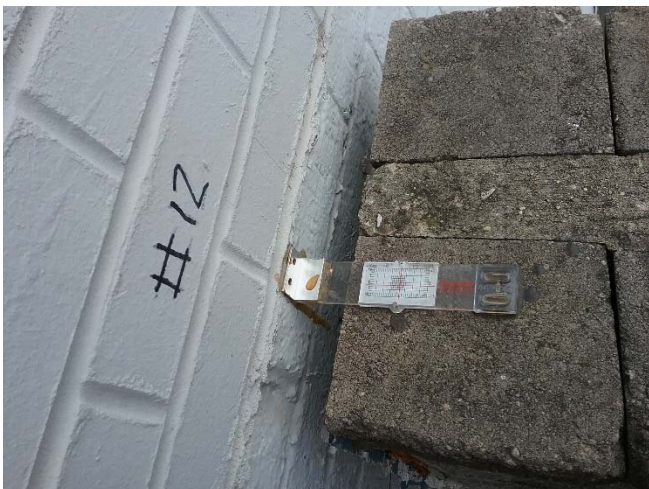
Crack gauge #12 installed on the western exterior stairwell showed lateral movement to the west (away from the building) of over 2.0 mm and a movement to the north of 1.9 mm over the first two quarters. The 15 March 2017 readings showed the stairs moved back east towards the wall slightly, narrowing the crack to 1.5 mm, and the northward reading increased slightly to 2.0 mm. This pattern of movement could be related to seasonal changes in the moisture content of underlying plastic soils resulting in some shrink-swell action, or to other environmental factors as noted above. The photos of crack gauge #12 also seem to show movement of the stairwell relative to the western wall of the building. This crack gauge will be closely monitored for additional signs of movement. Longer-term observations will yield more accurate information of the true spreading rates.

Photo 23: Crack gauge 12 positioned between the wall and the exterior west staircase.

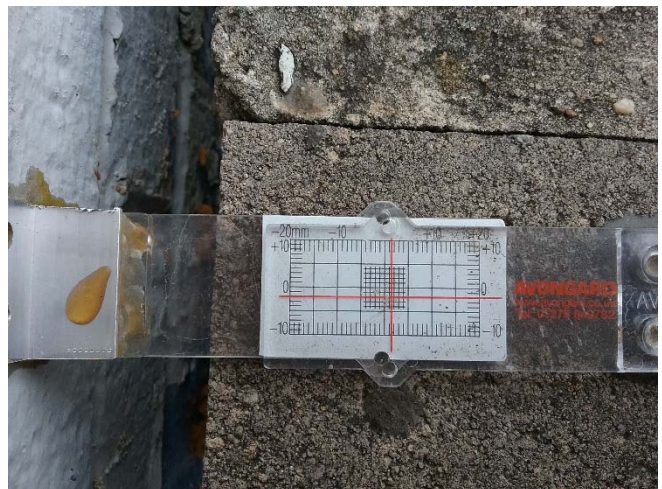
Photo 24: Close up view of crack gauge 12.

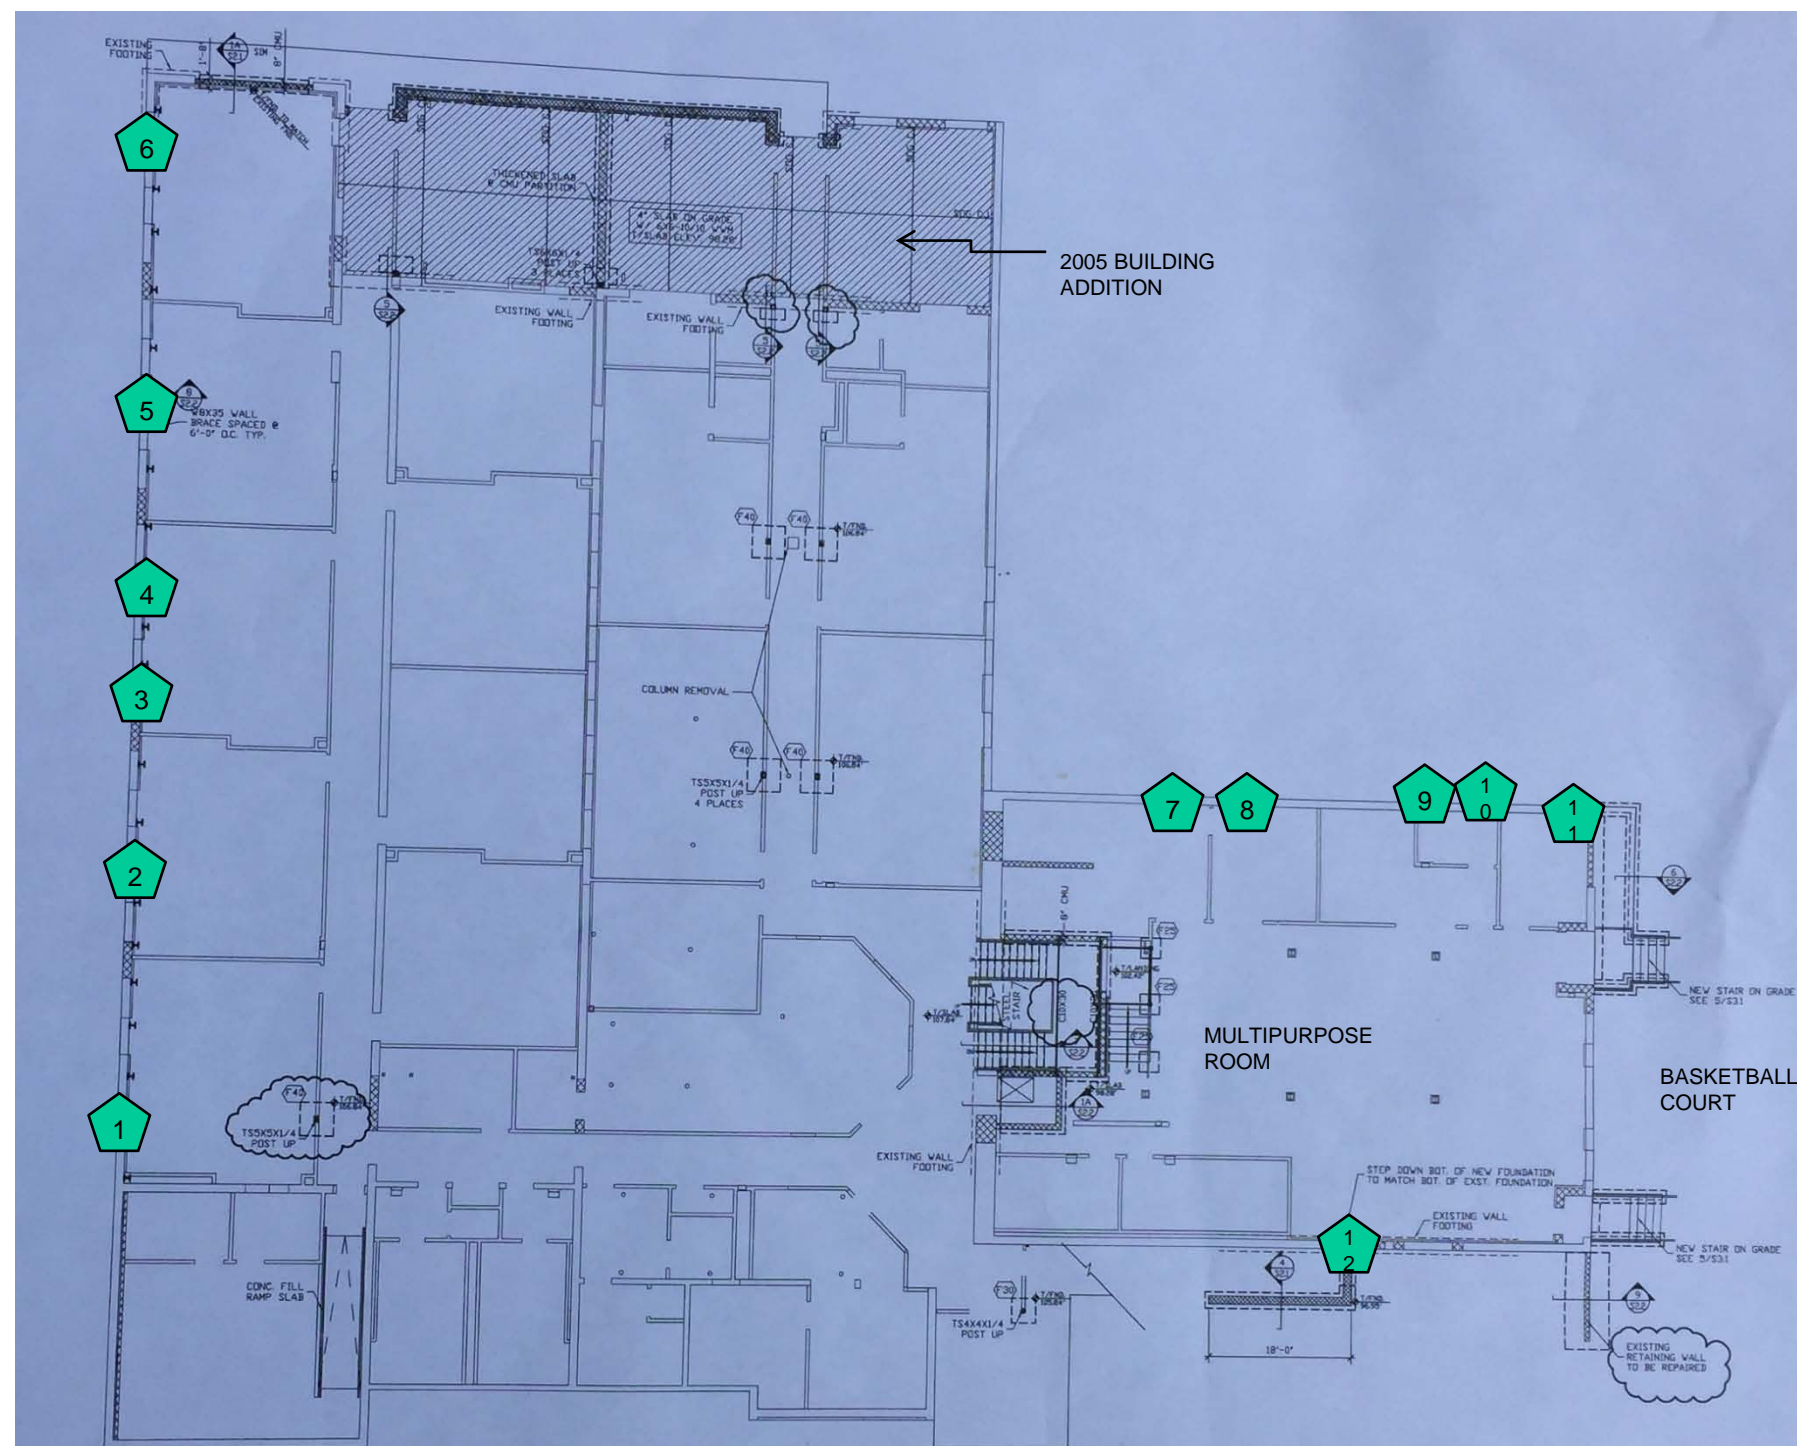
FIGURE 1

DESIGNATION AND APPROXIMATE LOCATION OF CRACK GAGES
