ACADEMY OF HOPE - WARD 5 & 8

EDUCATIONAL SPECIFICATION:

Report of Property Condition Assessment

Academy of Hope - Ward 5

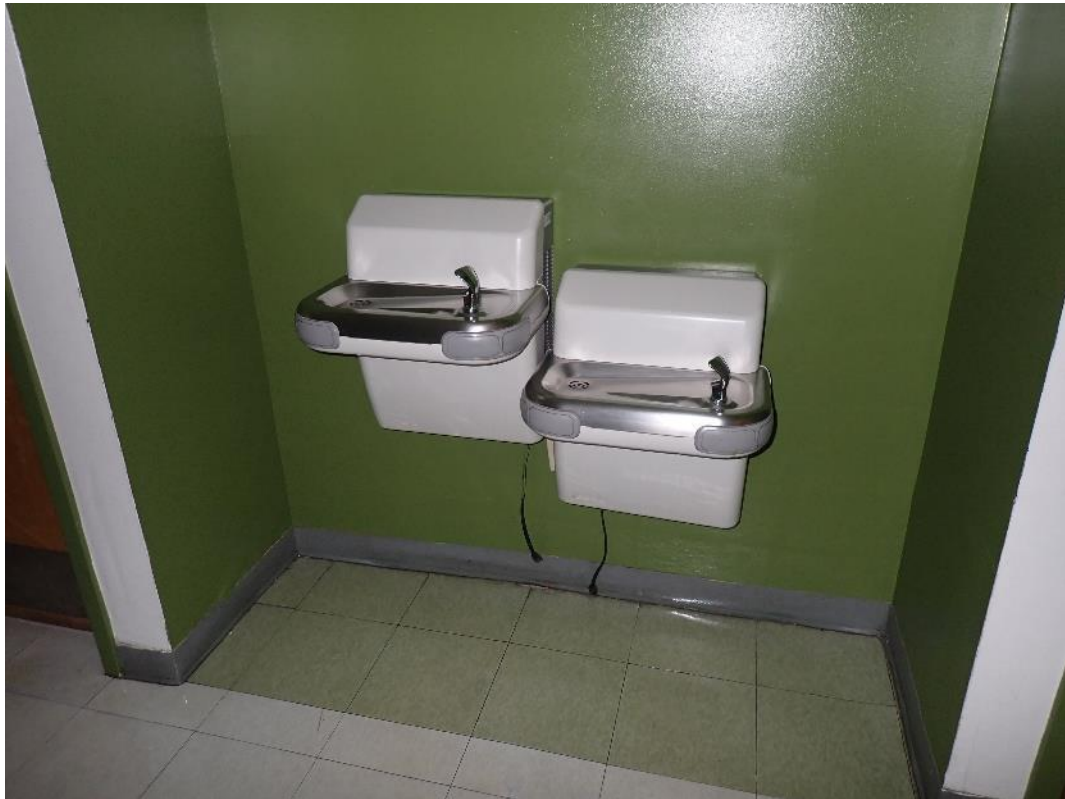
Photograph 1: Split level water fountain.

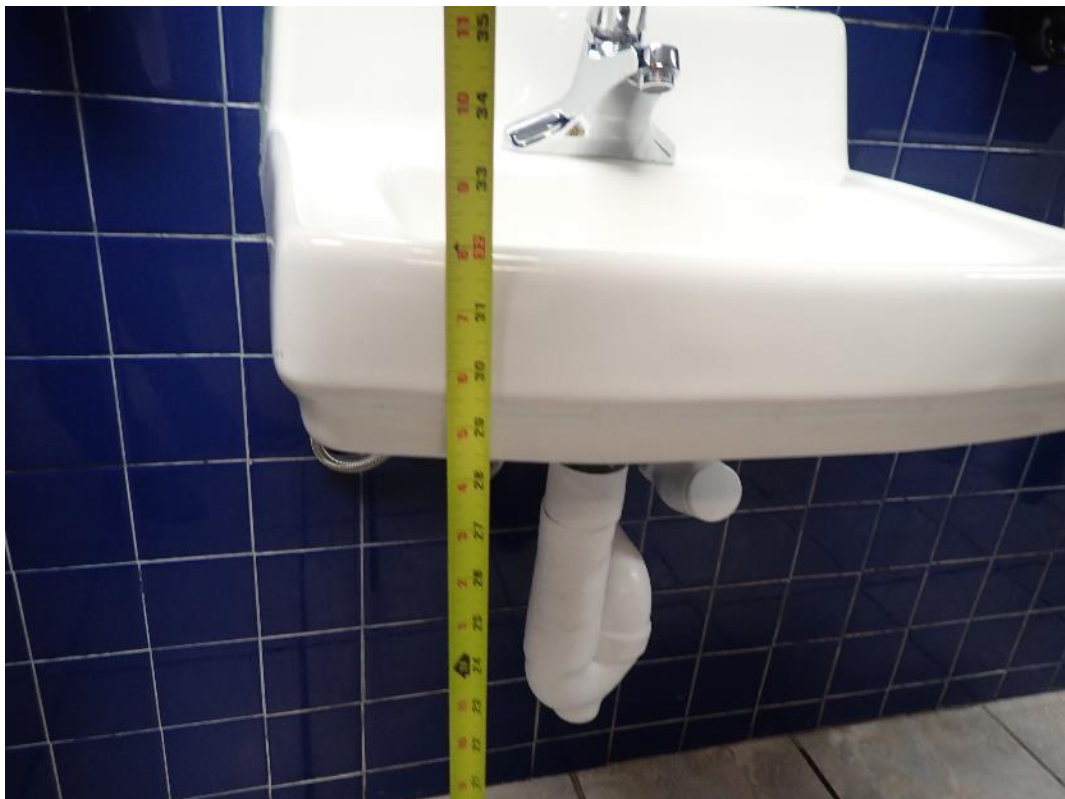
Photograph 4: Compliant lavatory in restroom.

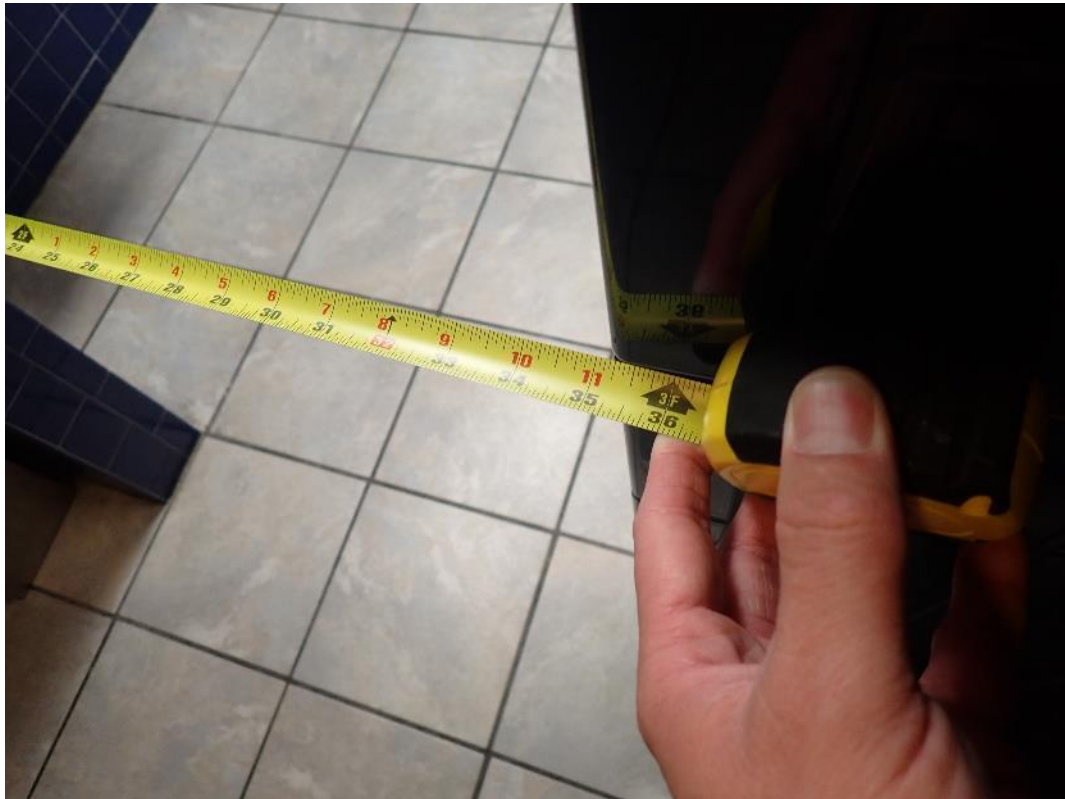
Photograph 5: Compliant clear opening at restroom door.

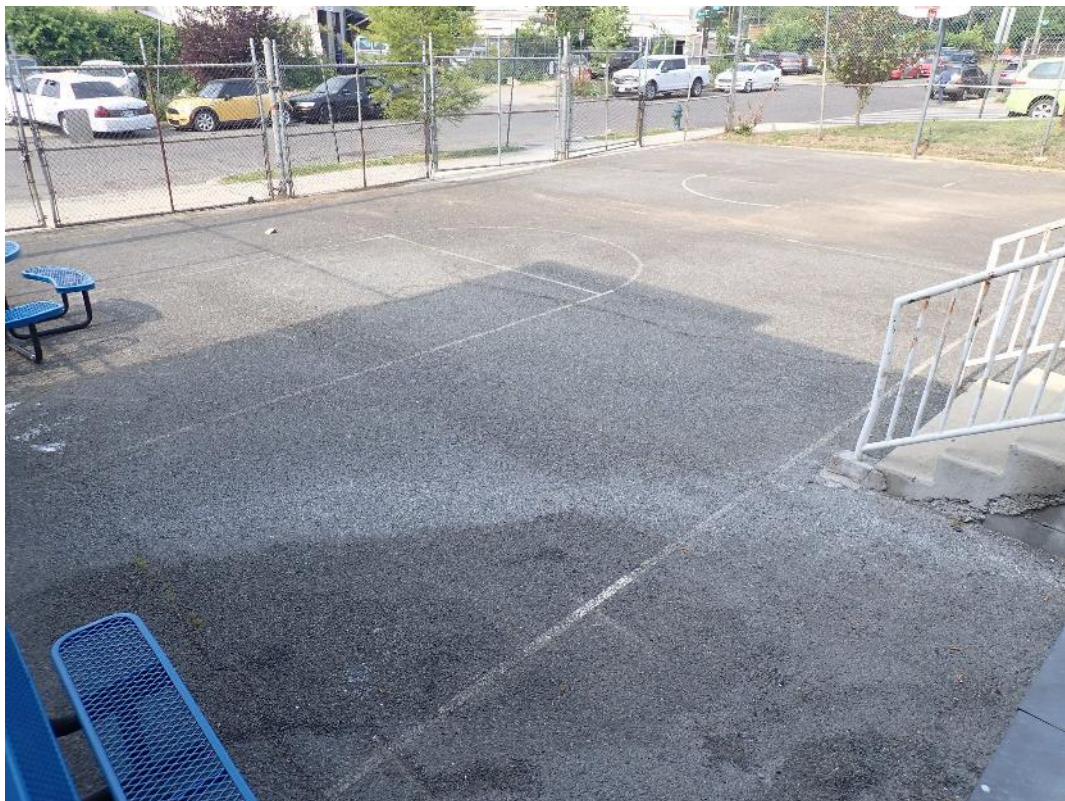
Photograph 6: Asphalt at rear basketball court.

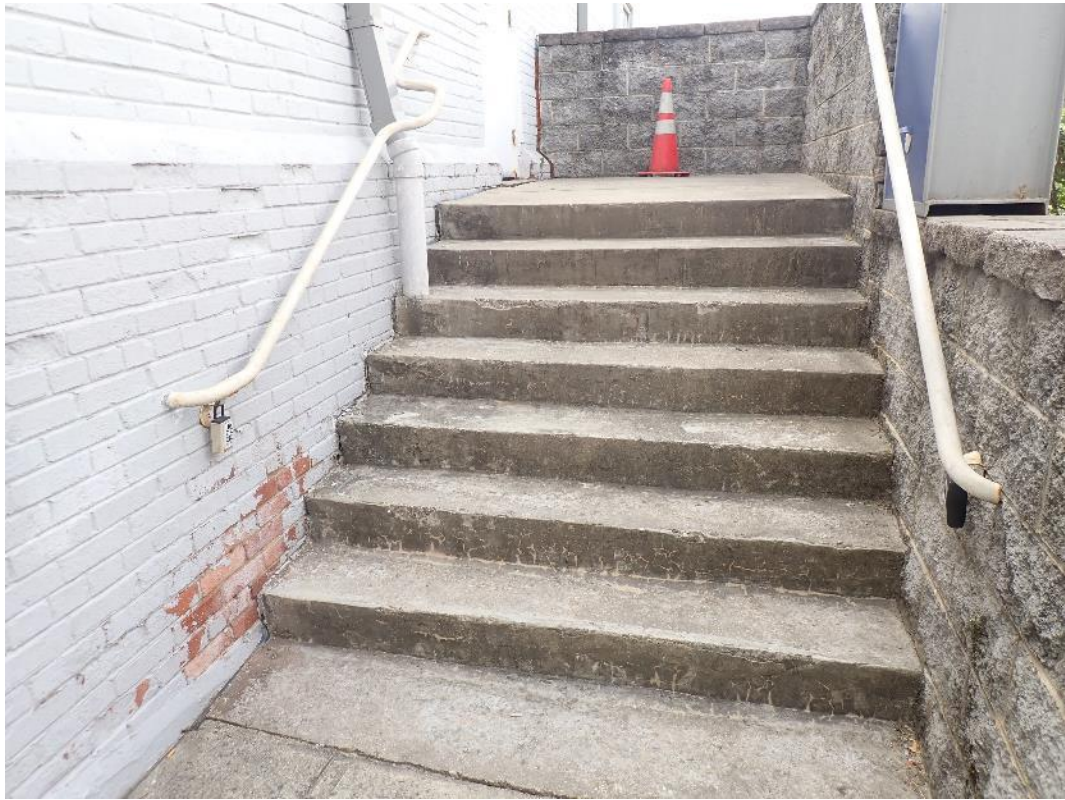
Photograph 11: Exterior steps to the south of the main entrance which have structural issues

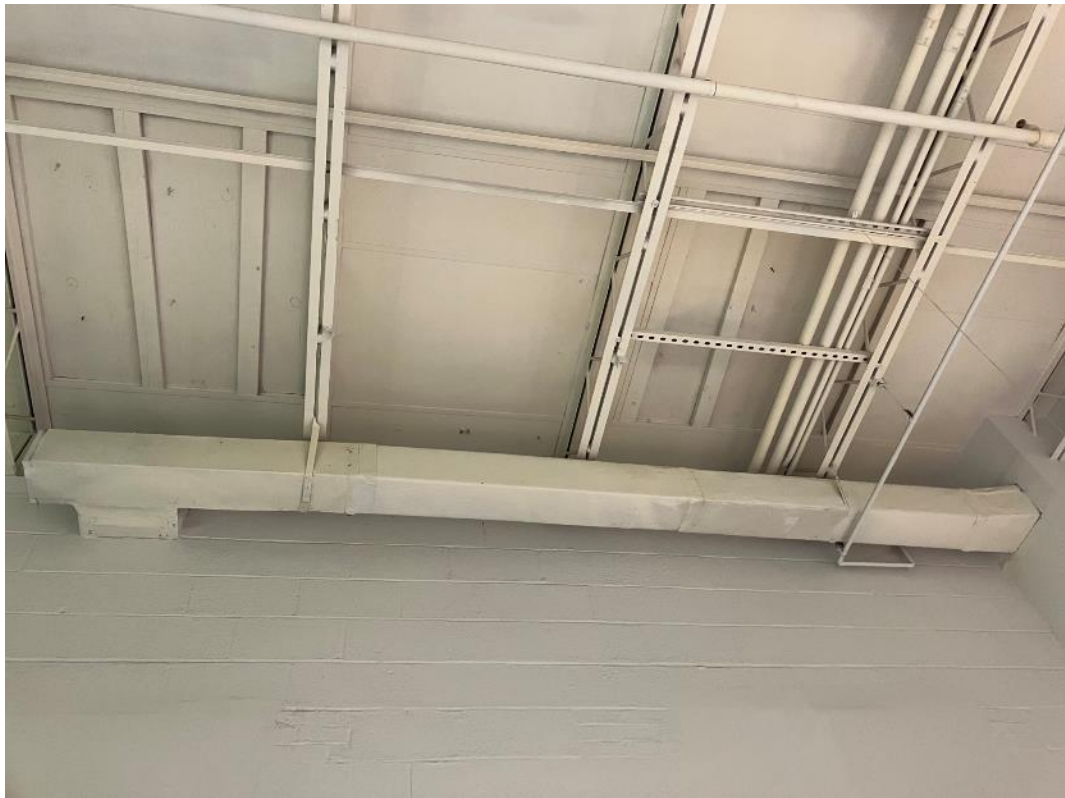
Photograph 12: Roof structure viewed from inside.

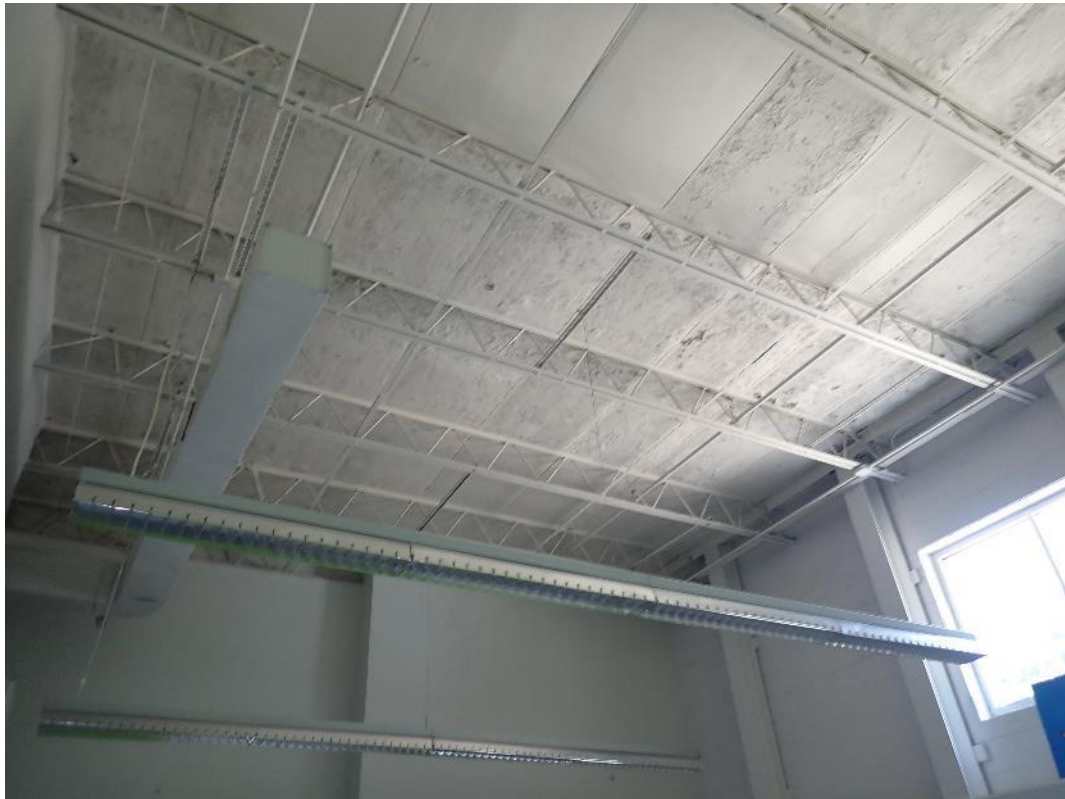
Photograph 13: Roof structure viewed from inside at classroom area

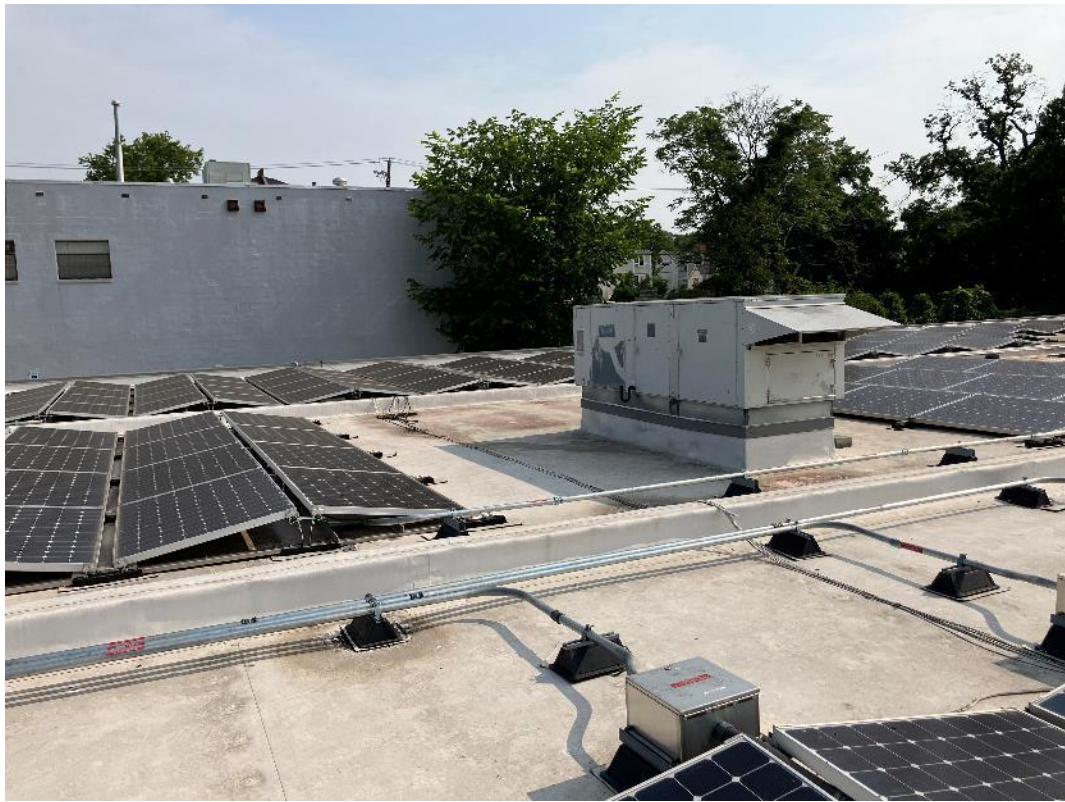
Photograph 16: Overview of roof.

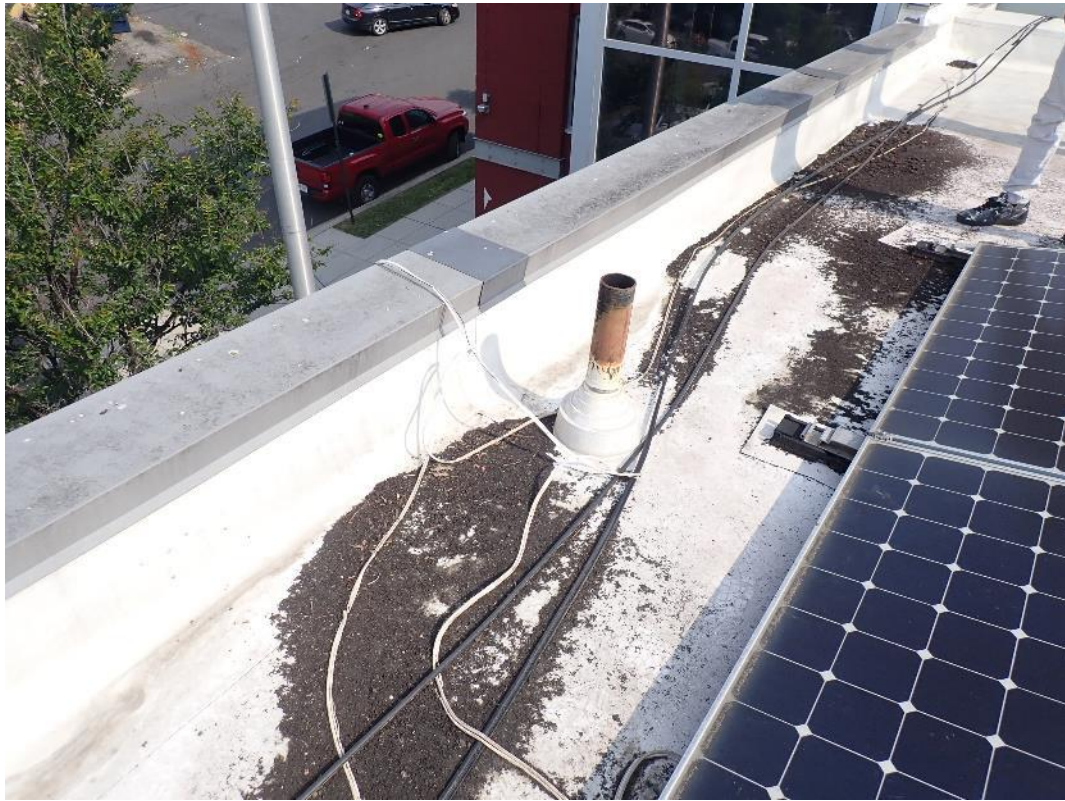
Photograph 19: Debris accumulation on roof.

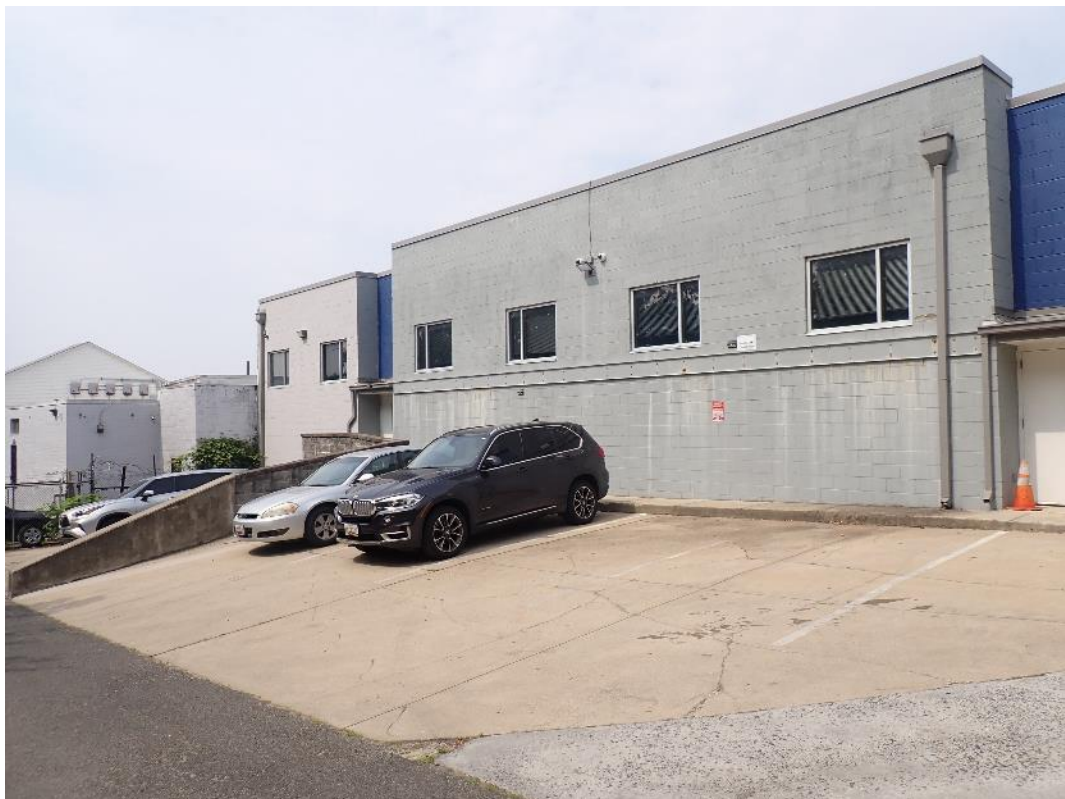
Photograph 22: Exterior wall systems and finishes.

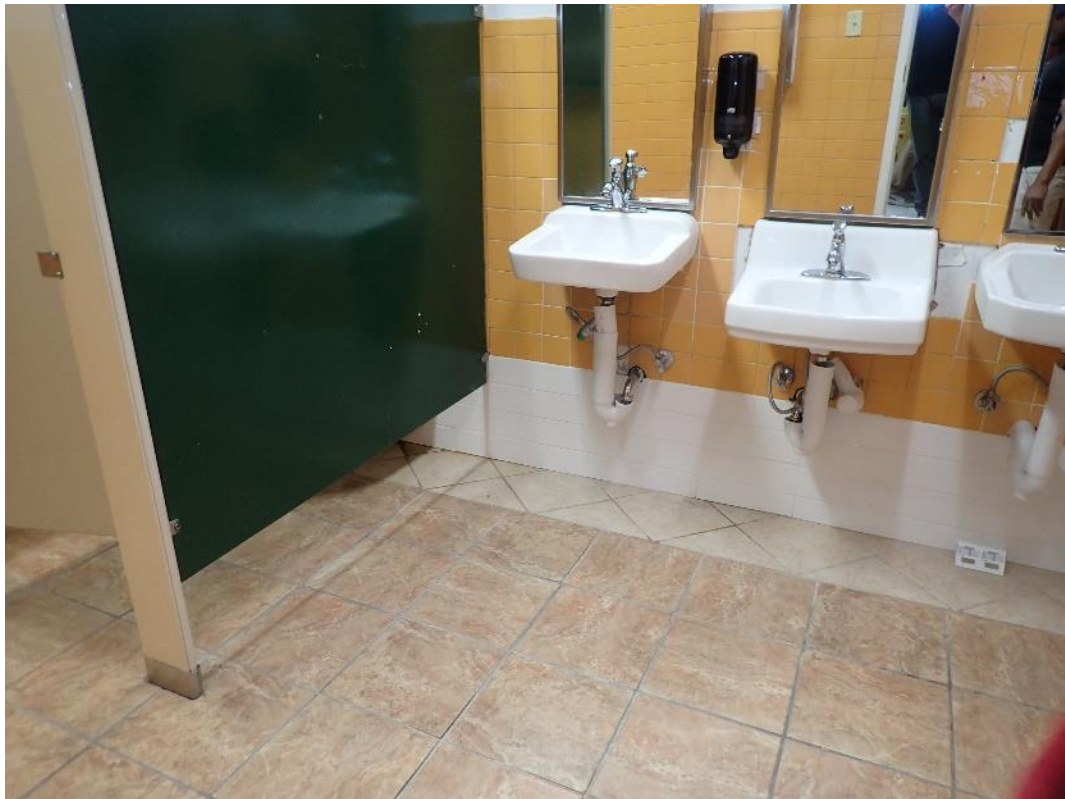
Photograph 26: Typical bathroom finishes.

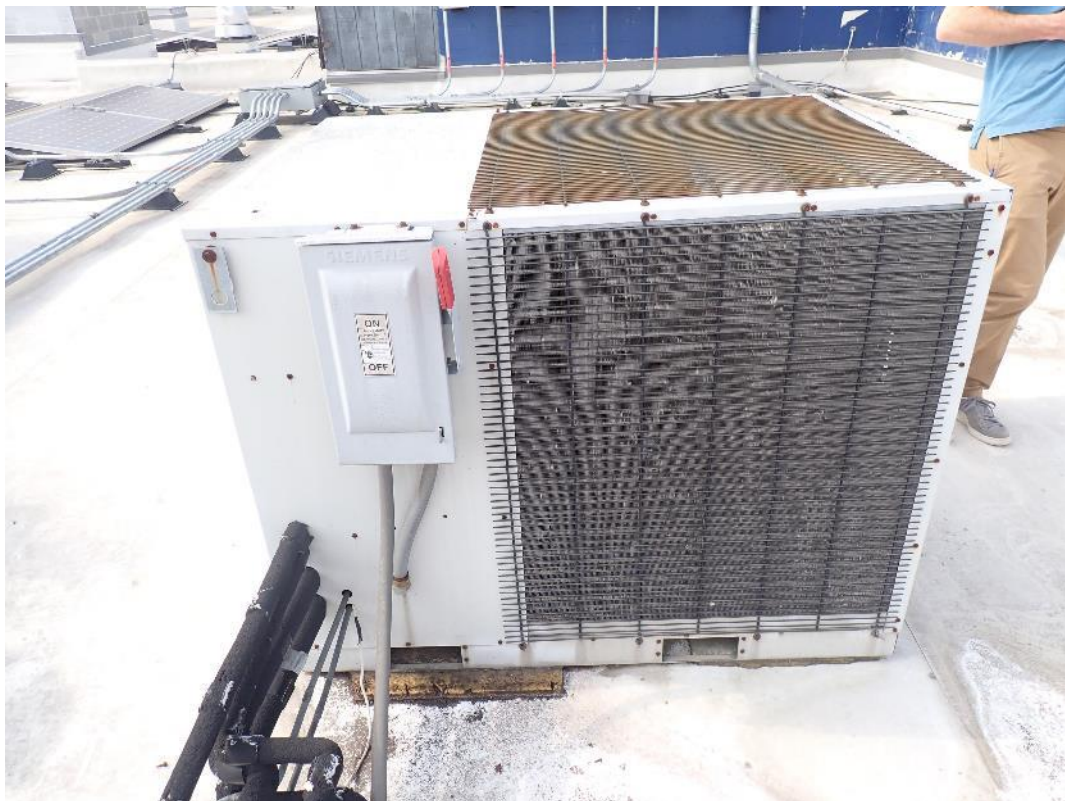
Photograph 30: Exterior condensing unit which serves one of two split systems.

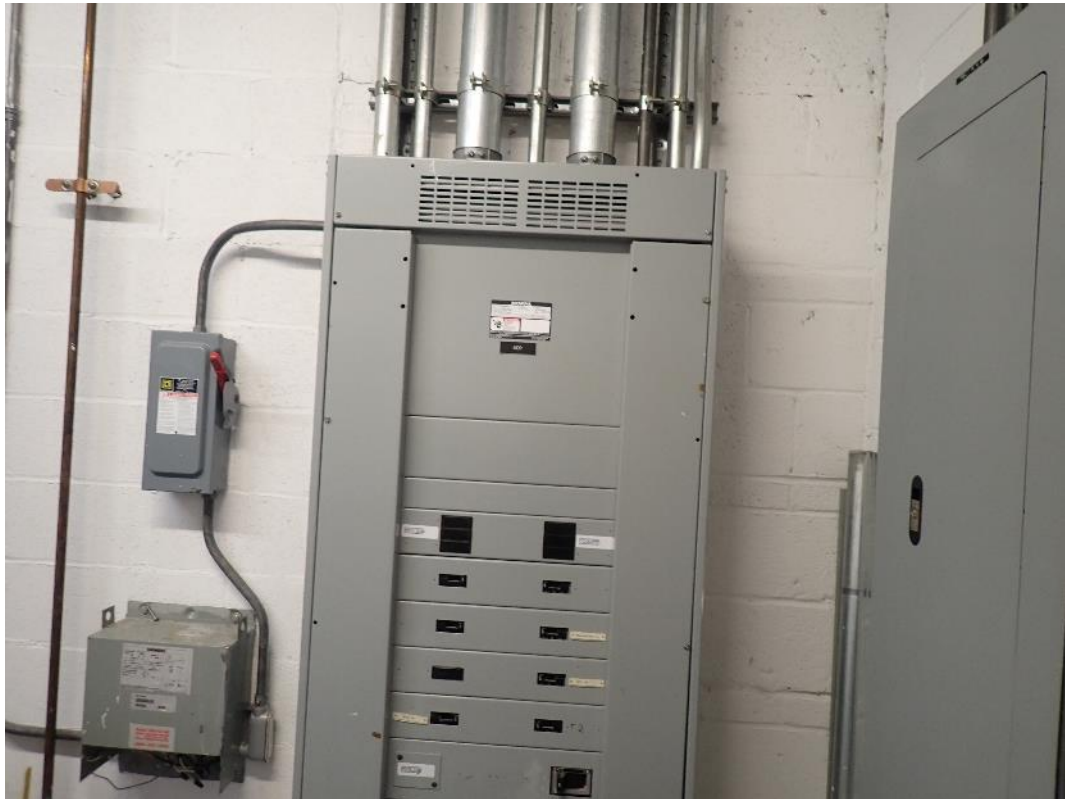
Photograph 35: Main distribution panel.

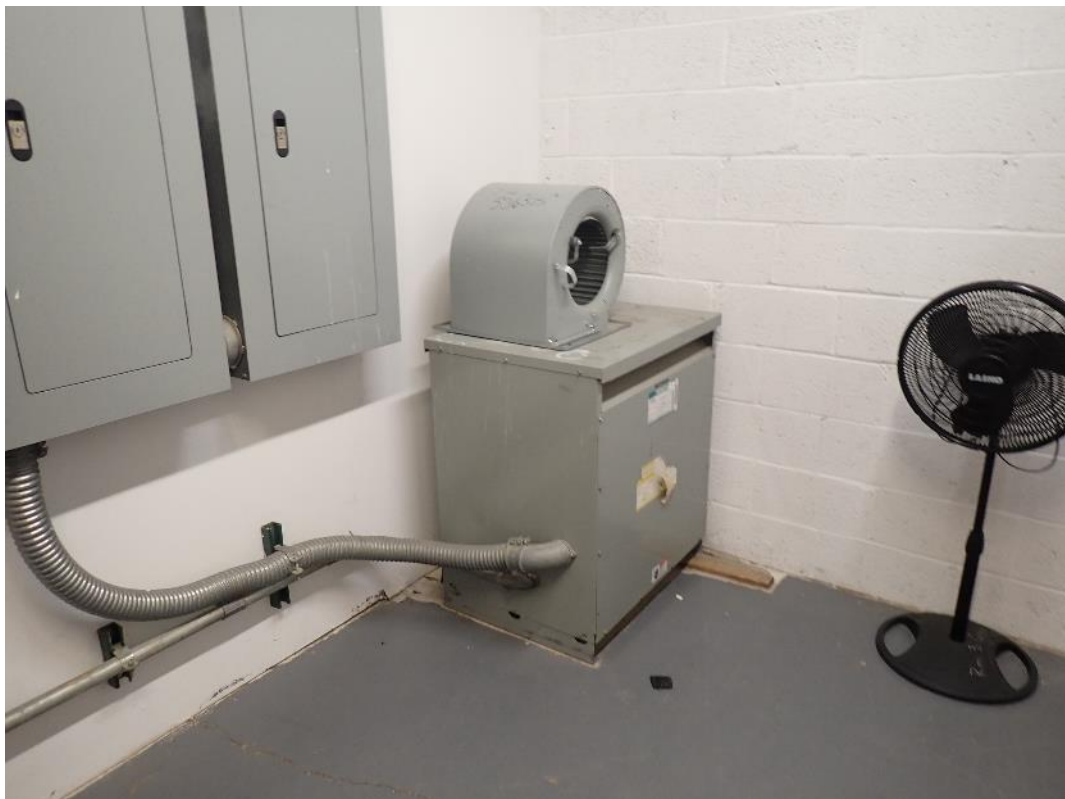
Photograph 36: Panelboards and step-down transformer.

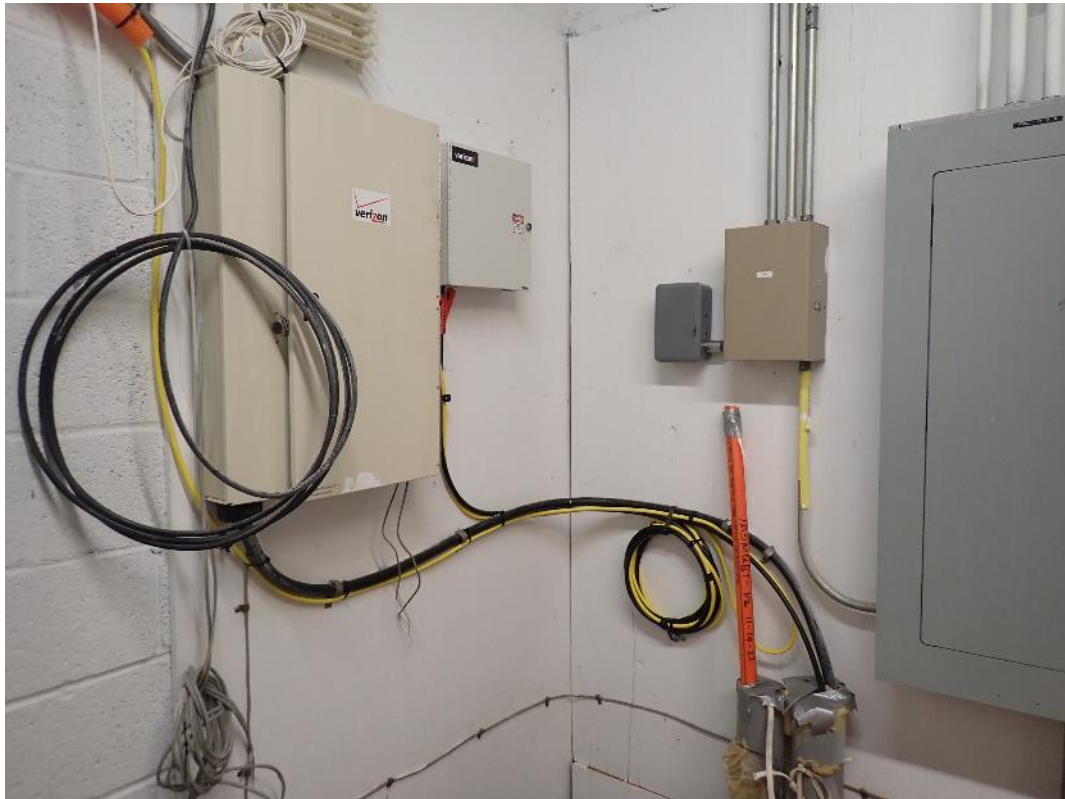
Photograph 37: Telecoms and data systems.

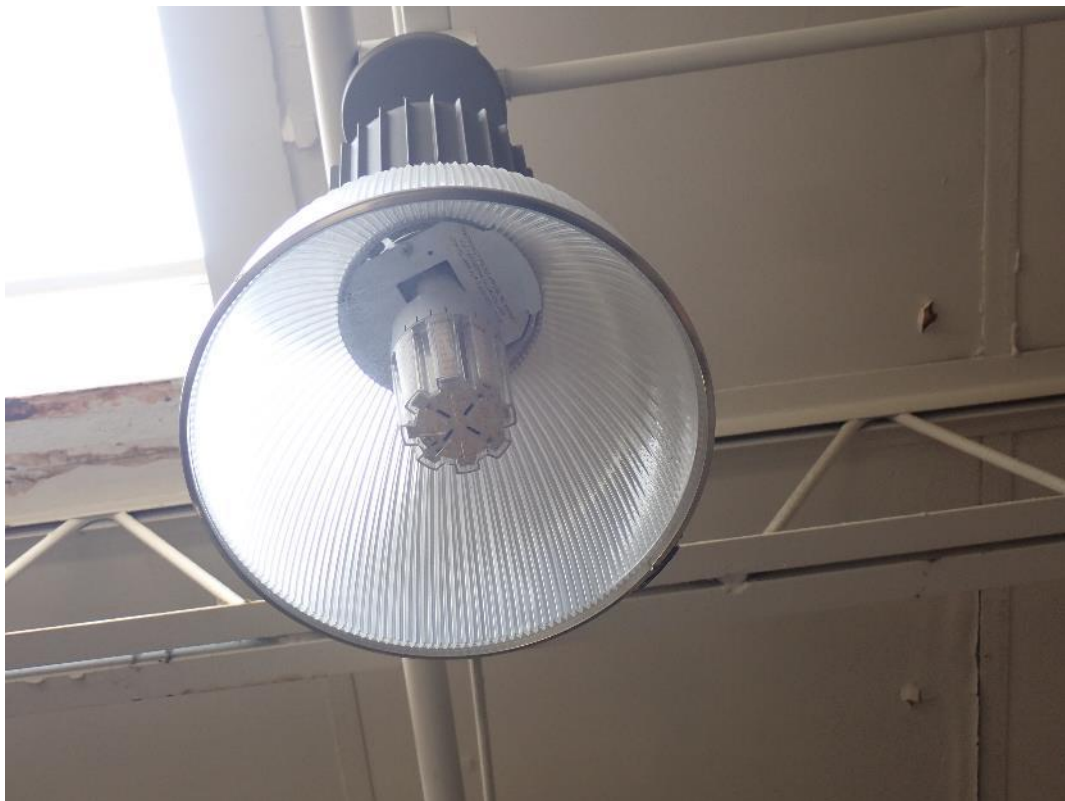
Photograph 38: Light fitting retrofitted with LED bulb.

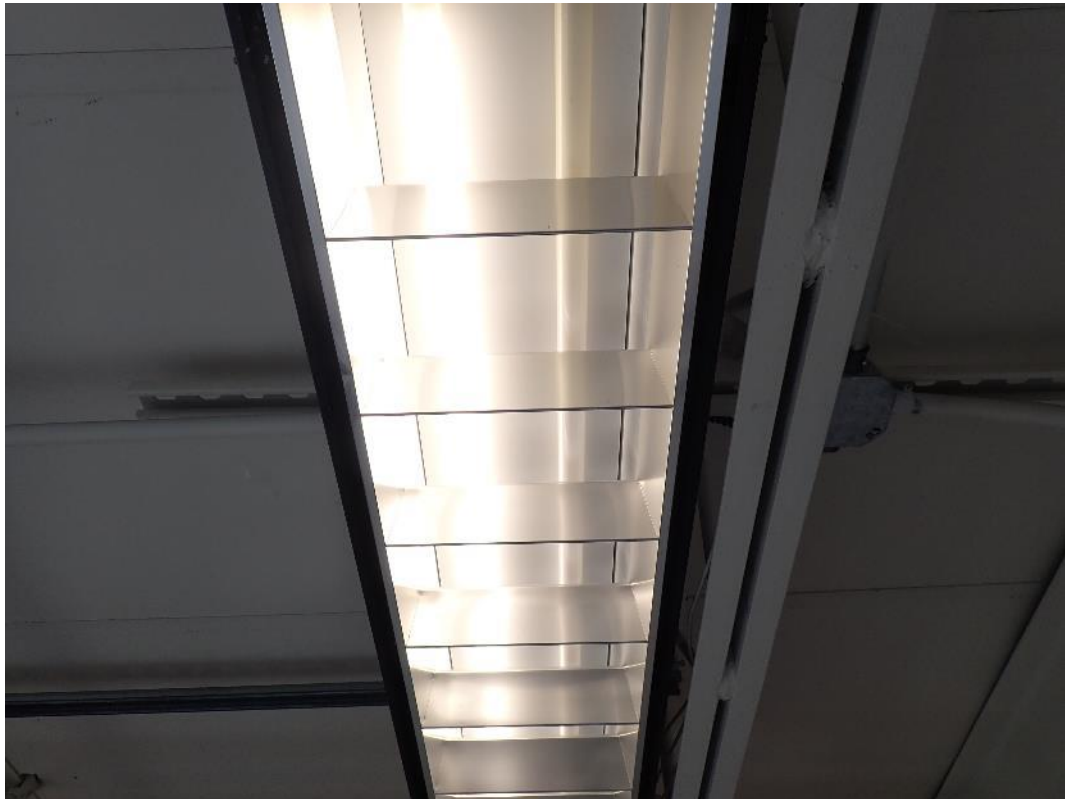
Photograph 39: Older fluorescent lighting.

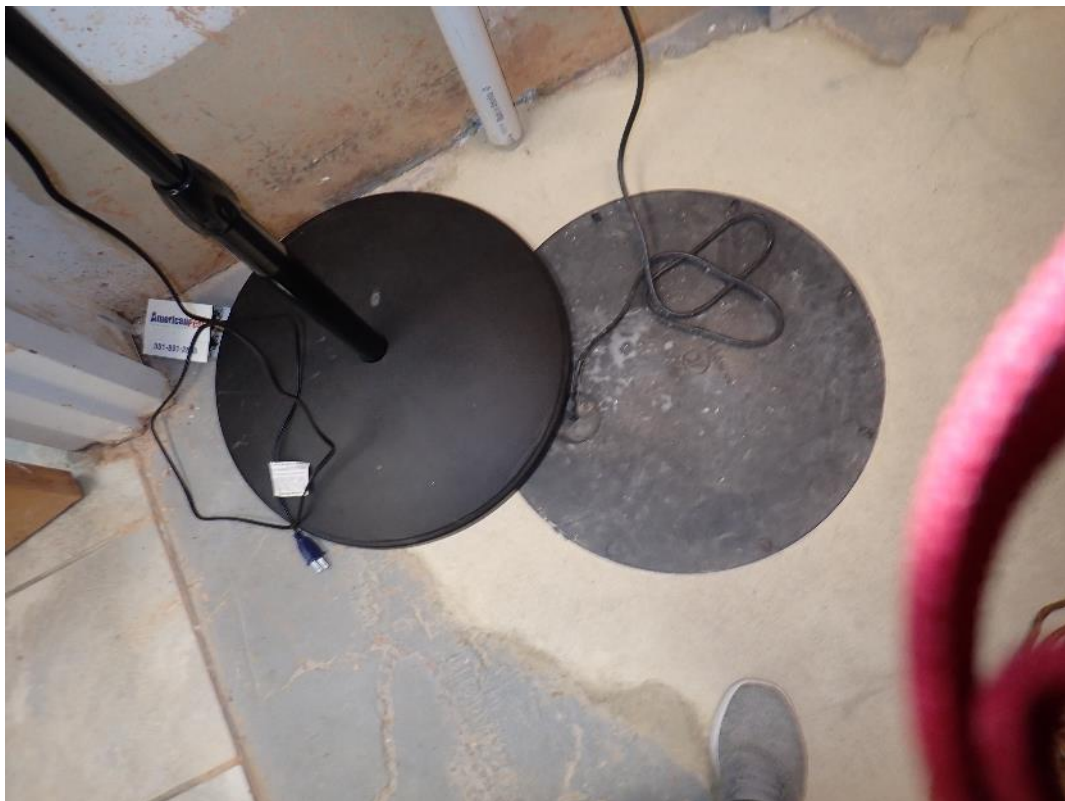
Photograph 40: Sump pump in basement area.

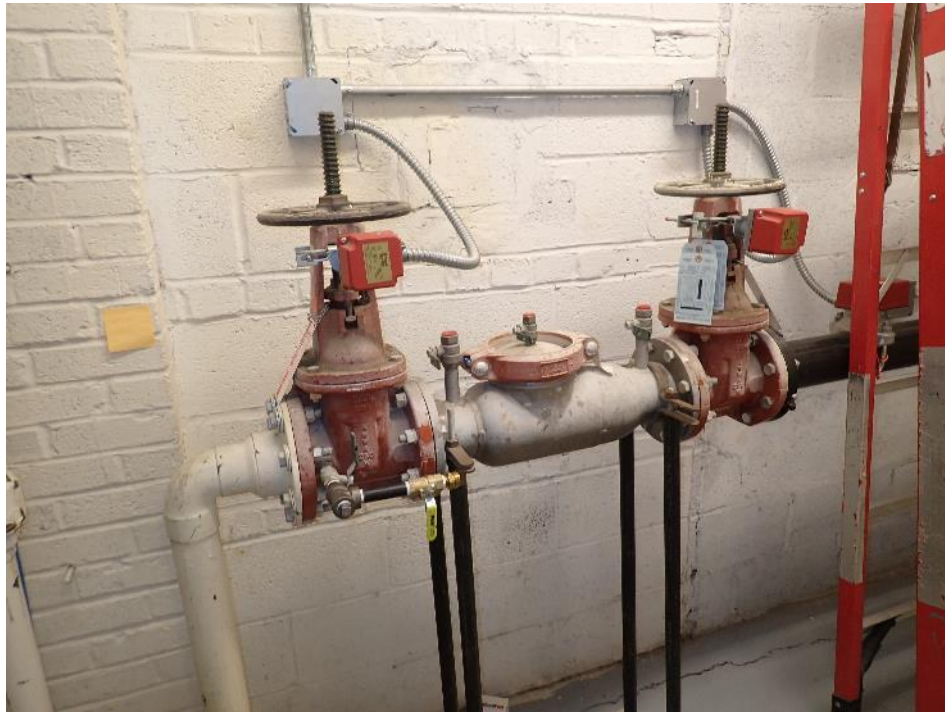
Photograph 41: Incoming sprinkler pipework.

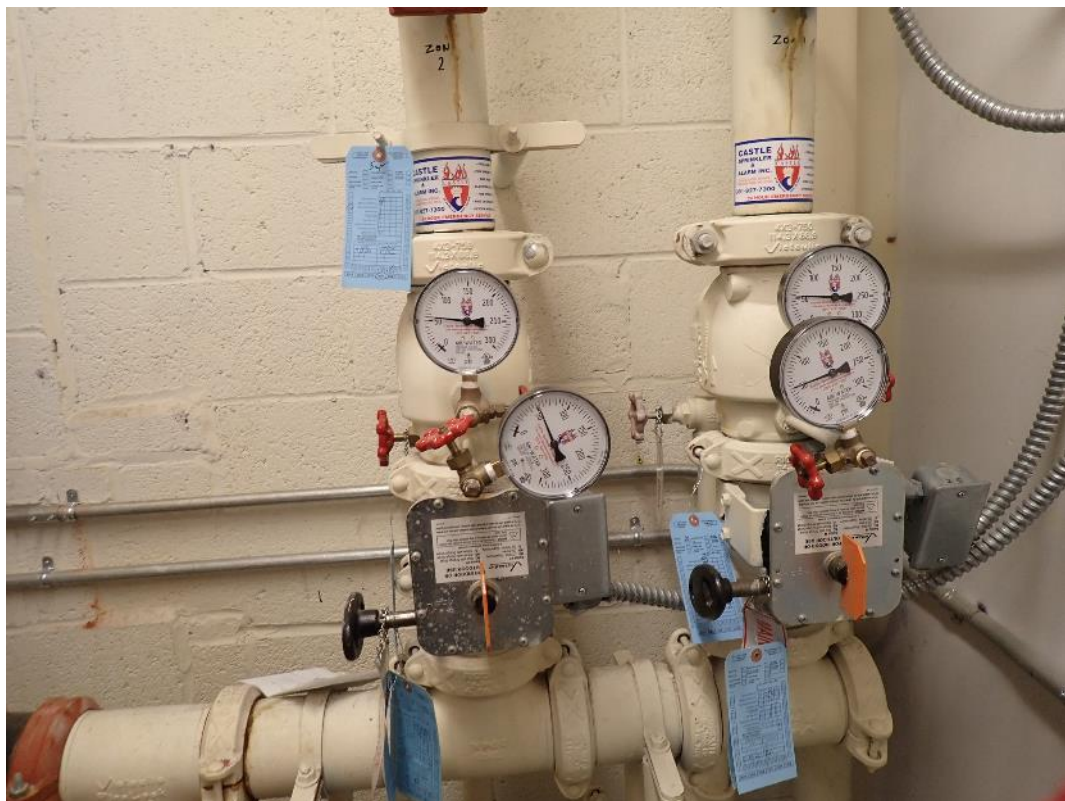
Photograph 42: Sprinkler system risers.

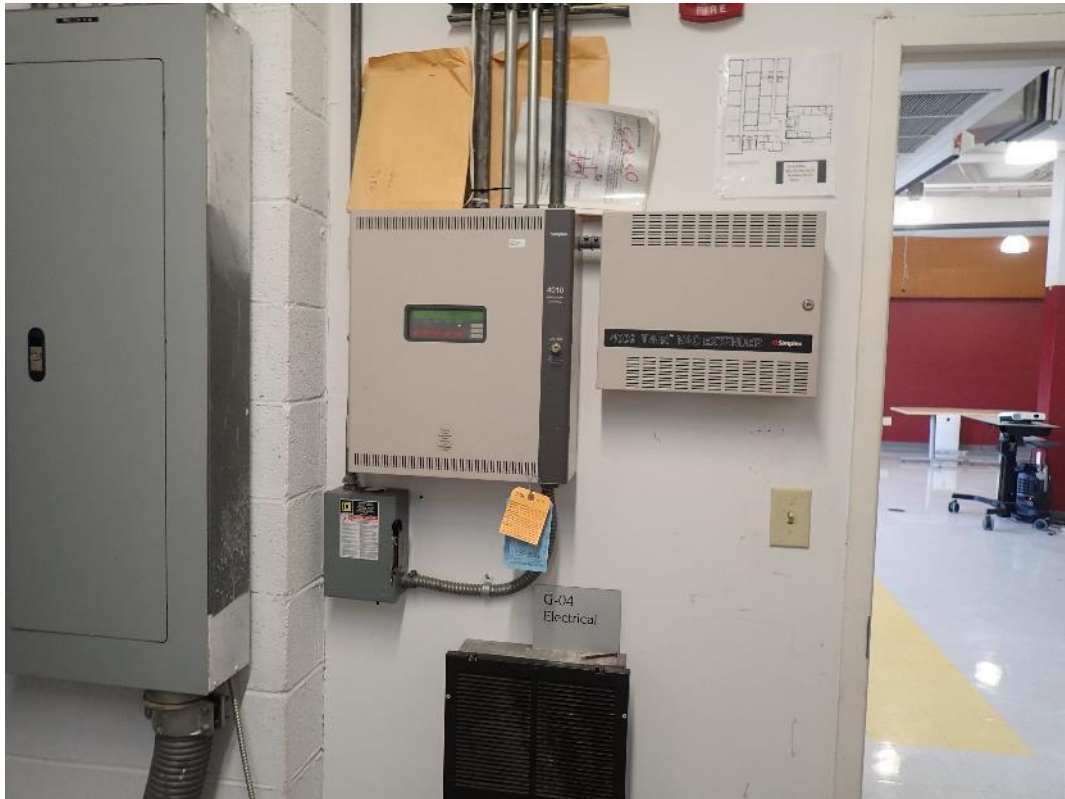
Photograph 43: Fire alarm control panel.

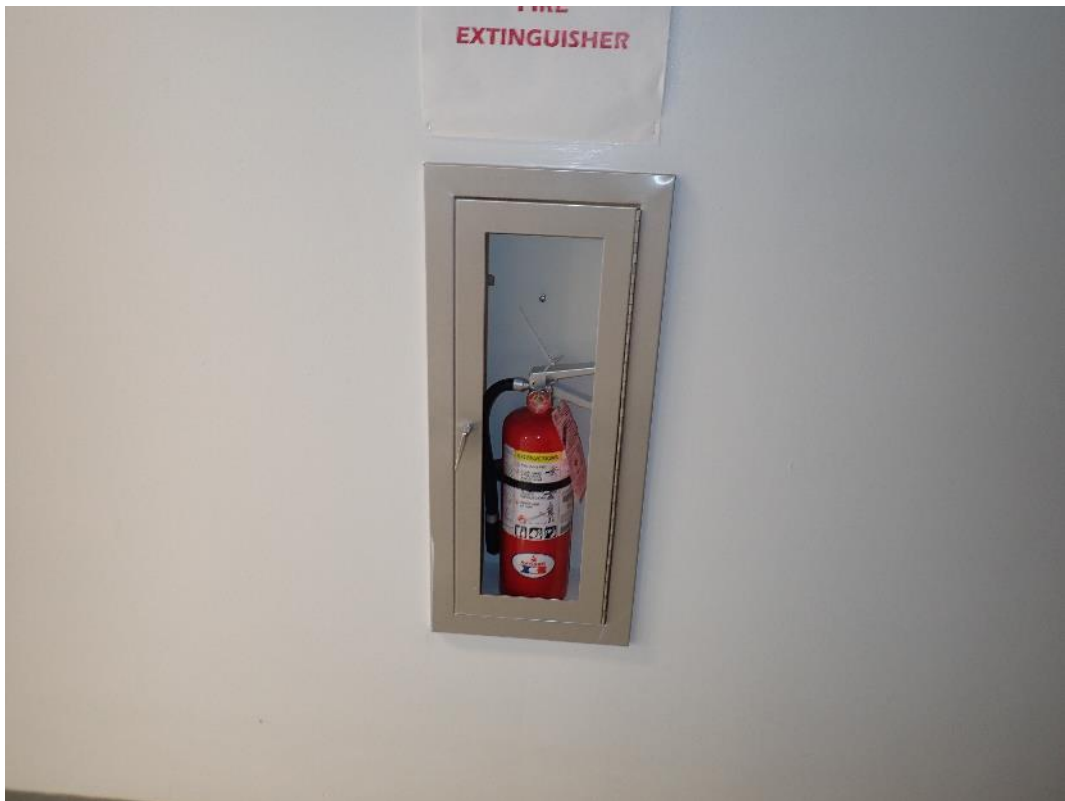
Photograph 44: Handheld fire extinguisher.

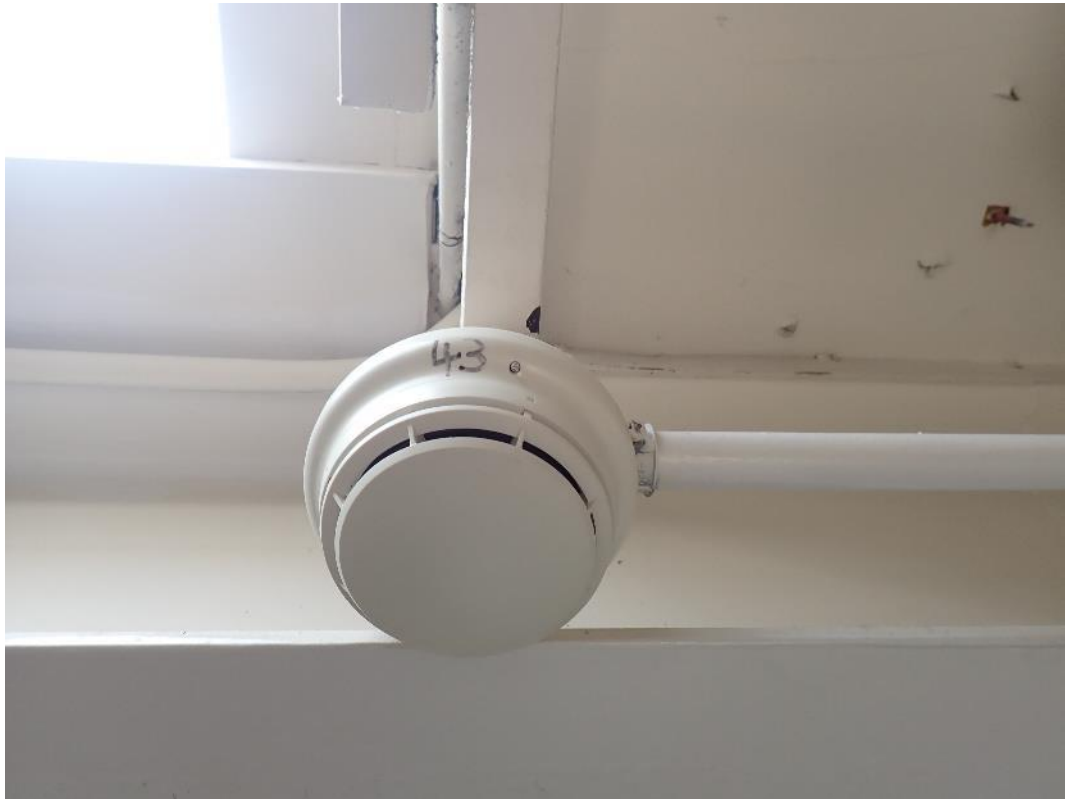
Photograph 45: Typical smoke alarm.

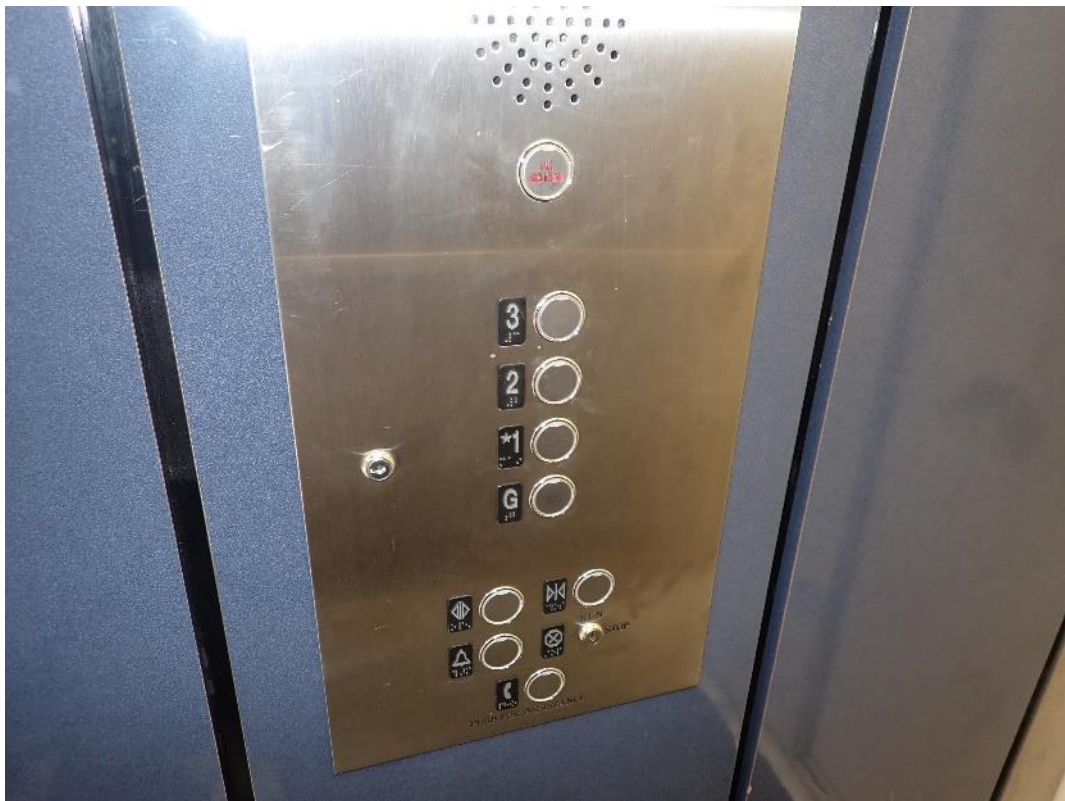
Photograph 46: Elevator car control panel.

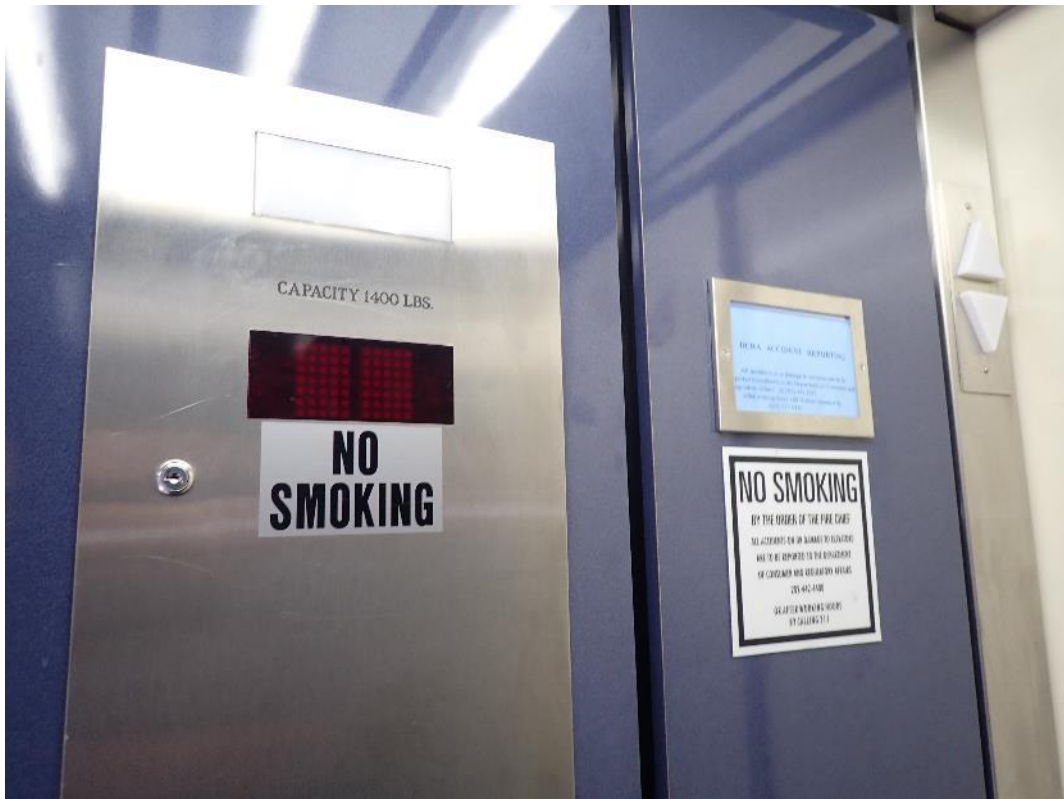
Photograph 47: Elevator car control panel and cab finishes.

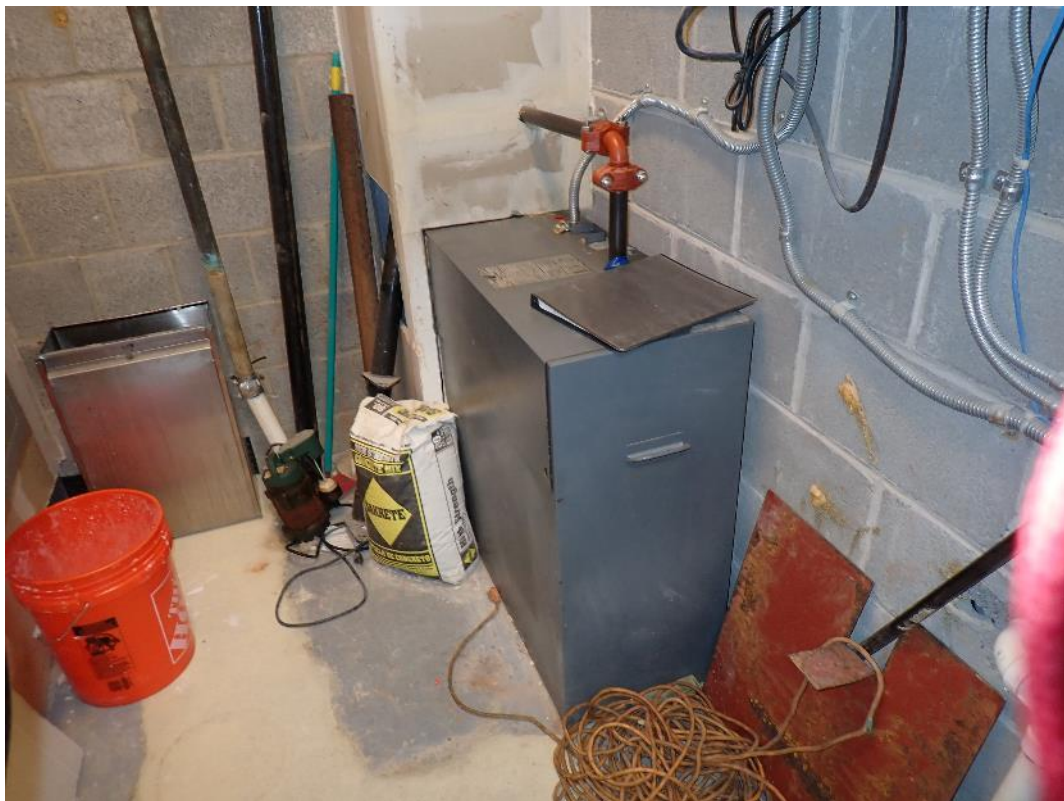
Photograph 48: Elevator hydraulic pump unit.

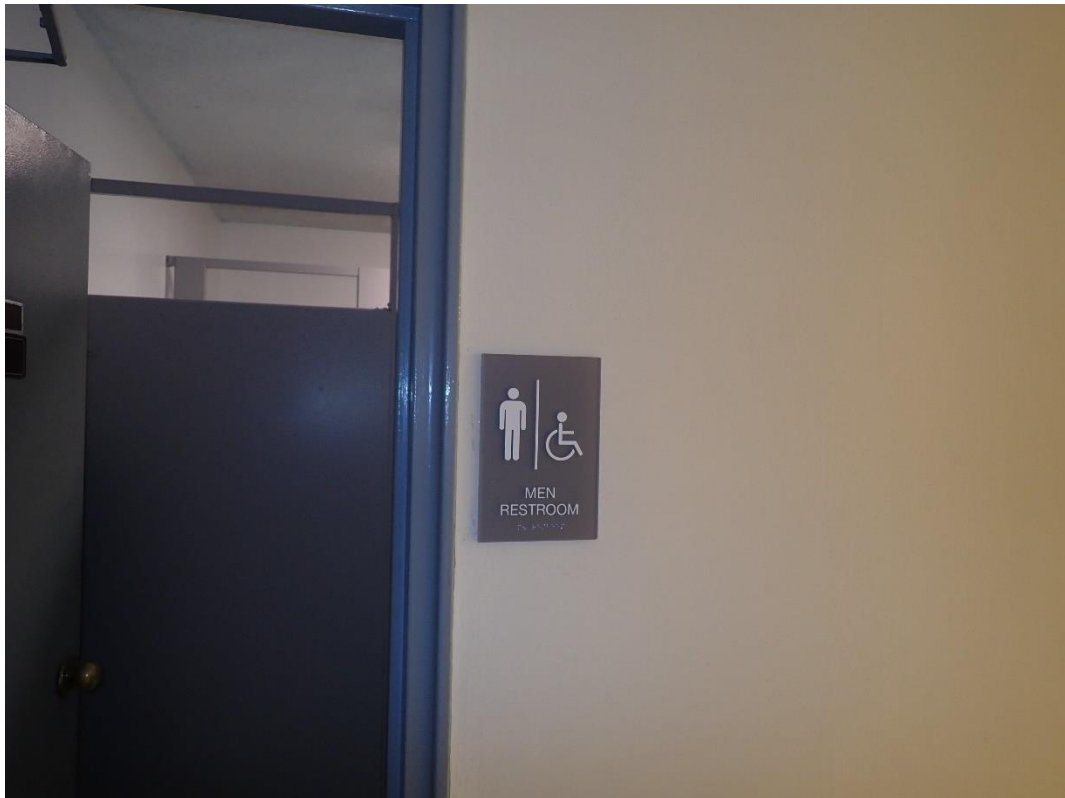
Photograph 4: Accessible signage to non-accessible restrooms.
