ACADEMY OF HOPE - WARD 5 & 8

EDUCATIONAL SPECIFICATION:

Report of Property Condition Assessment

Academy of Hope - Ward 5

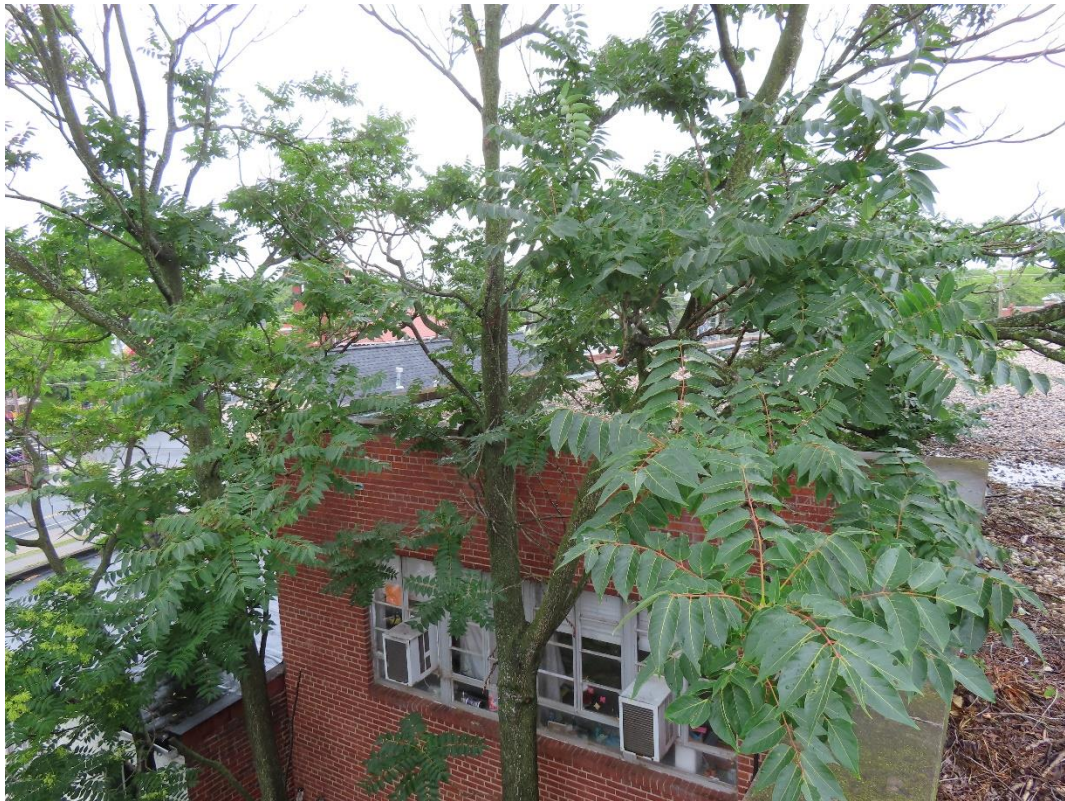
Photograph 8: Trees encroaching on roof.

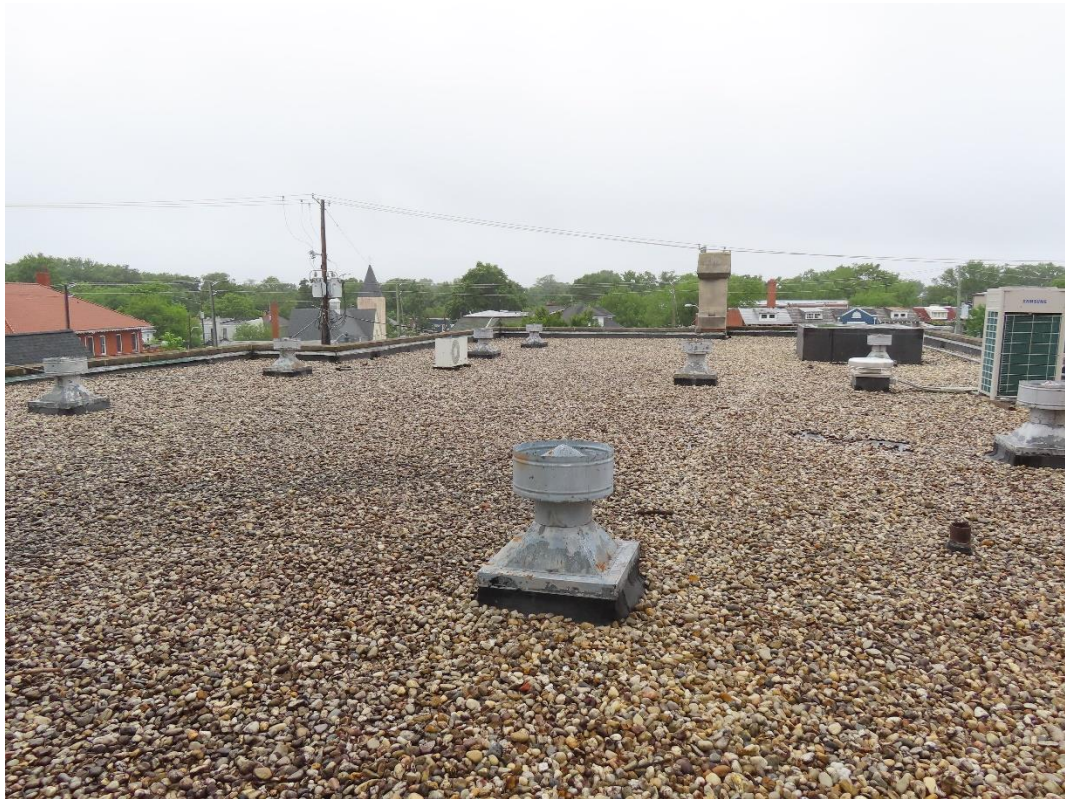
Photograph 10: Ballasted EPDM roof.

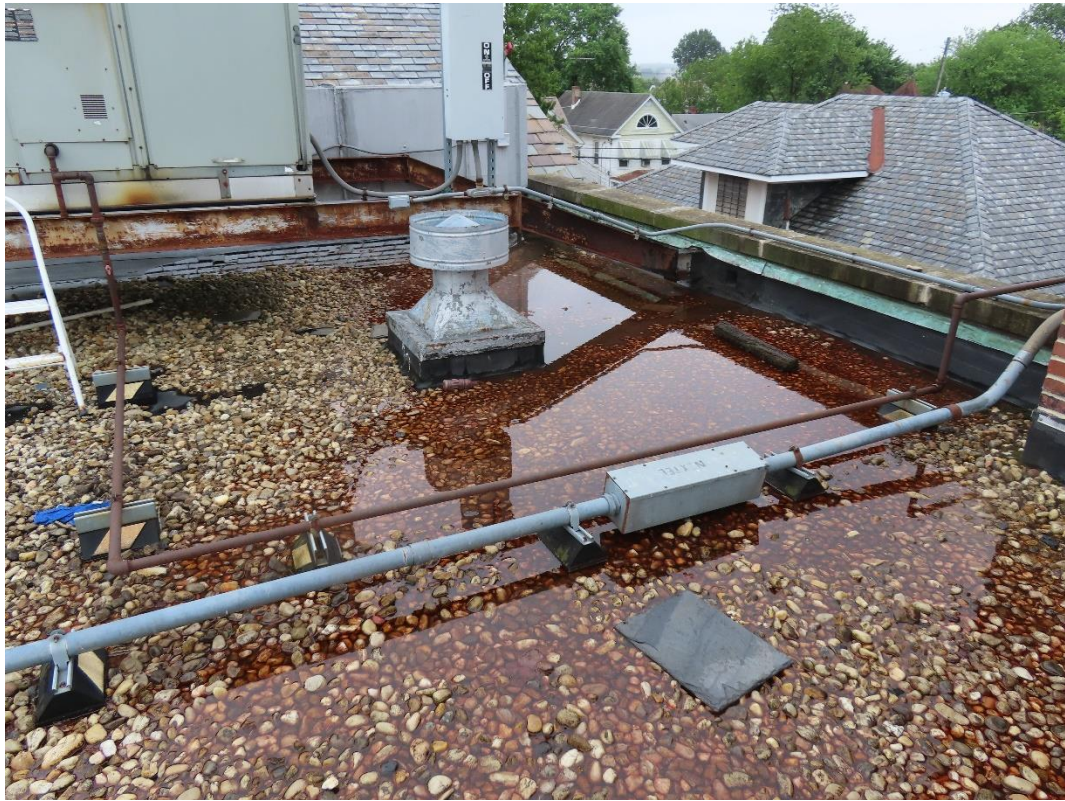
Photograph 11: Ponding water at roof level

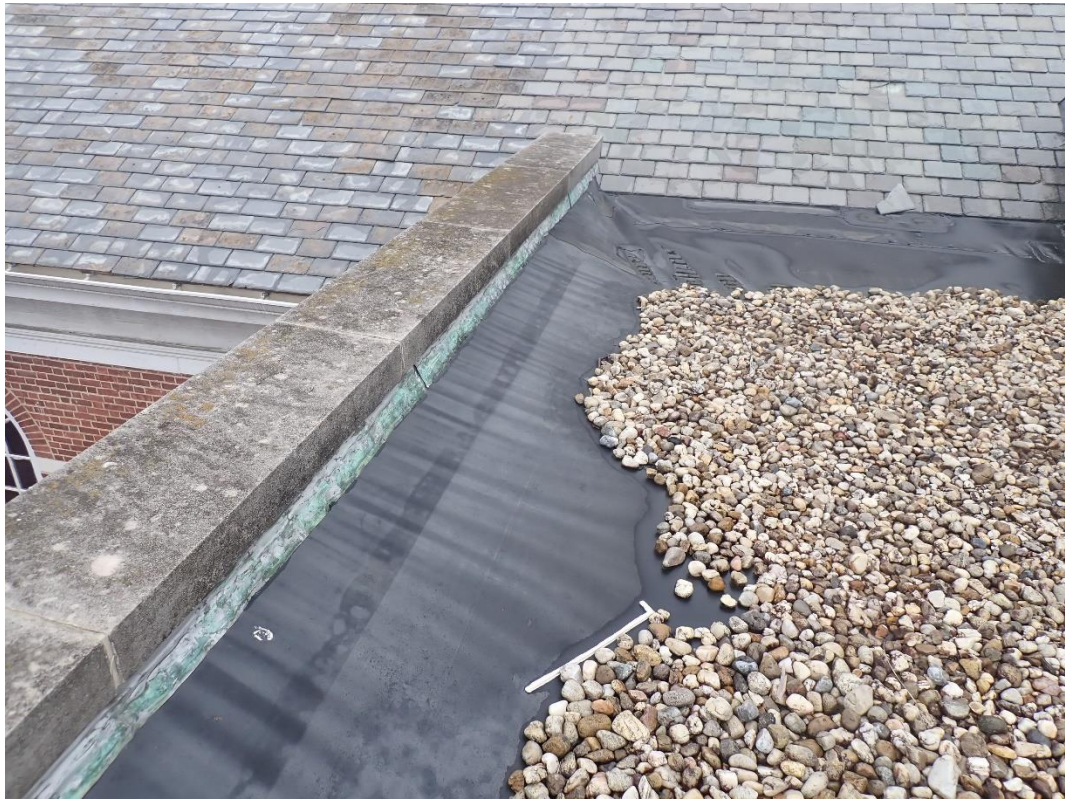
Photograph 12: "Tenting" of ballasted EPDM roofing.

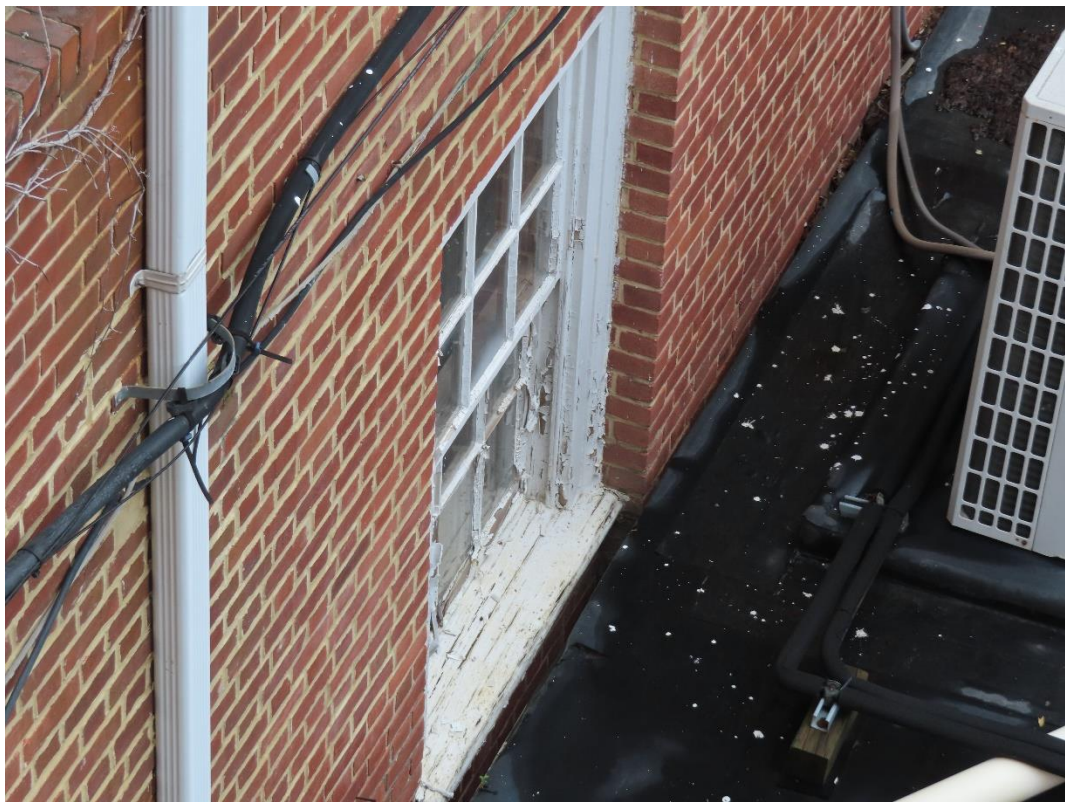
Photograph 18: Flaking paint to wood windows.

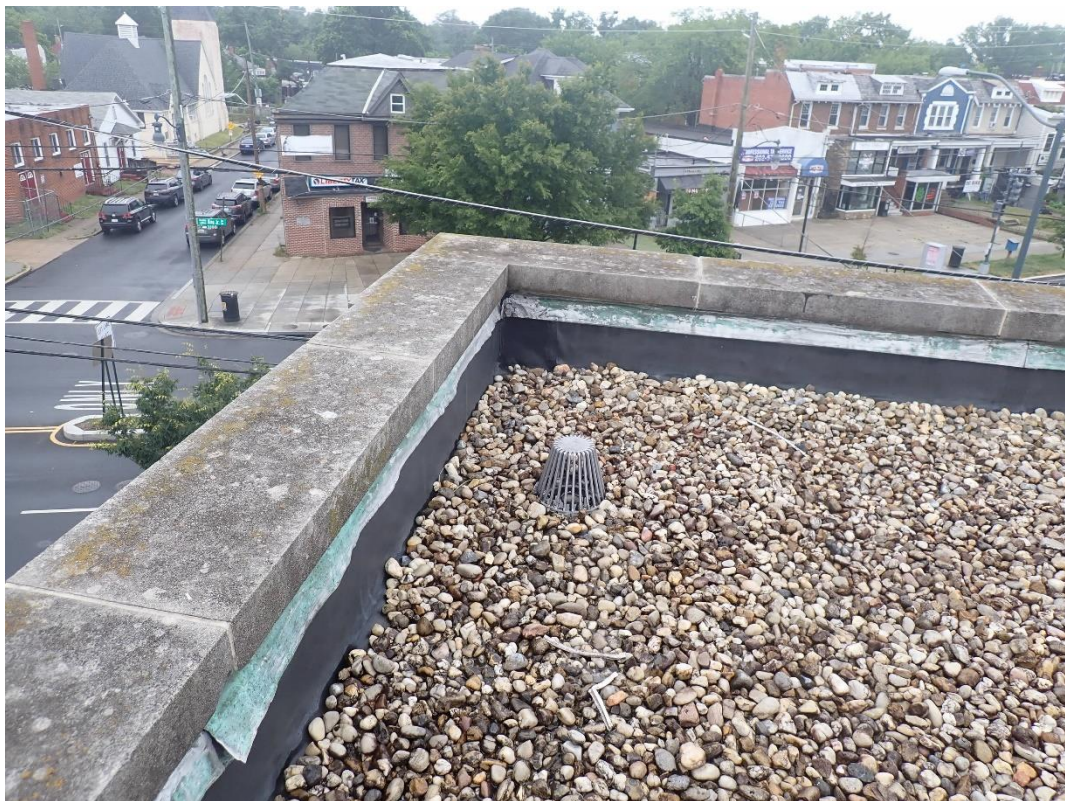
Photograph 20: Stone parapet and copper flashing.

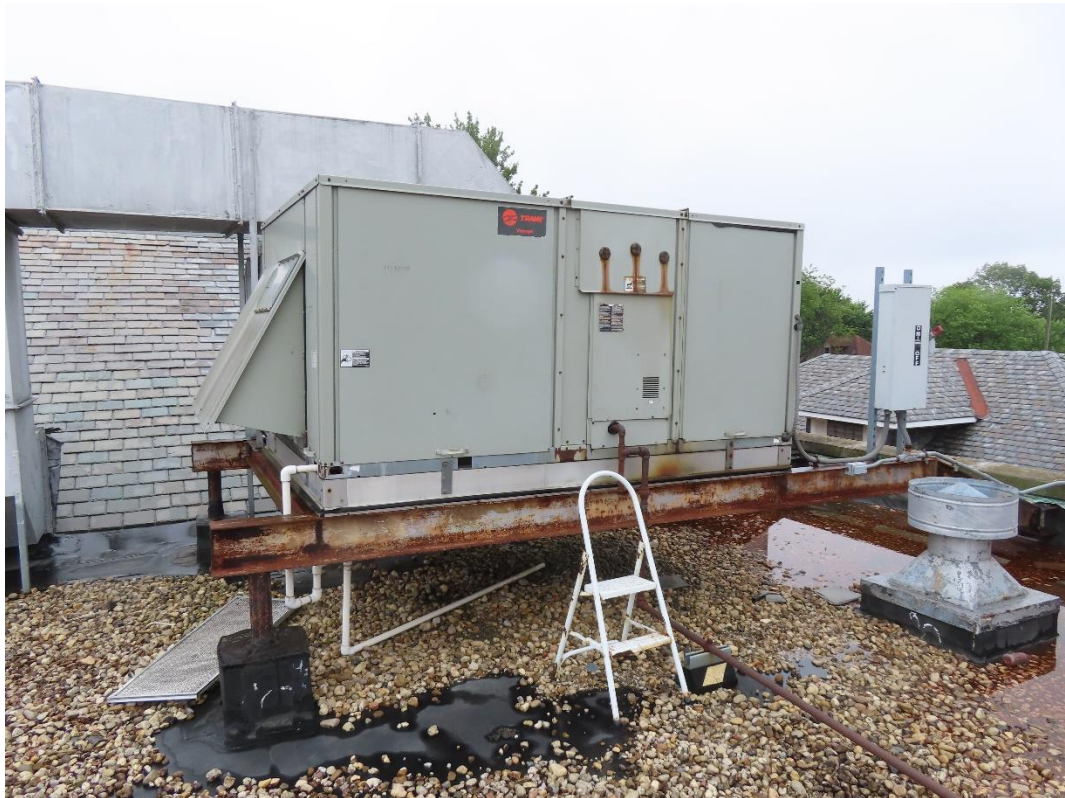
Photograph 22: 12.5 ton rooftop package unit.

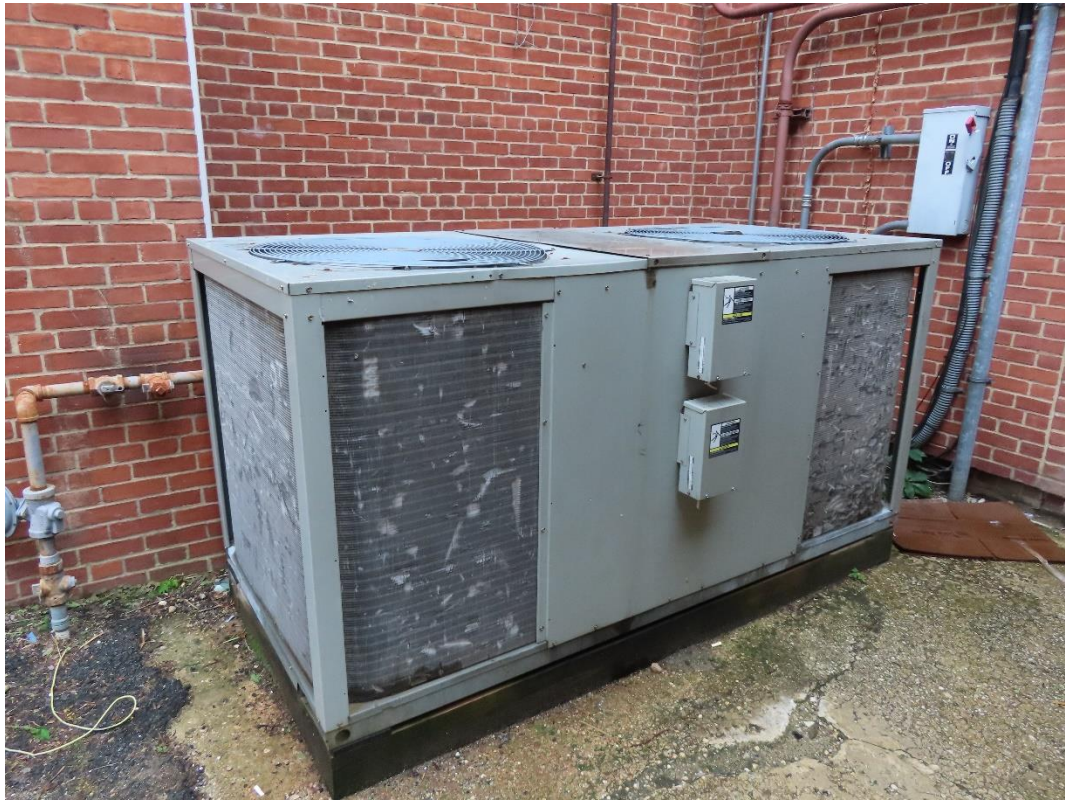
Photograph 23: 20 ton exterior condensing unit

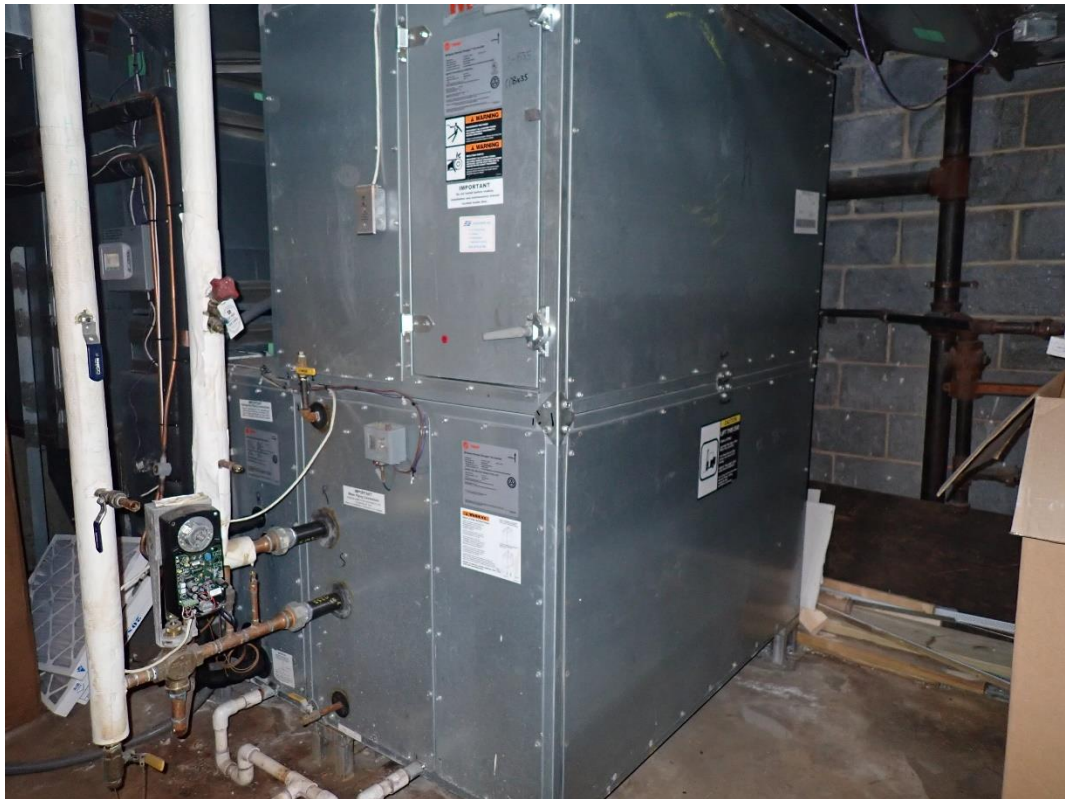
Photograph 24: Trane air-handling unit.

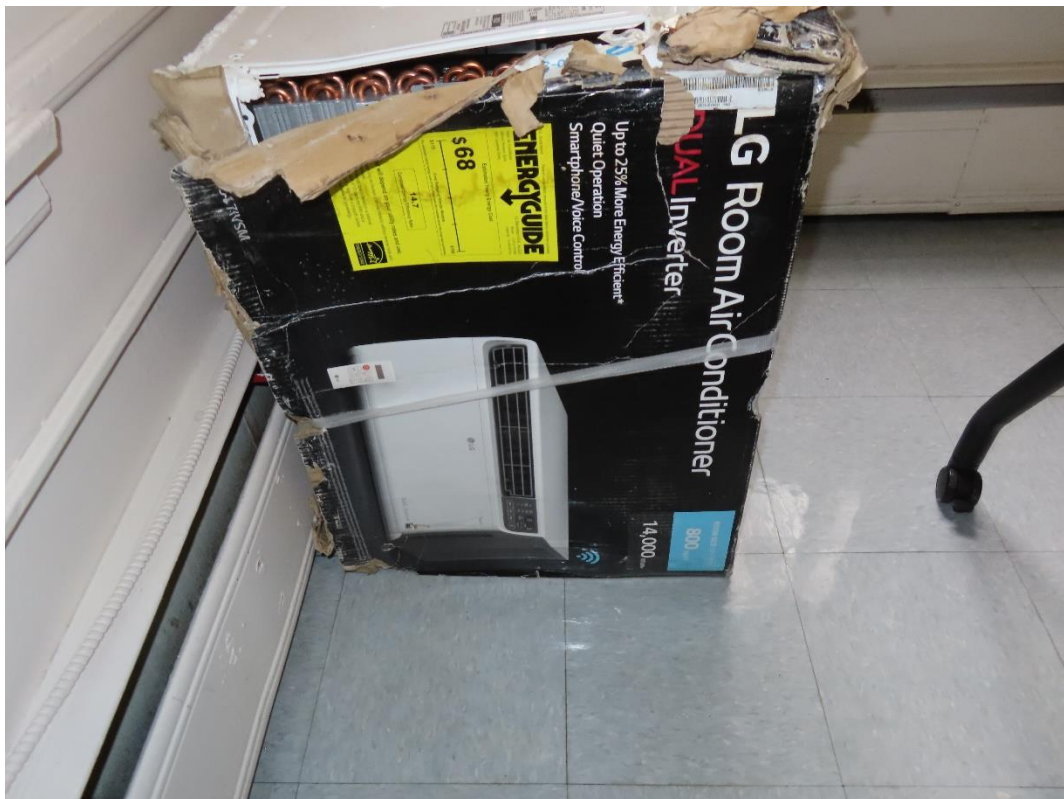
Photograph 28: Baseboard radiators and spare window A/C unit.

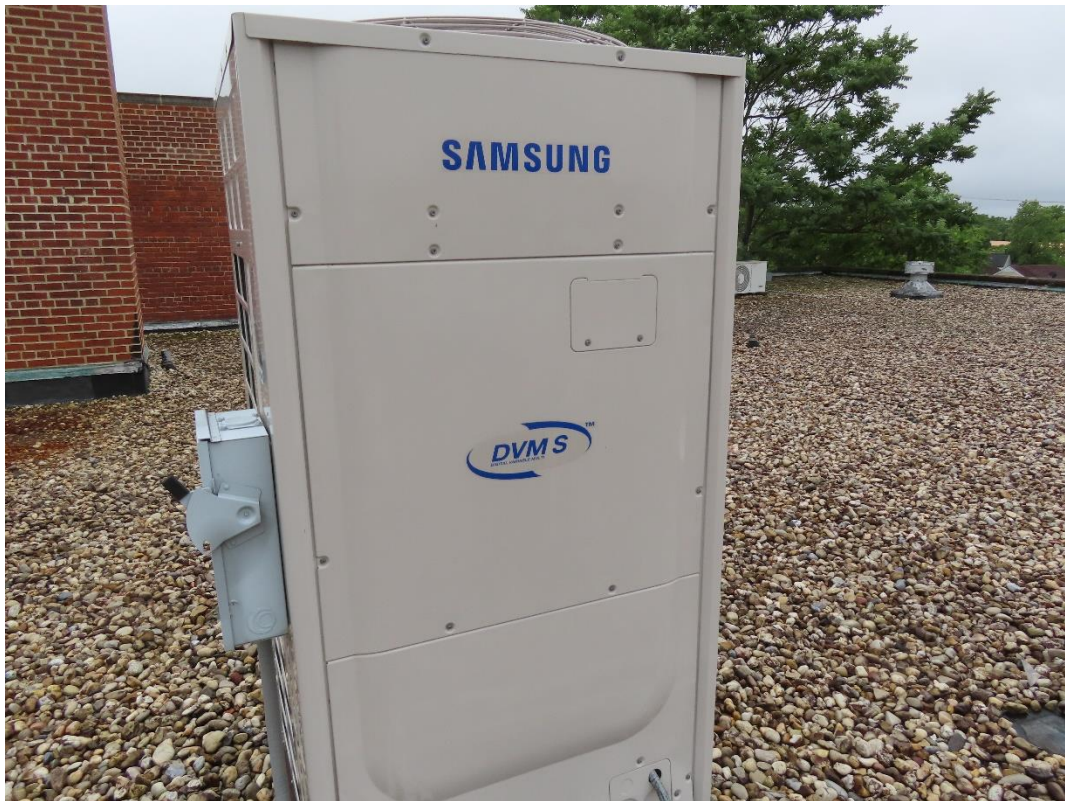
Photograph 31: 6 Ton VRF split heat pump unit.

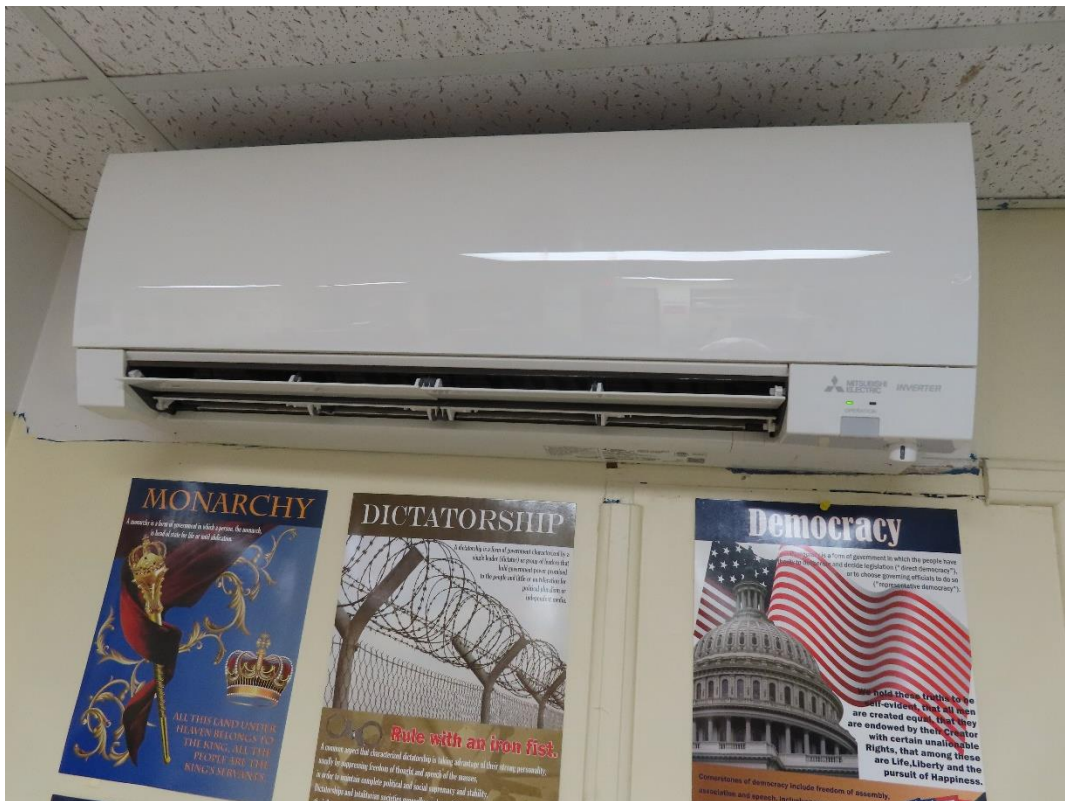
Photograph 32: Mini-split interior air fan coil unit

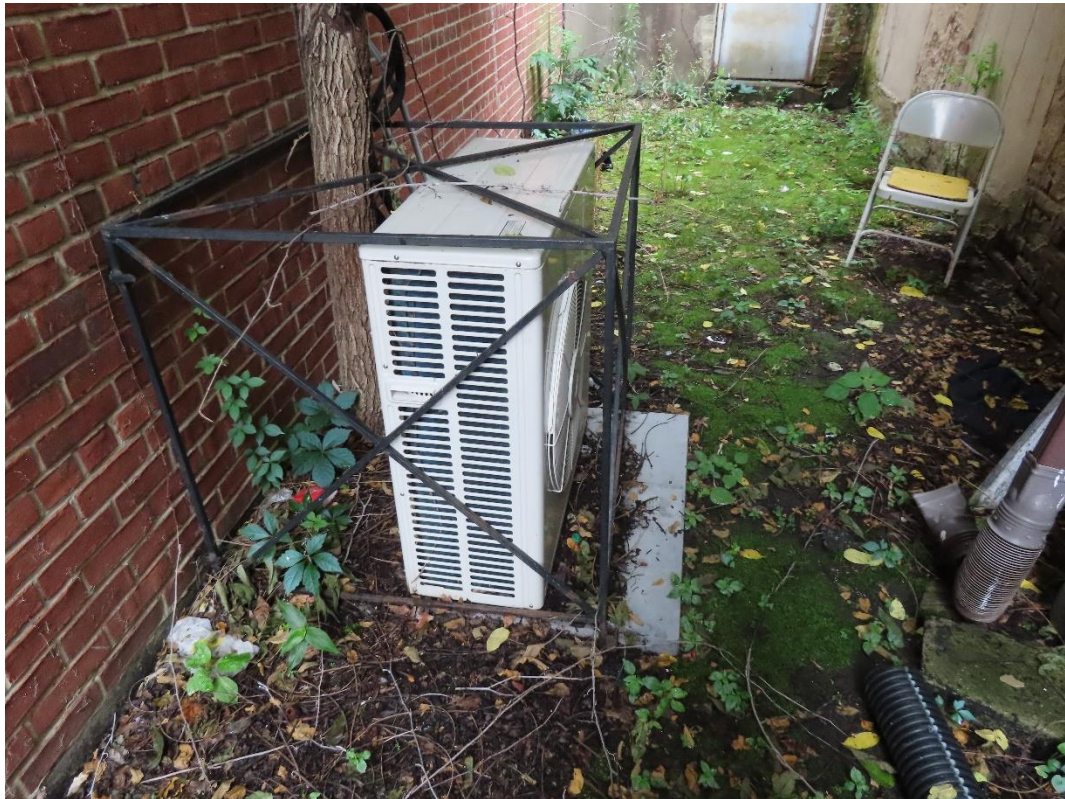
Photograph 33: Mini-split external condenser unit.

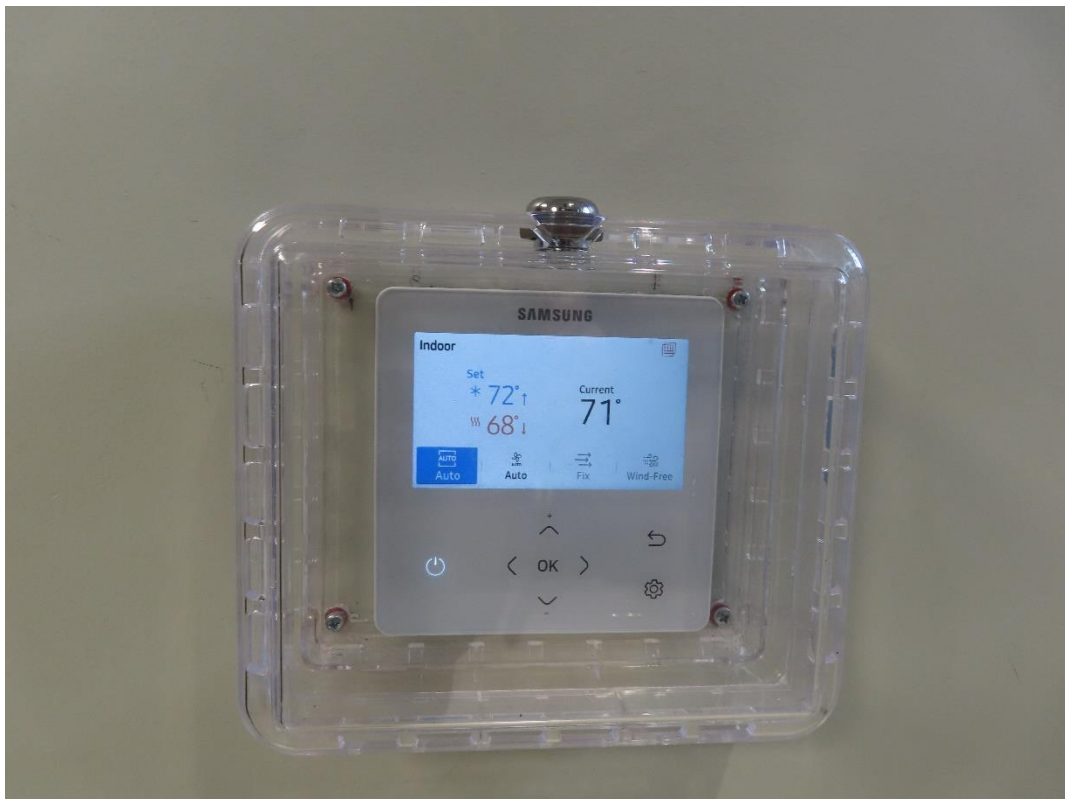
Photograph 34: VRF control thermostat.

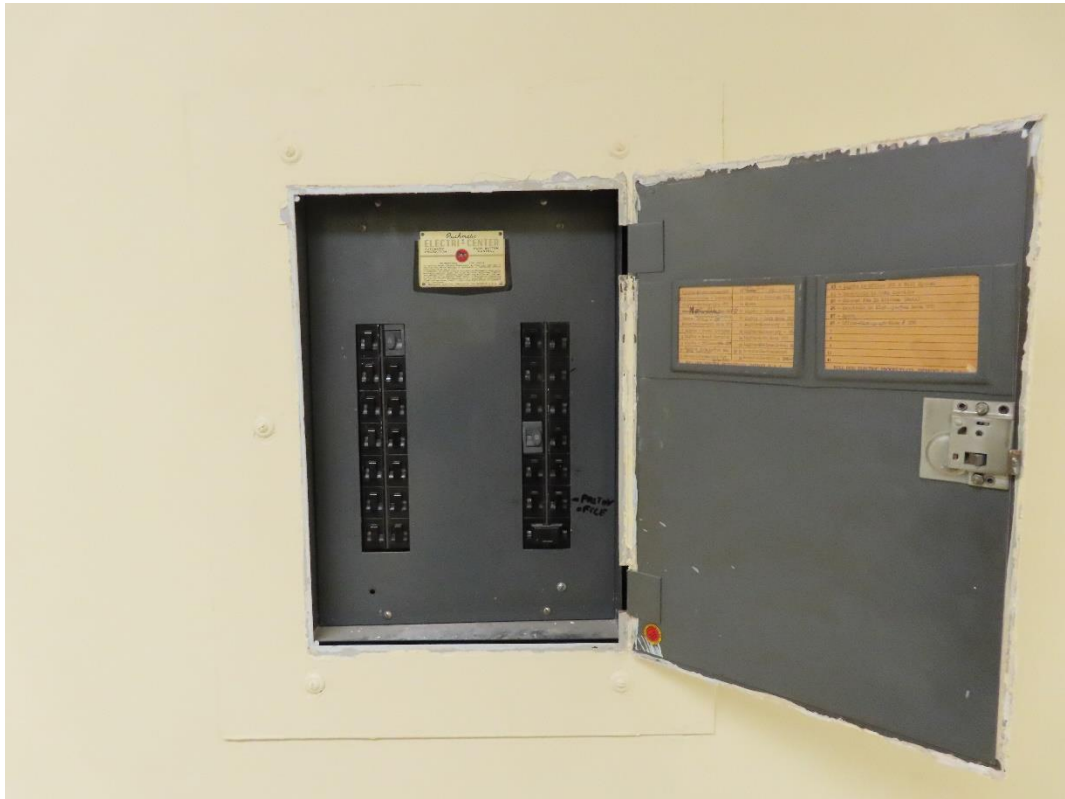
Photograph 35: Bulldog Pushmatic Breaker panel.

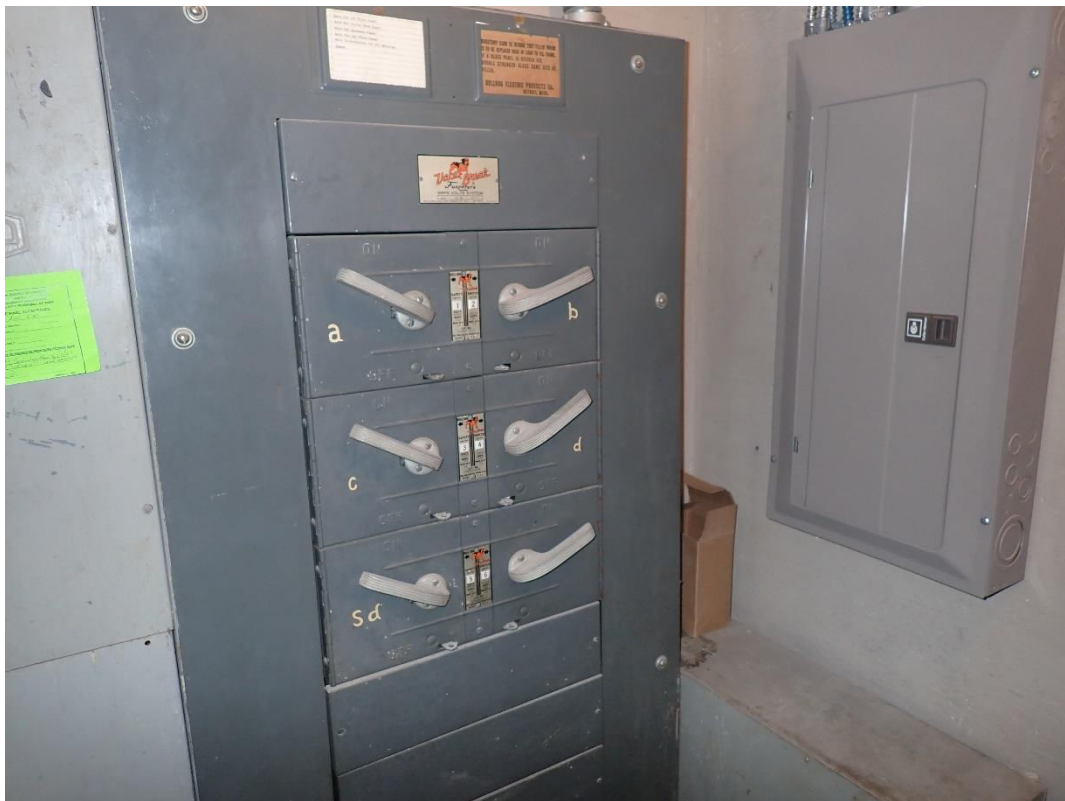
Photograph 36: Bulldog 400 amp main disconnect.

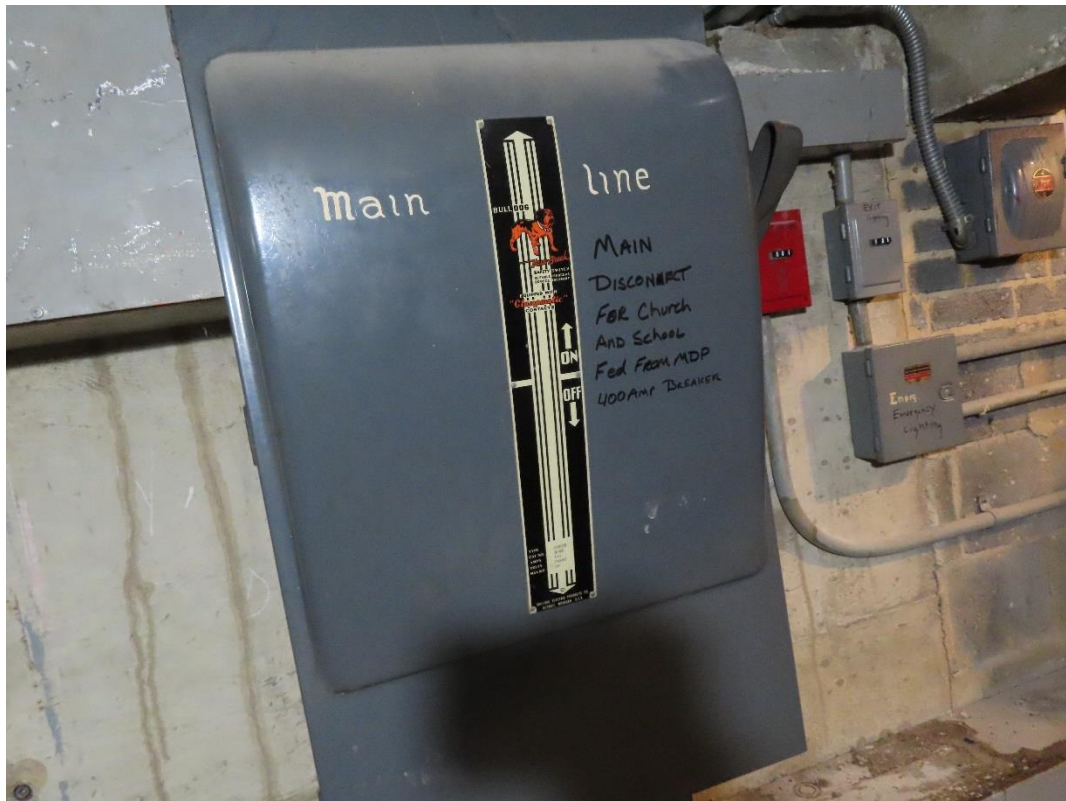
Photograph 37: Bulldog disconnect switch

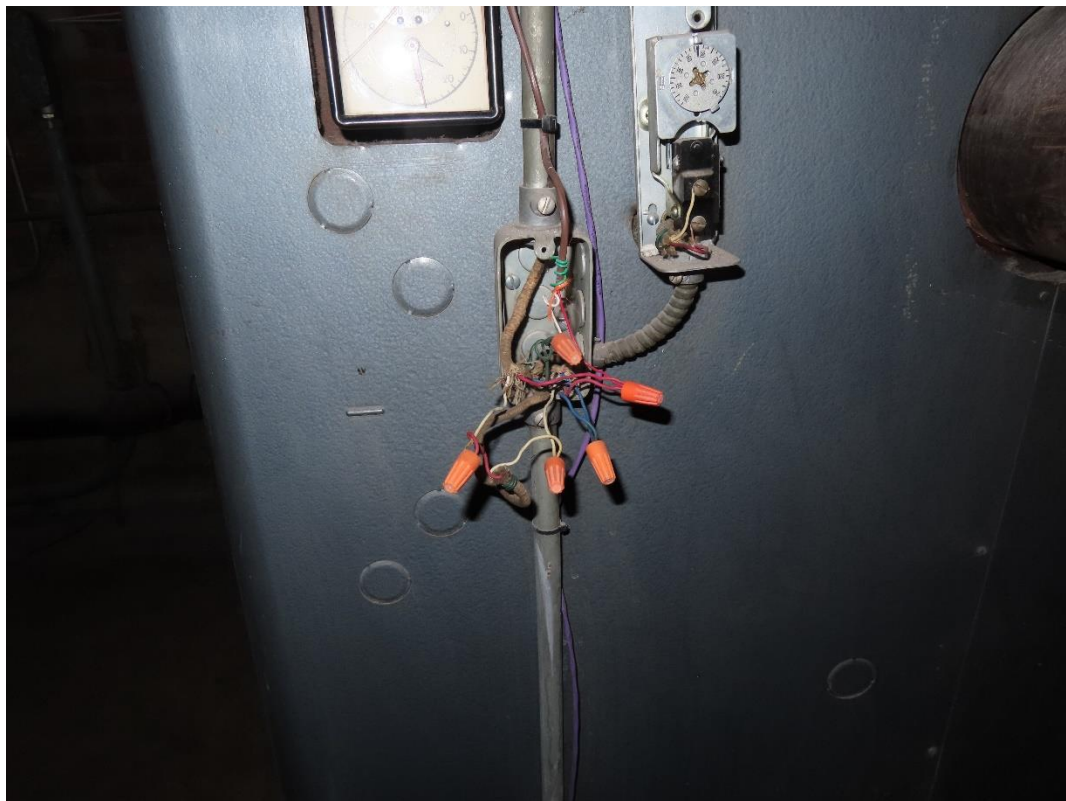
Photograph 38: Exposed electrical connections.

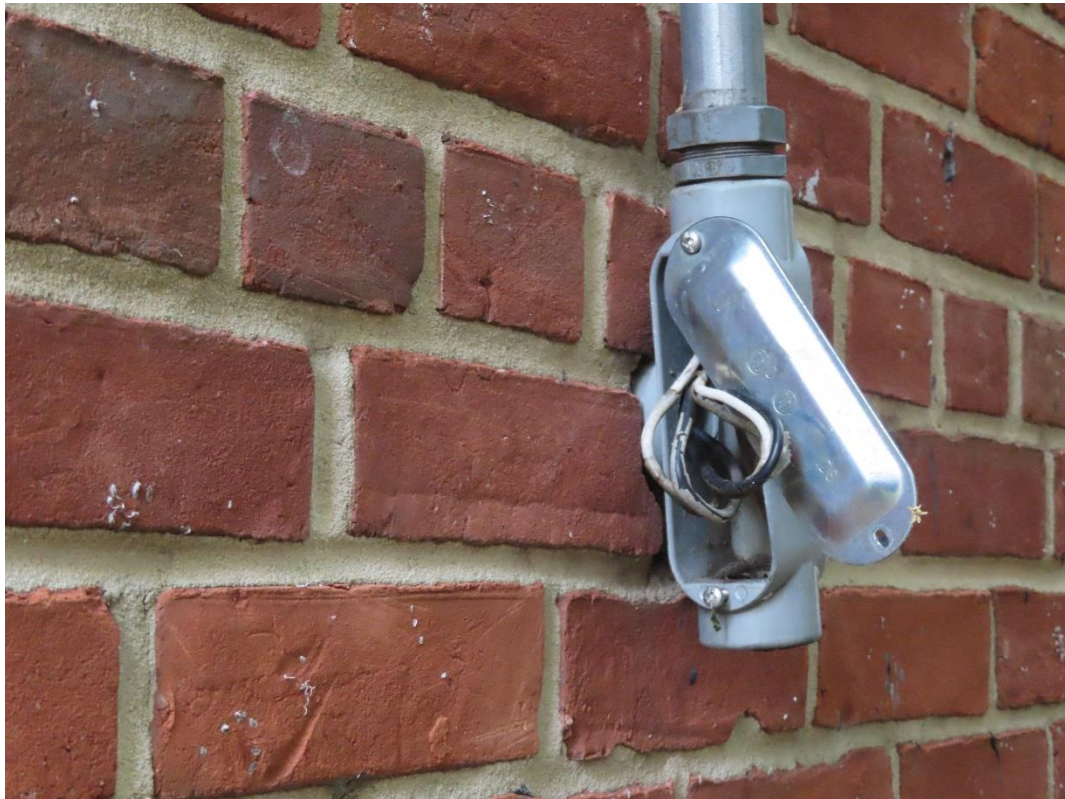
Photograph 39: Open electrical junction box.

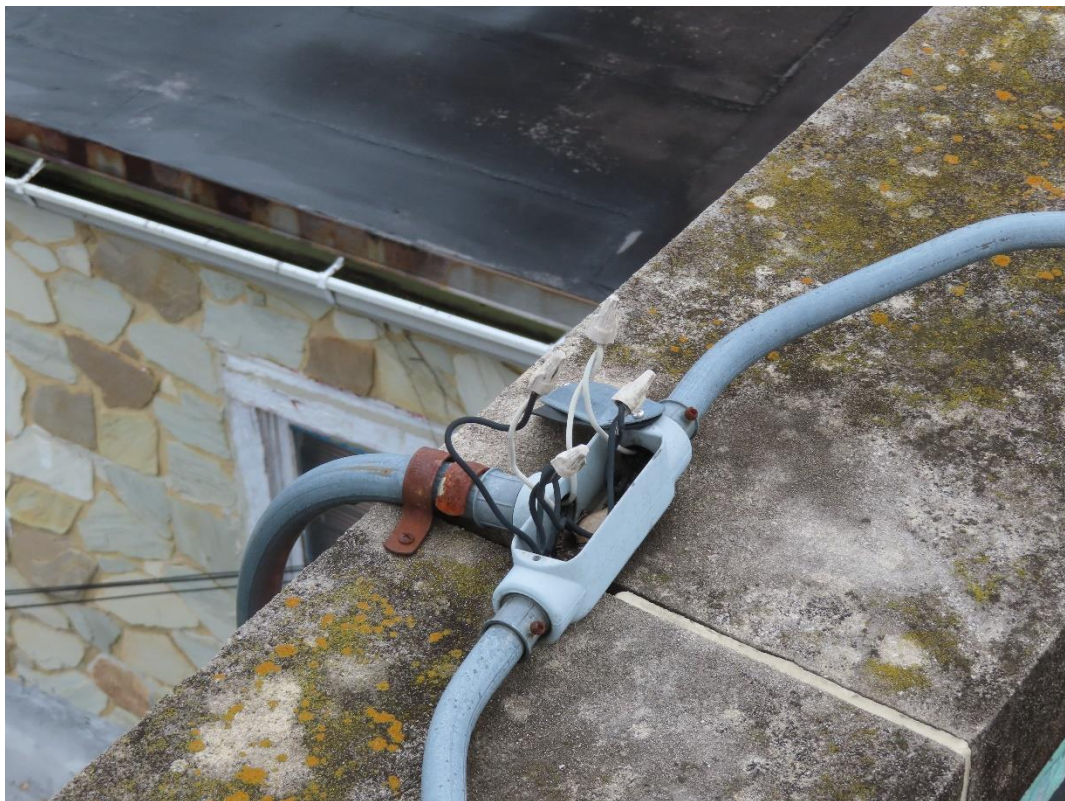
Photograph 40: Exposed electrical connections.

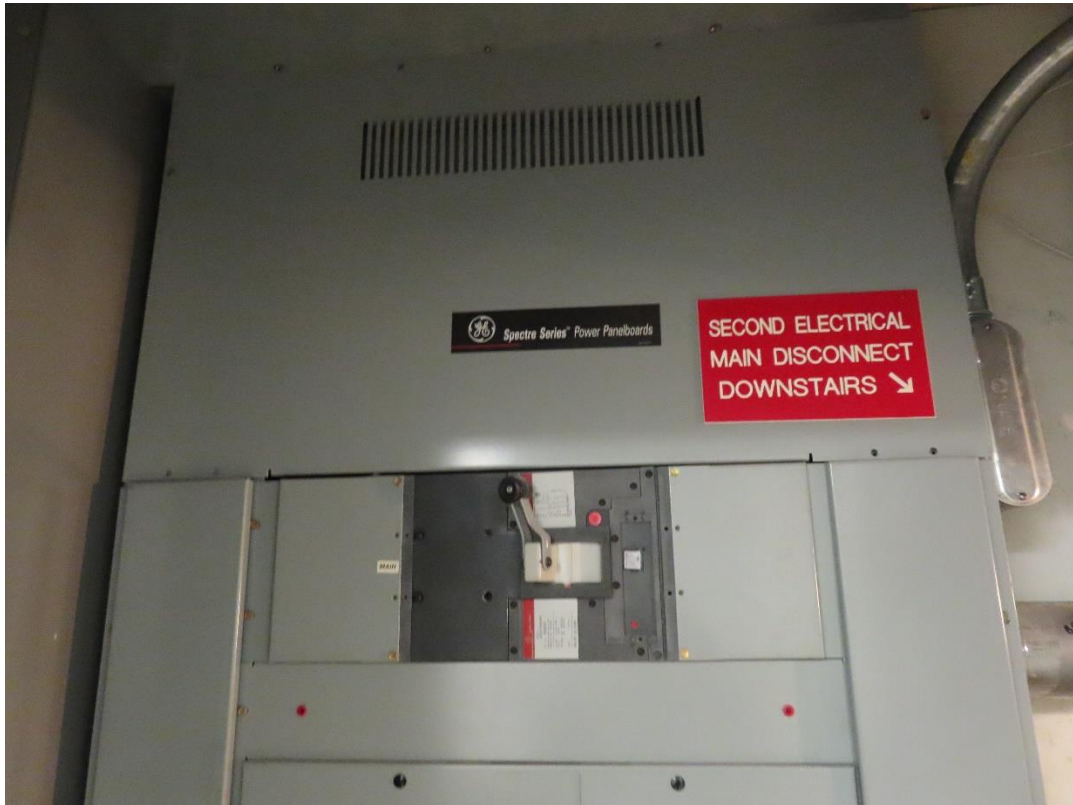
Photograph 41: GE main disconnect.

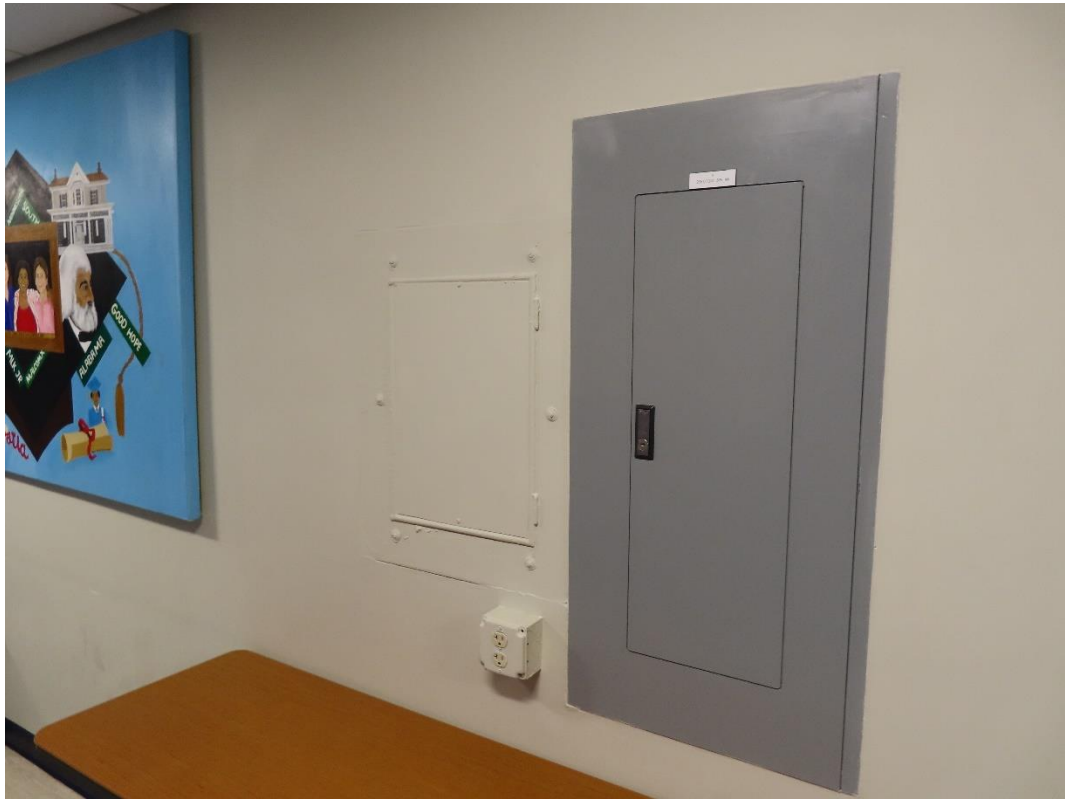
Photograph 42: New breaker panel in lobby.

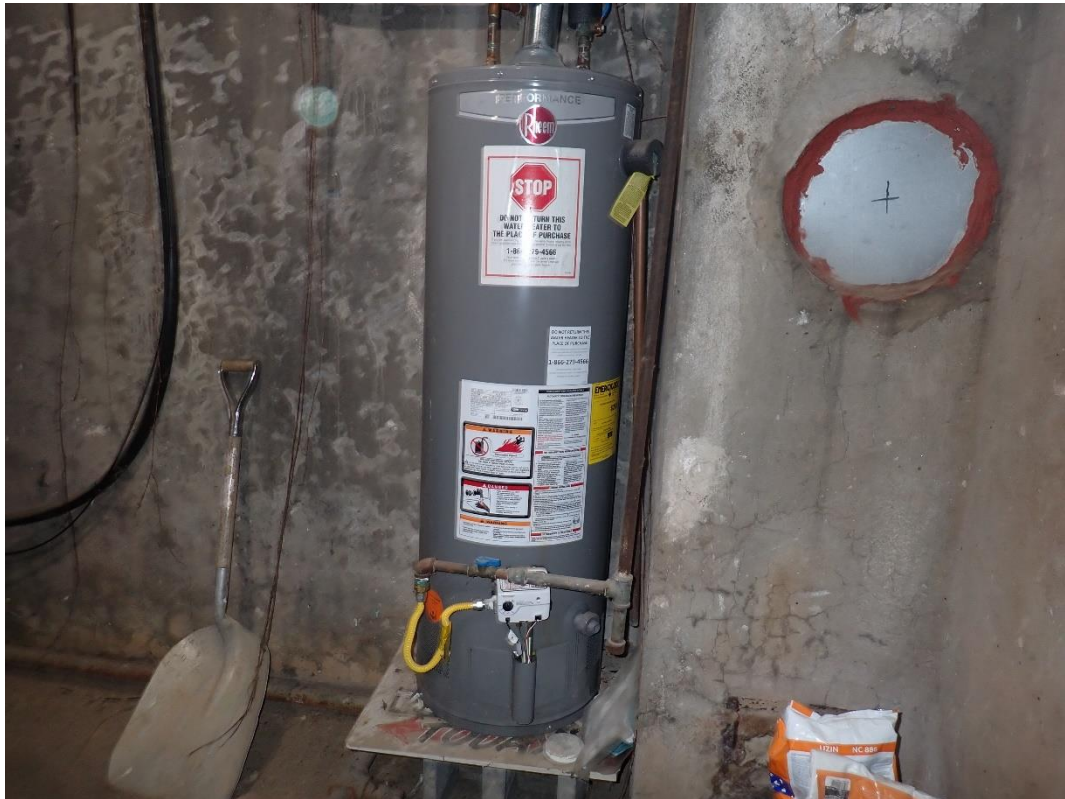
Photograph 45: Hot water heater.

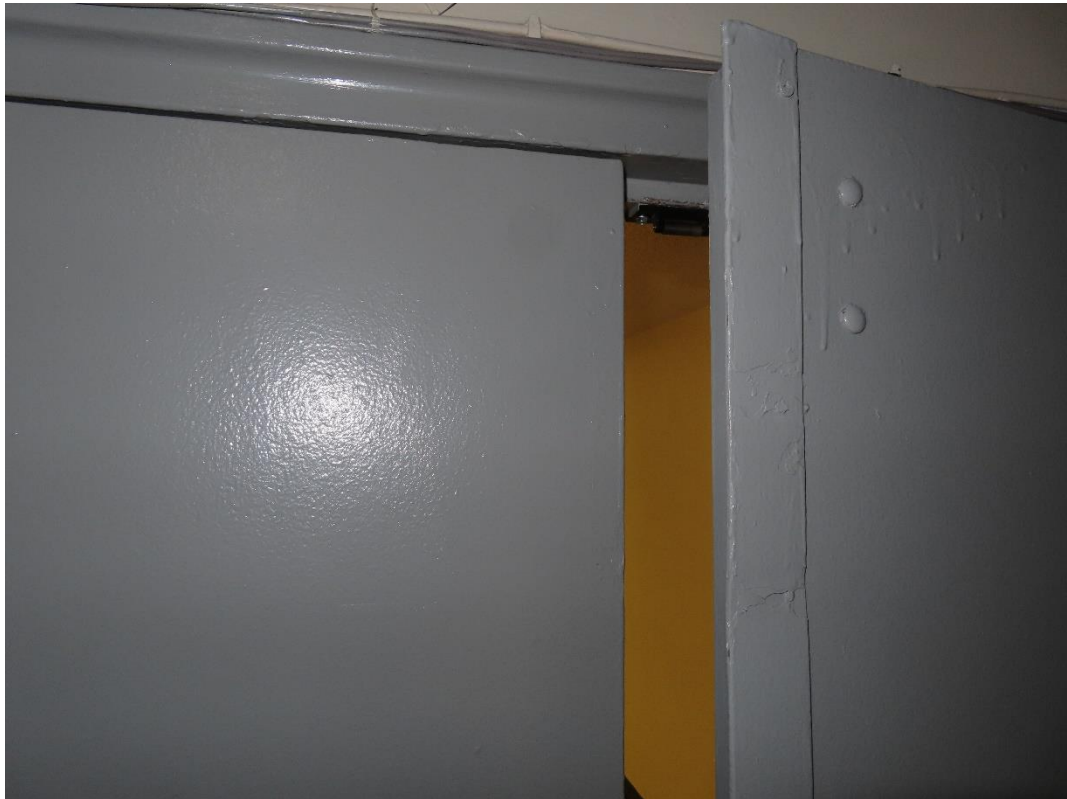
We also noted that the doors from the corridor into stairwell B on the middle floor could not be opened. We also noted on the same floor, that the doors leading onto stairwell A could only be opened if operated in the correct sequence. Both issues are a matter of life safety and should be repaired as a matter of urgency, to ensure that all doors onto stairwells open when the push bar is activated, regardless of the sequence in which the doors are opened.

Photograph 49: Flange restricting operation of egress doors

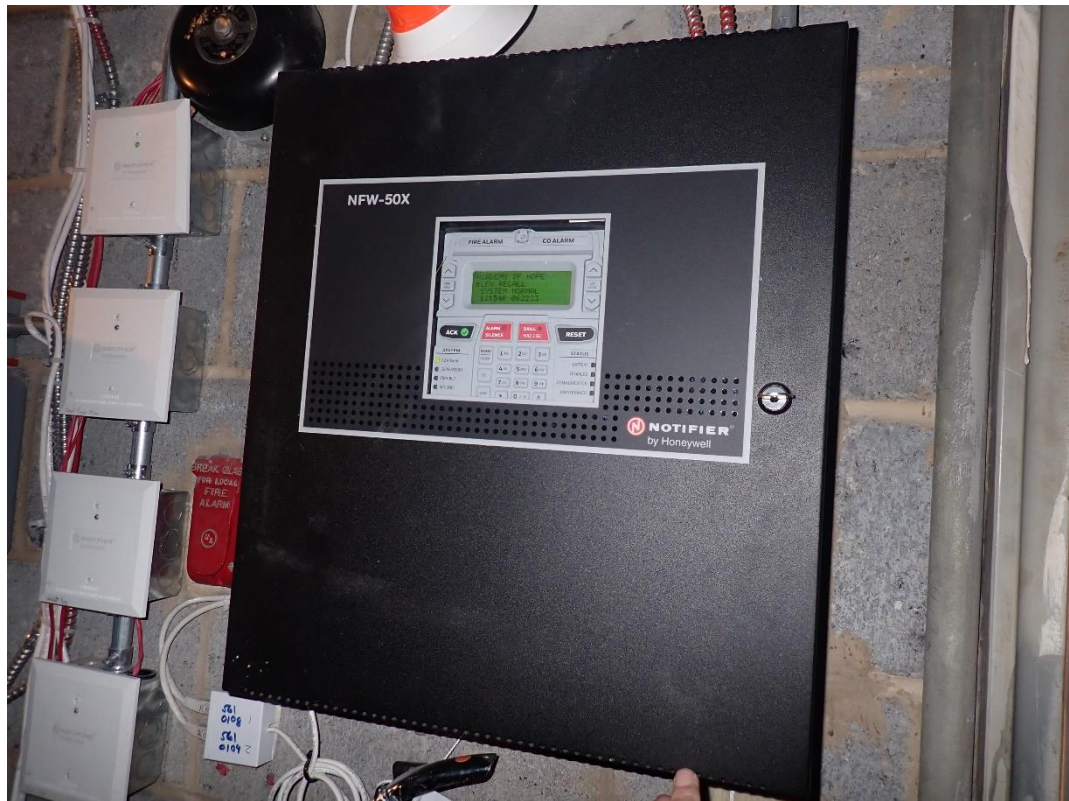
Photograph 51: Fire alarm panel.

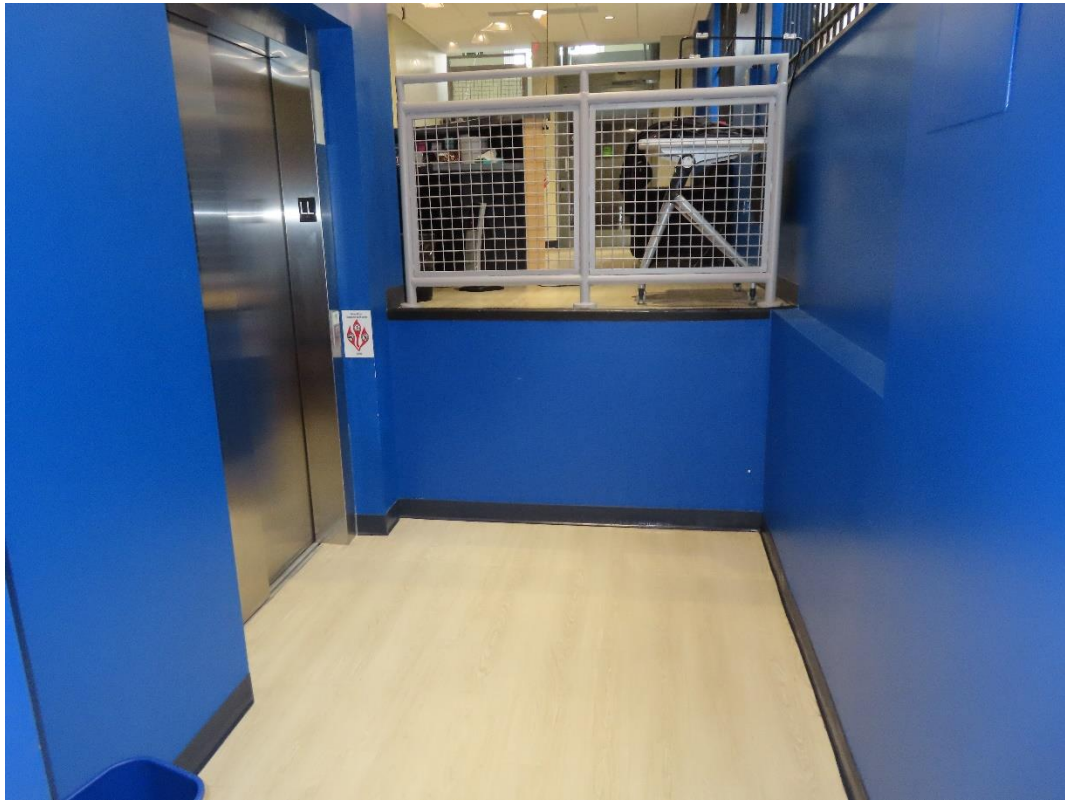
Photograph 53: Machine room-less elevator entry at lower ground floor.
