ACADEMY OF HOPE - WARD 5 & 8

EDUCATIONAL SPECIFICATION:

Report of Property Condition Assessment

Academy of Hope - Ward 5

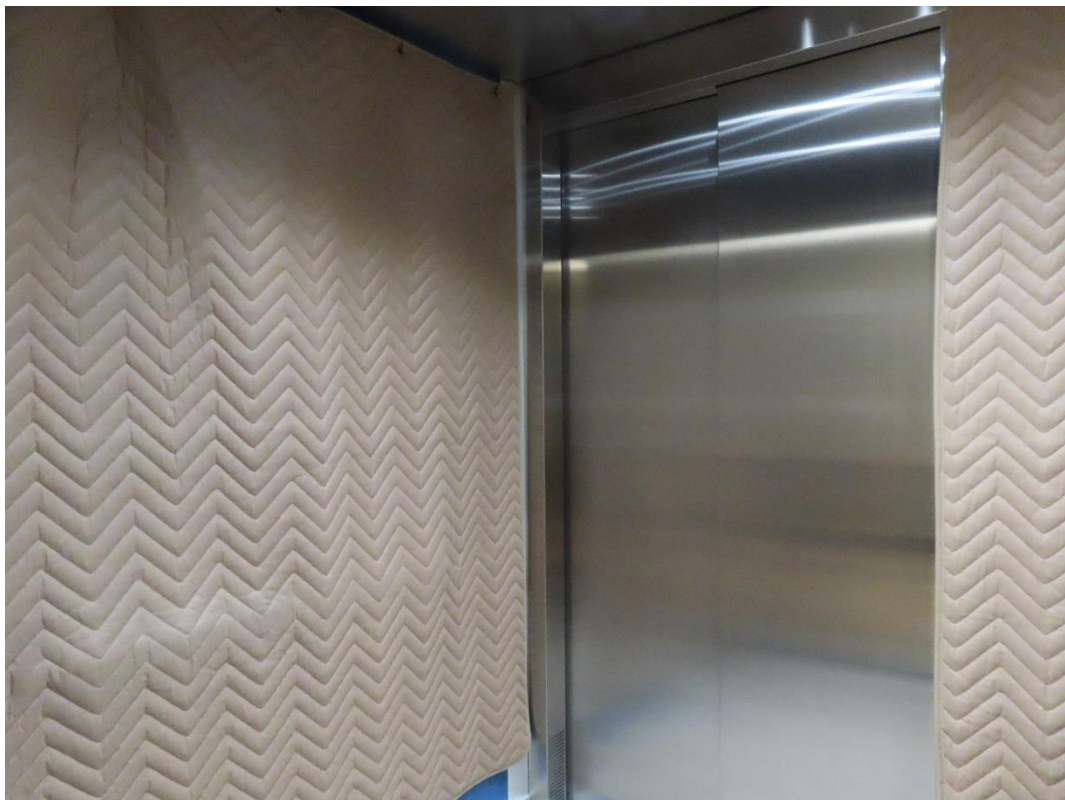
Photograph 54: Elevator cab interior.
