ACADEMY OF HOPE - WARD 5 & 8

EDUCATIONAL SPECIFICATION:

Report of Property Condition Assessment

Academy of Hope - Ward 5

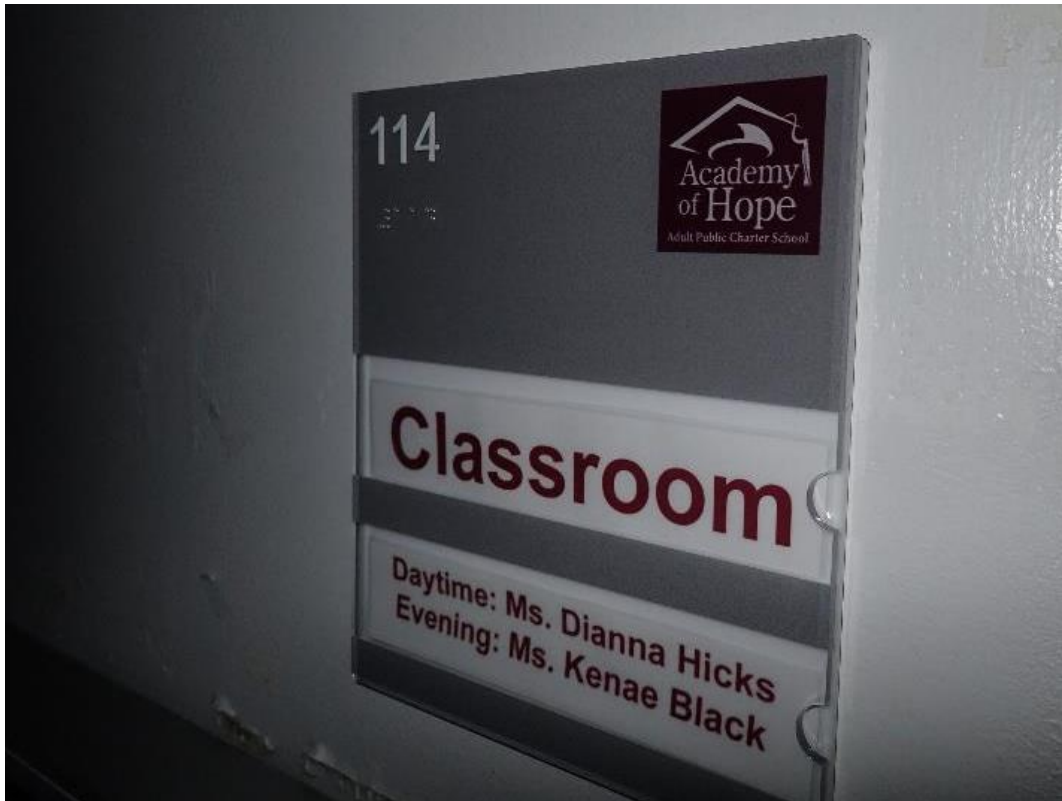
Photograph 2: Accessible signage.

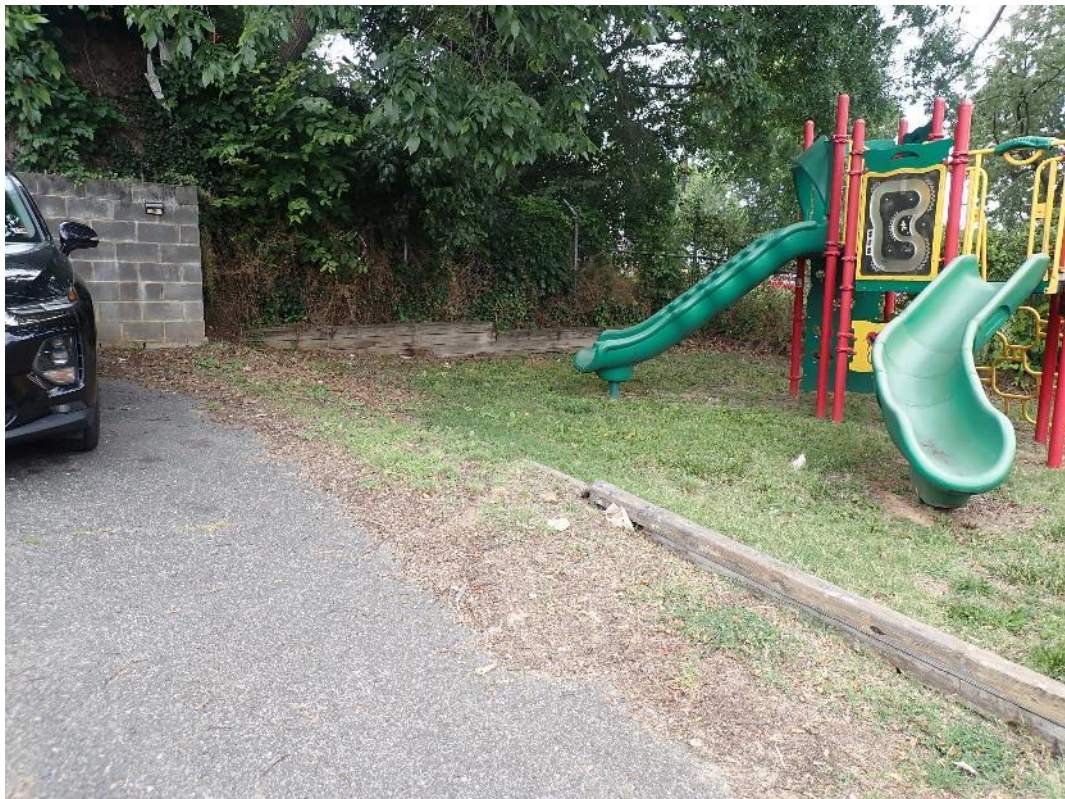
Photograph 10: Grassed areas and play equipment.

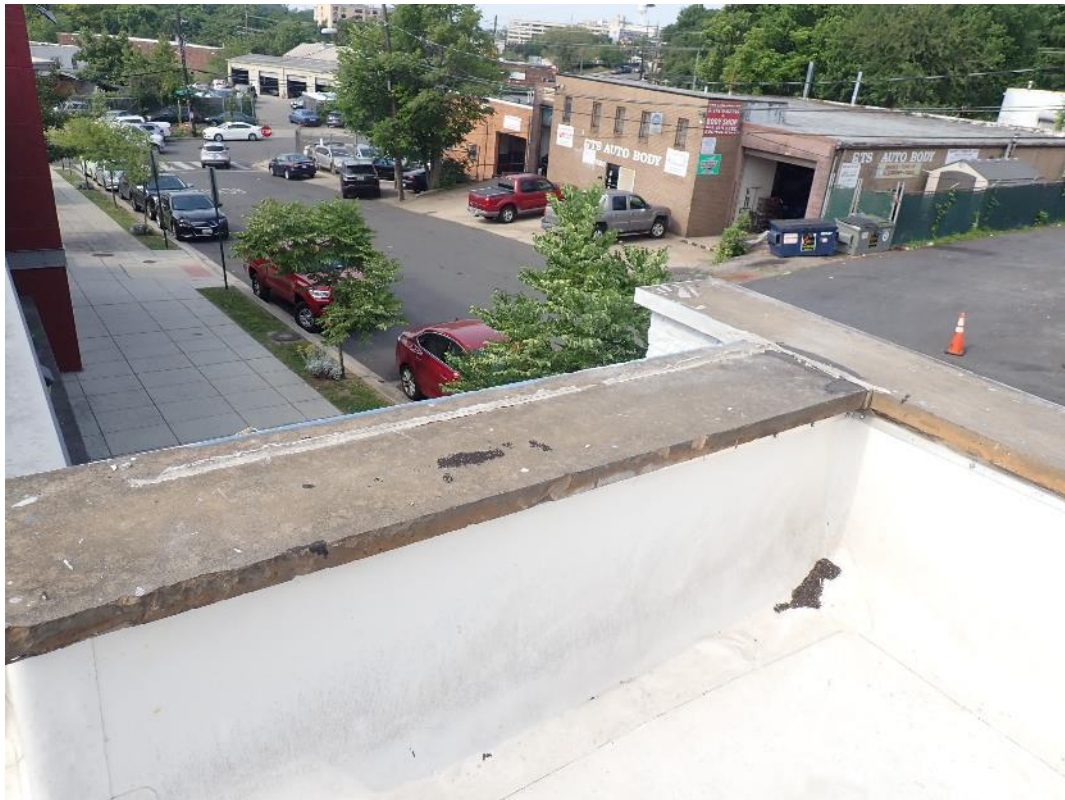
Photograph 18: Roof parapets.

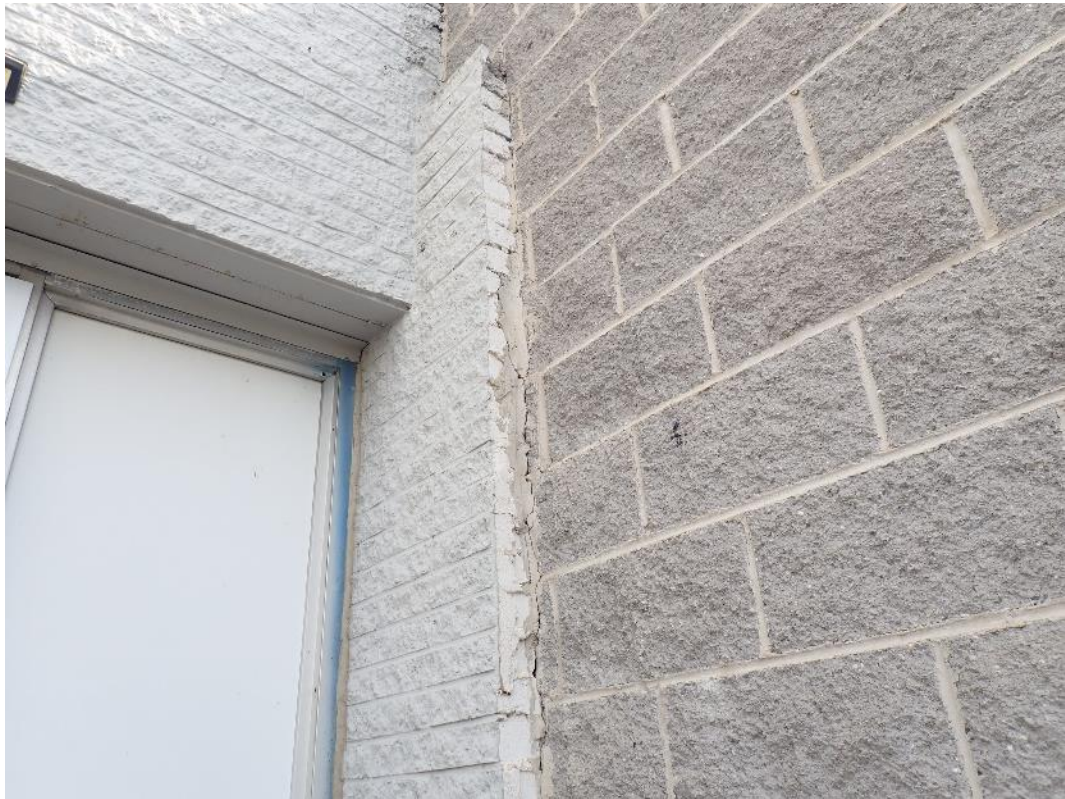
Photograph 21: Brick and split-face CMU walls.

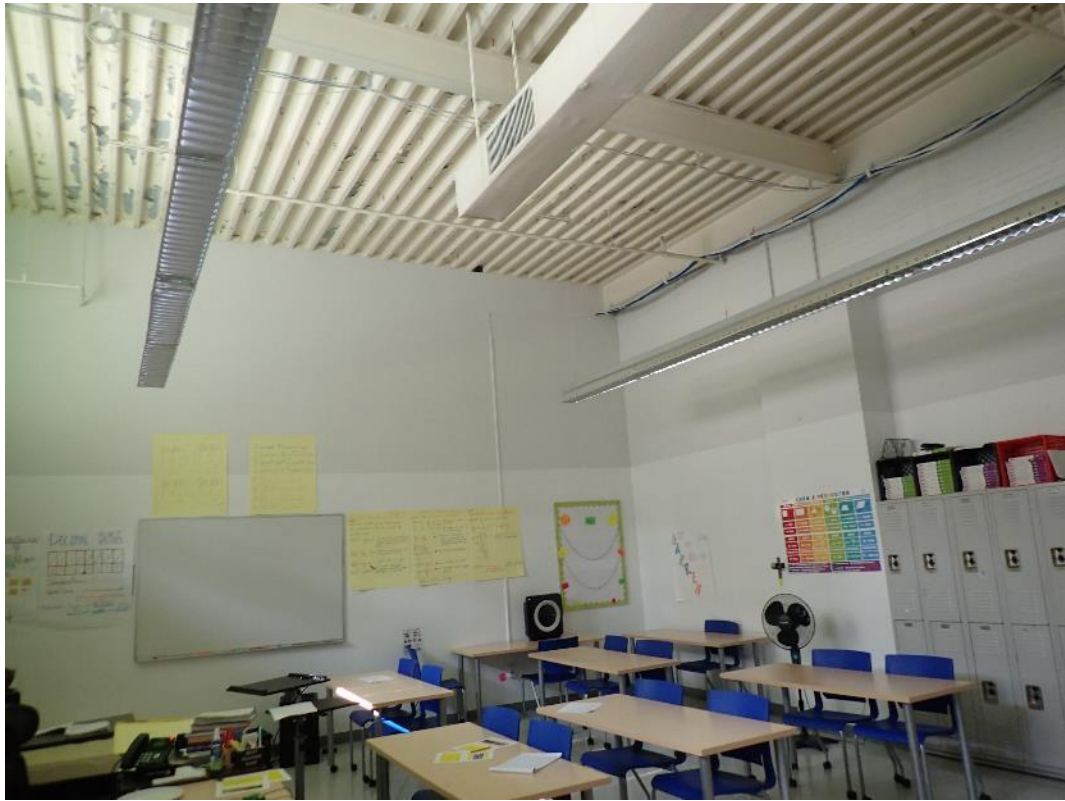
Photograph 25: Typical classroom finishes.

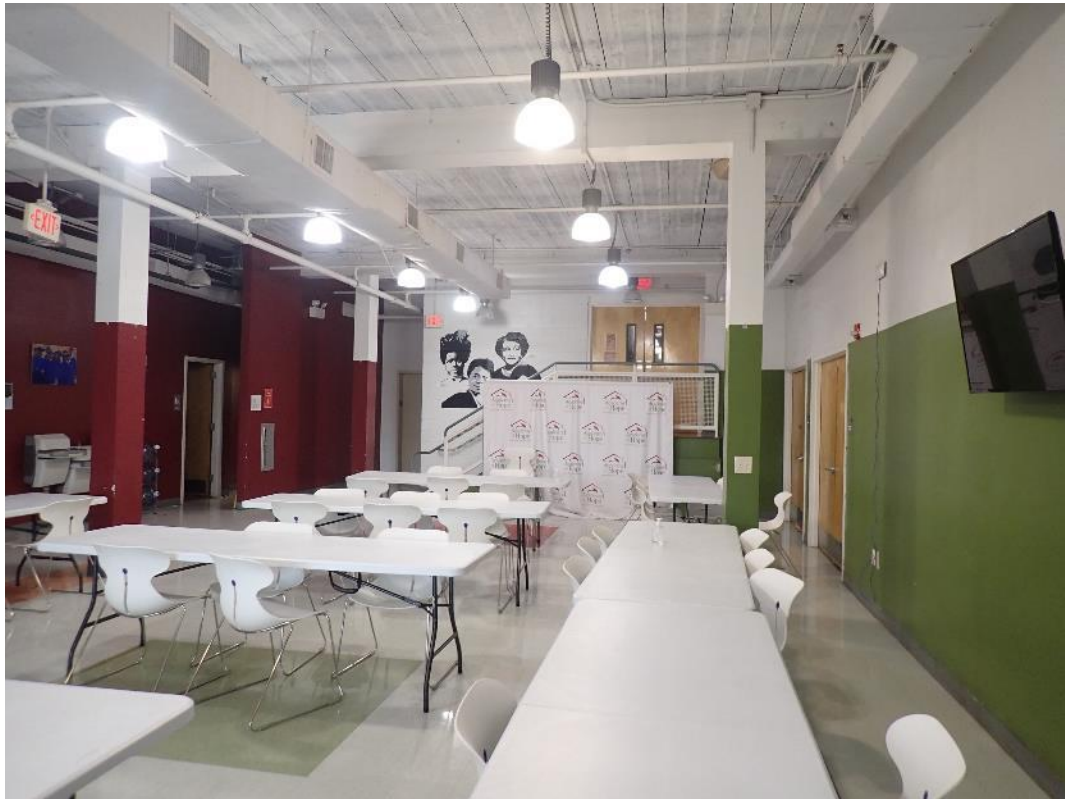
Photograph 27: Interior breakout space.

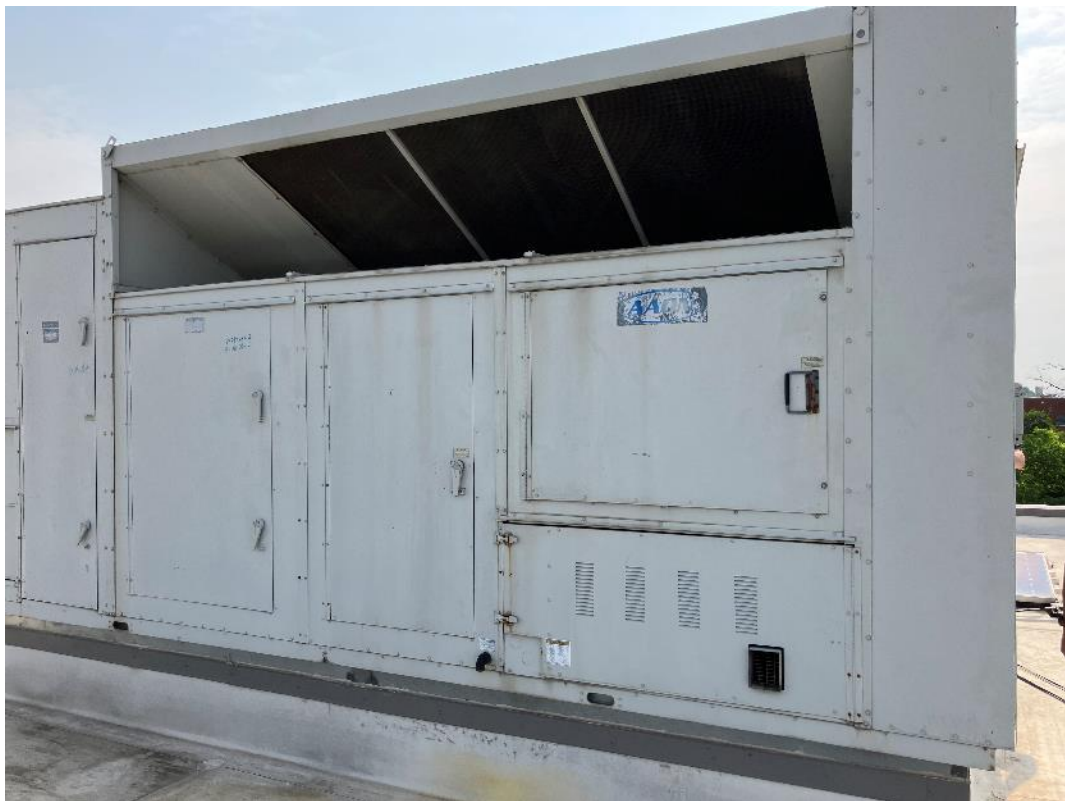
Photograph 28: Rooftop unit.

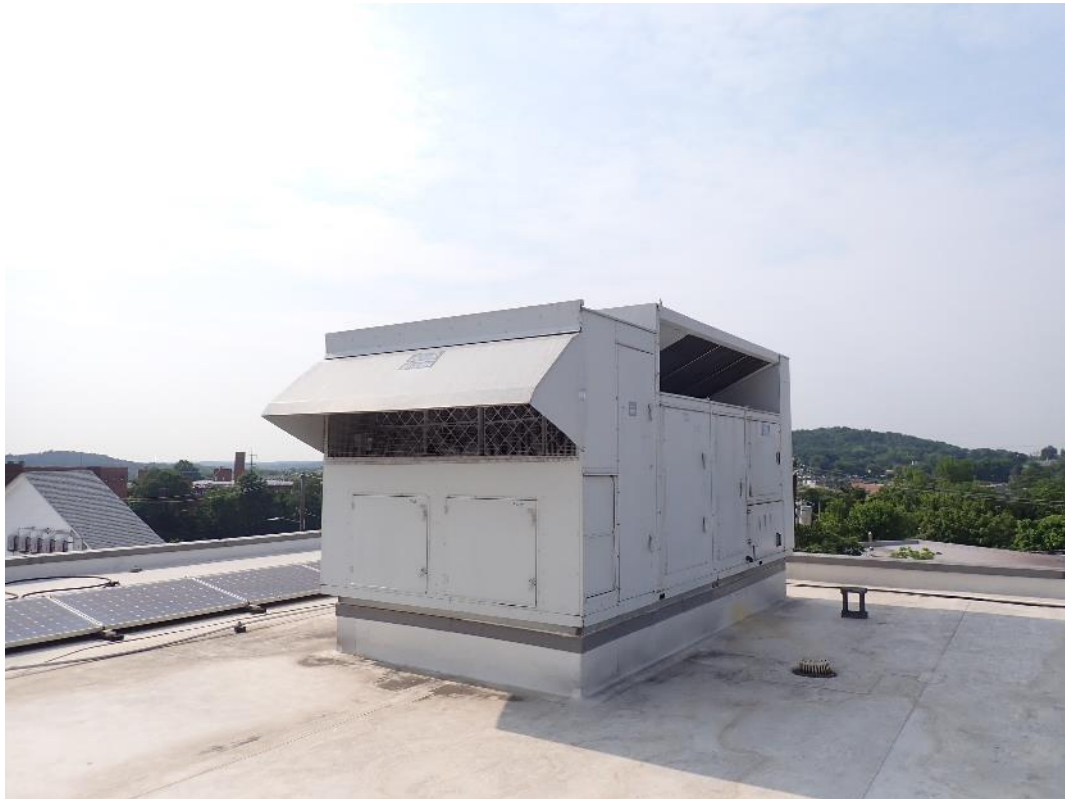
Photograph 29: Rooftop unit.

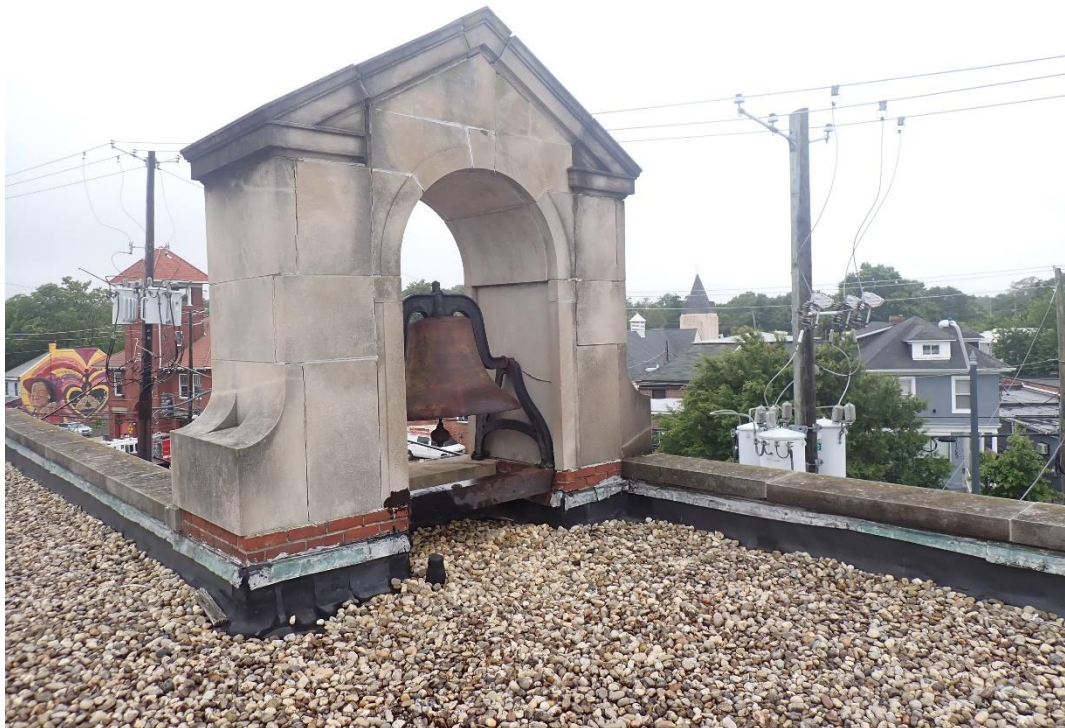
Photograph 14: Bell tower.

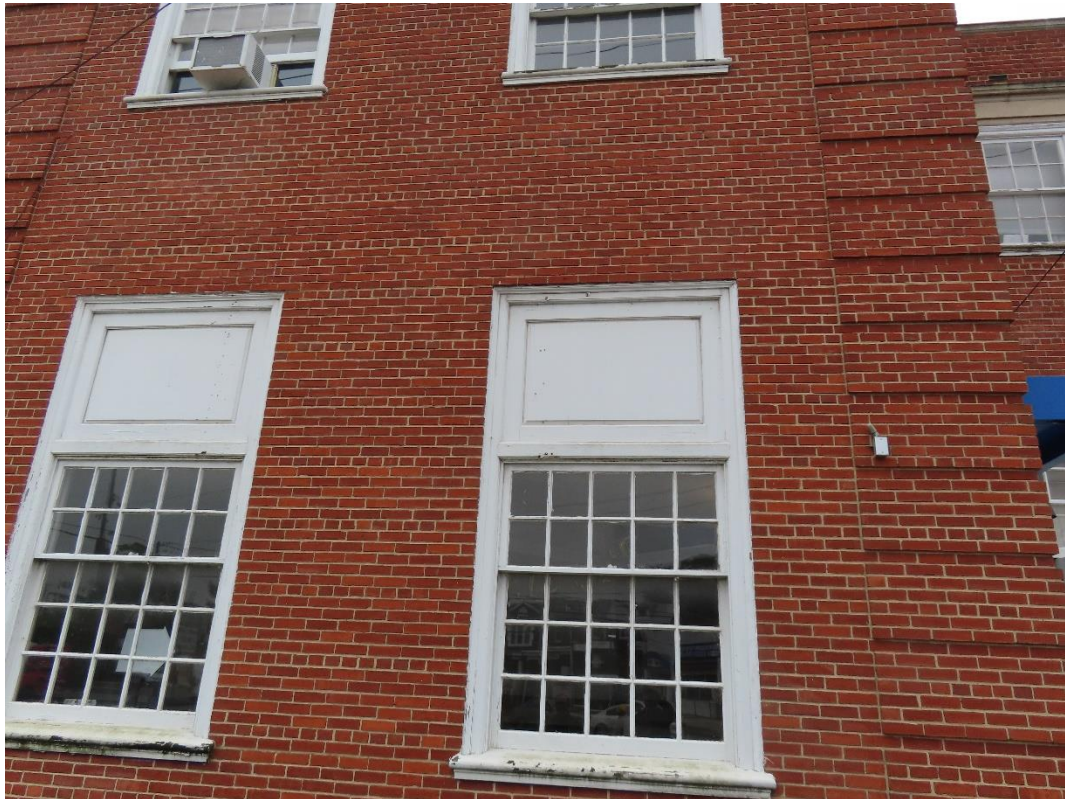
Photograph 19: Exterior windows.

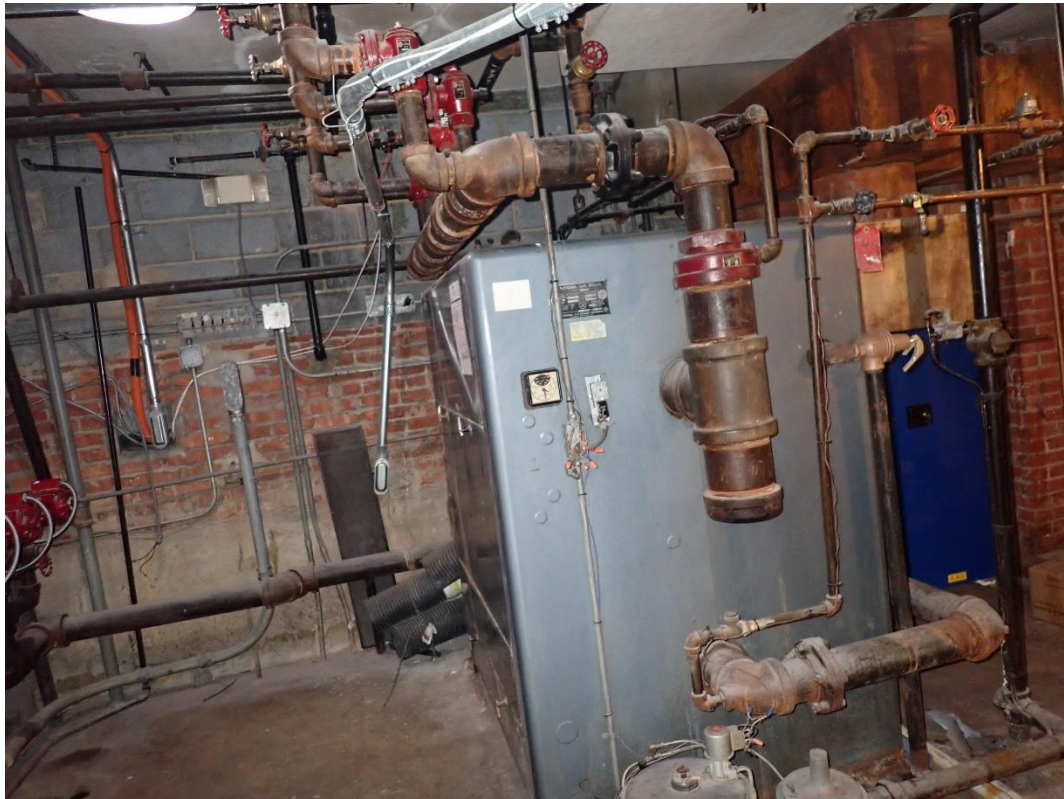
Photograph 25: Hydronic boiler.

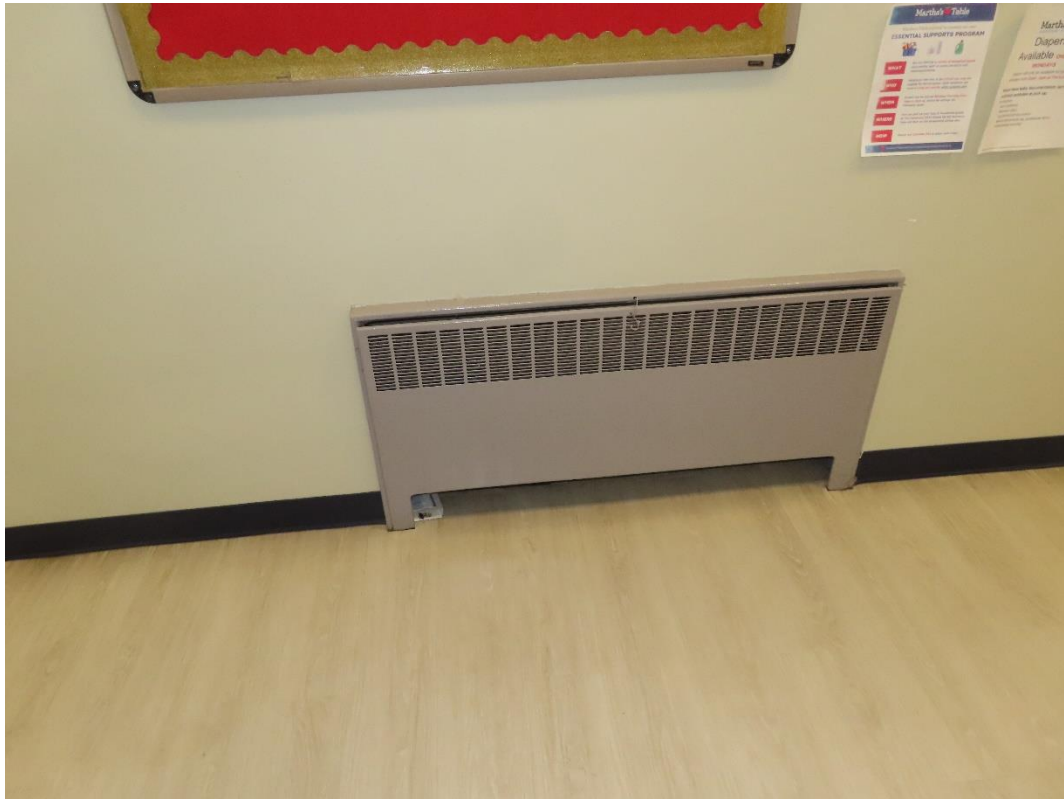
Photograph 27: Alcove radiator.

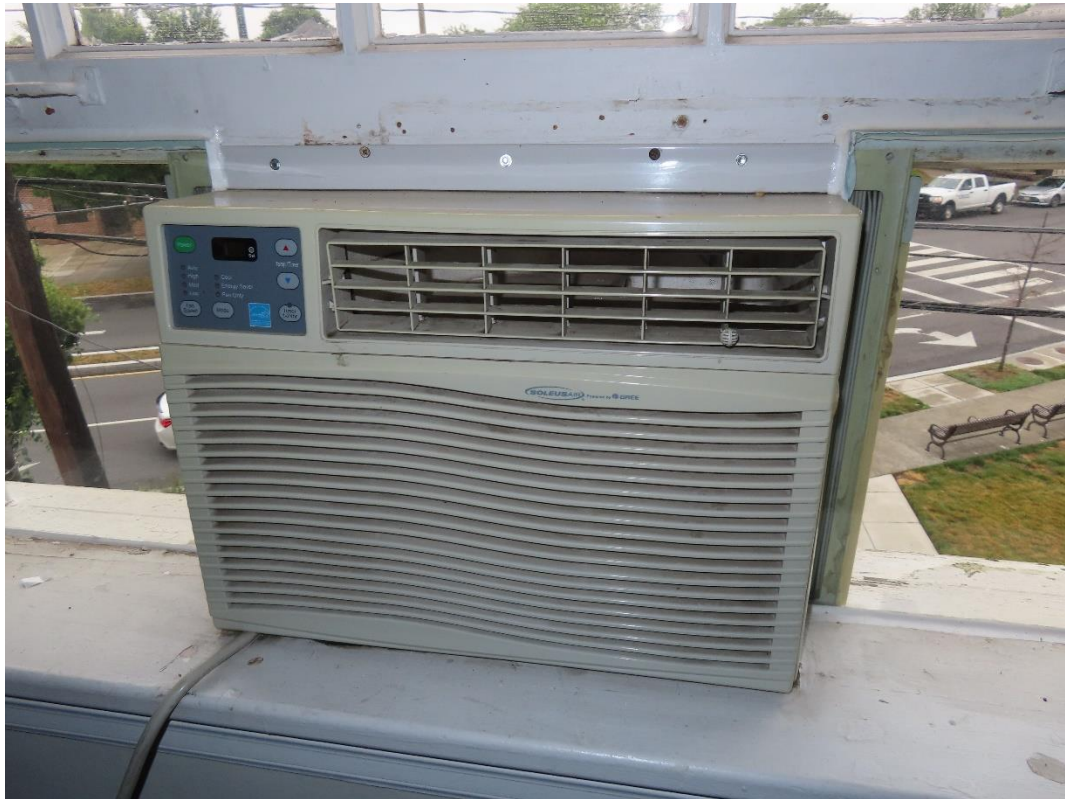
Photograph 29: Typical window A/C unit.

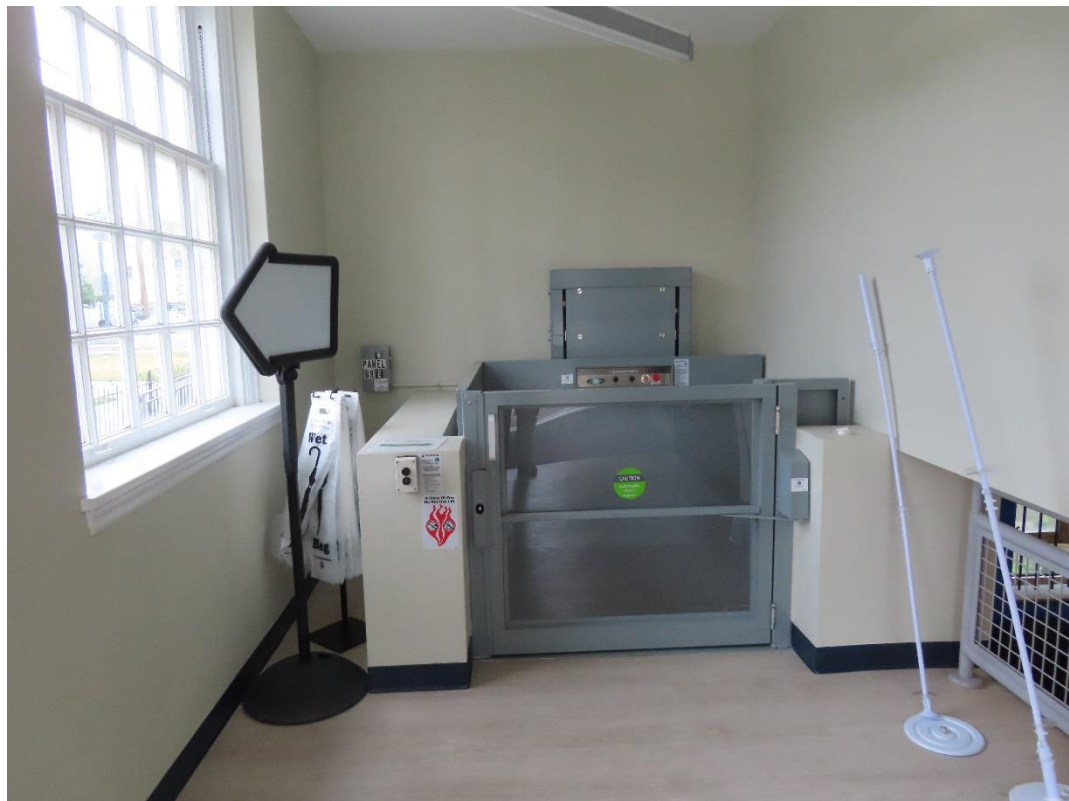
The elevator and platform lift all appeared to date from the 2020's, or thereabouts, and were in fair condition. Subject to routine maintenance costs, we do not anticipate any capital expenditure on these components during the term.

Photograph 52: Platform elevator.
